## New York State Department of Transportation Yellow Flag 7B21N6W018

*BIN:* 3338900

*Feature Carried:* 971HX

*Feature Crossed:* BLACK RIVER

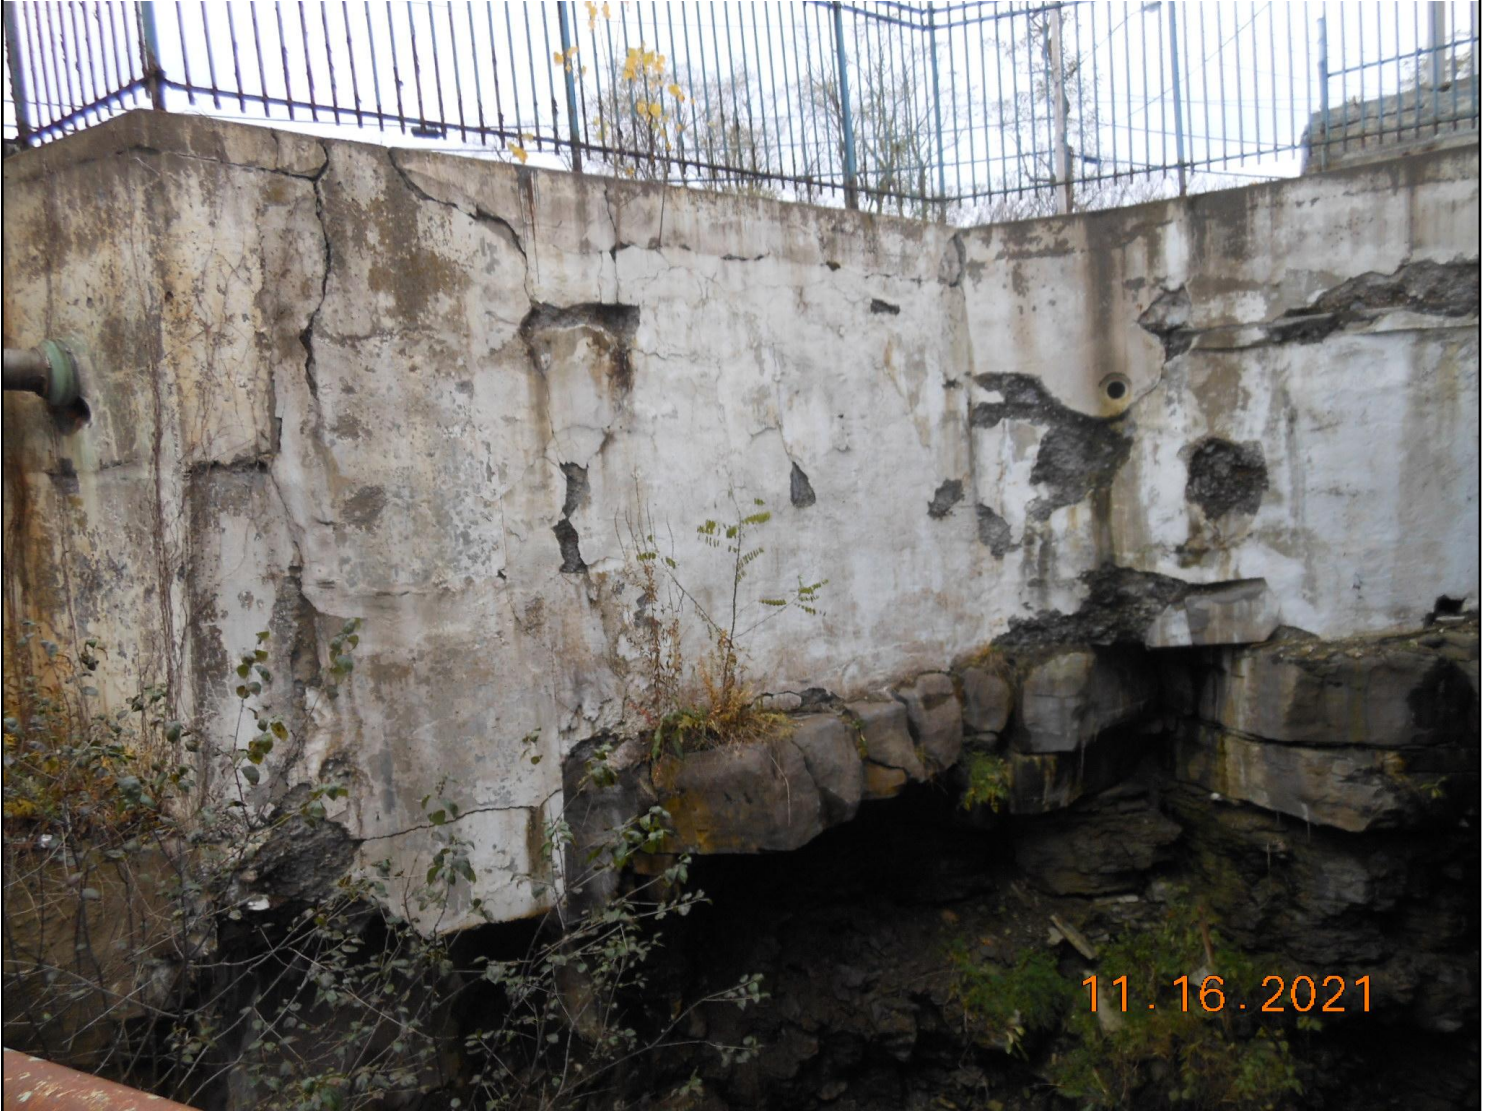
Photo Number: 3

***Attachment Description: Begin Left Wingwall***

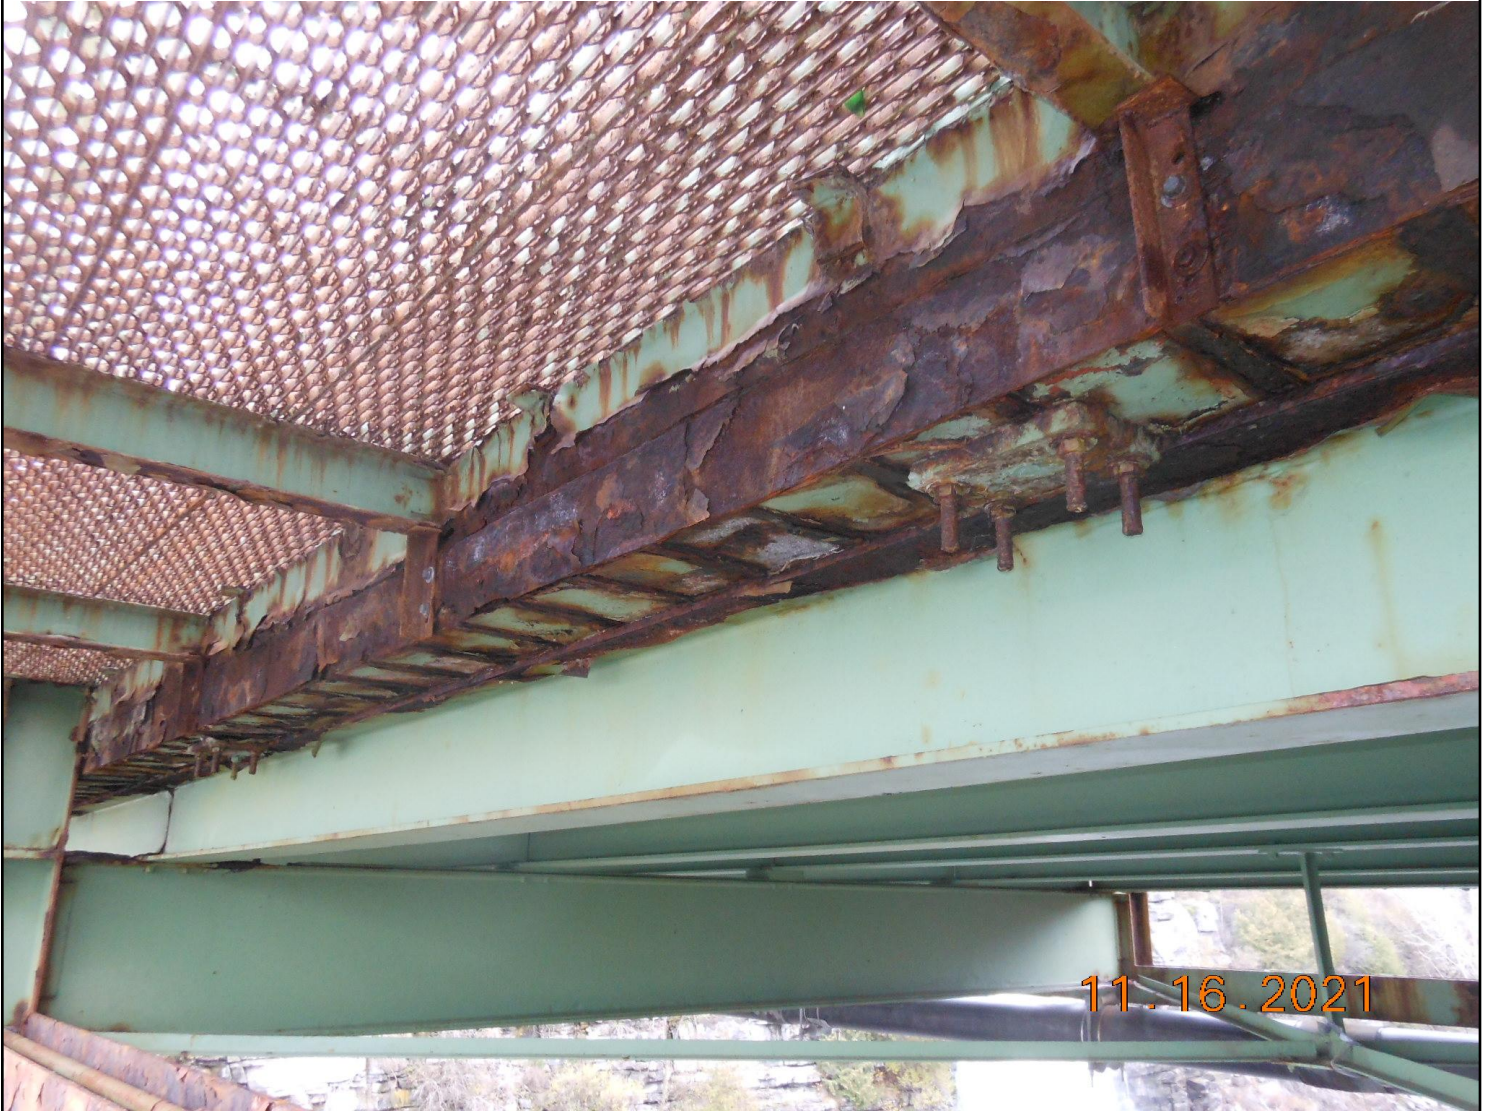
Photo Number: 3

2021 Flag Conditions: The steel channel embedded in the left deck fascia still has heavy section loss with perforations throughout the length of the bridge therefore this repeat yellow flag is issued (flag photos 3 through 5). Conditions have not changed significantly since Yellow Flag 7B2095W004 was issued.

Significance: Section loss of the steel channel embedded in the left deck fascia reduces the capacity of the left sidewalk.

**Attachment Description: Left Fascia Channel between L02 and L03 from Begin**

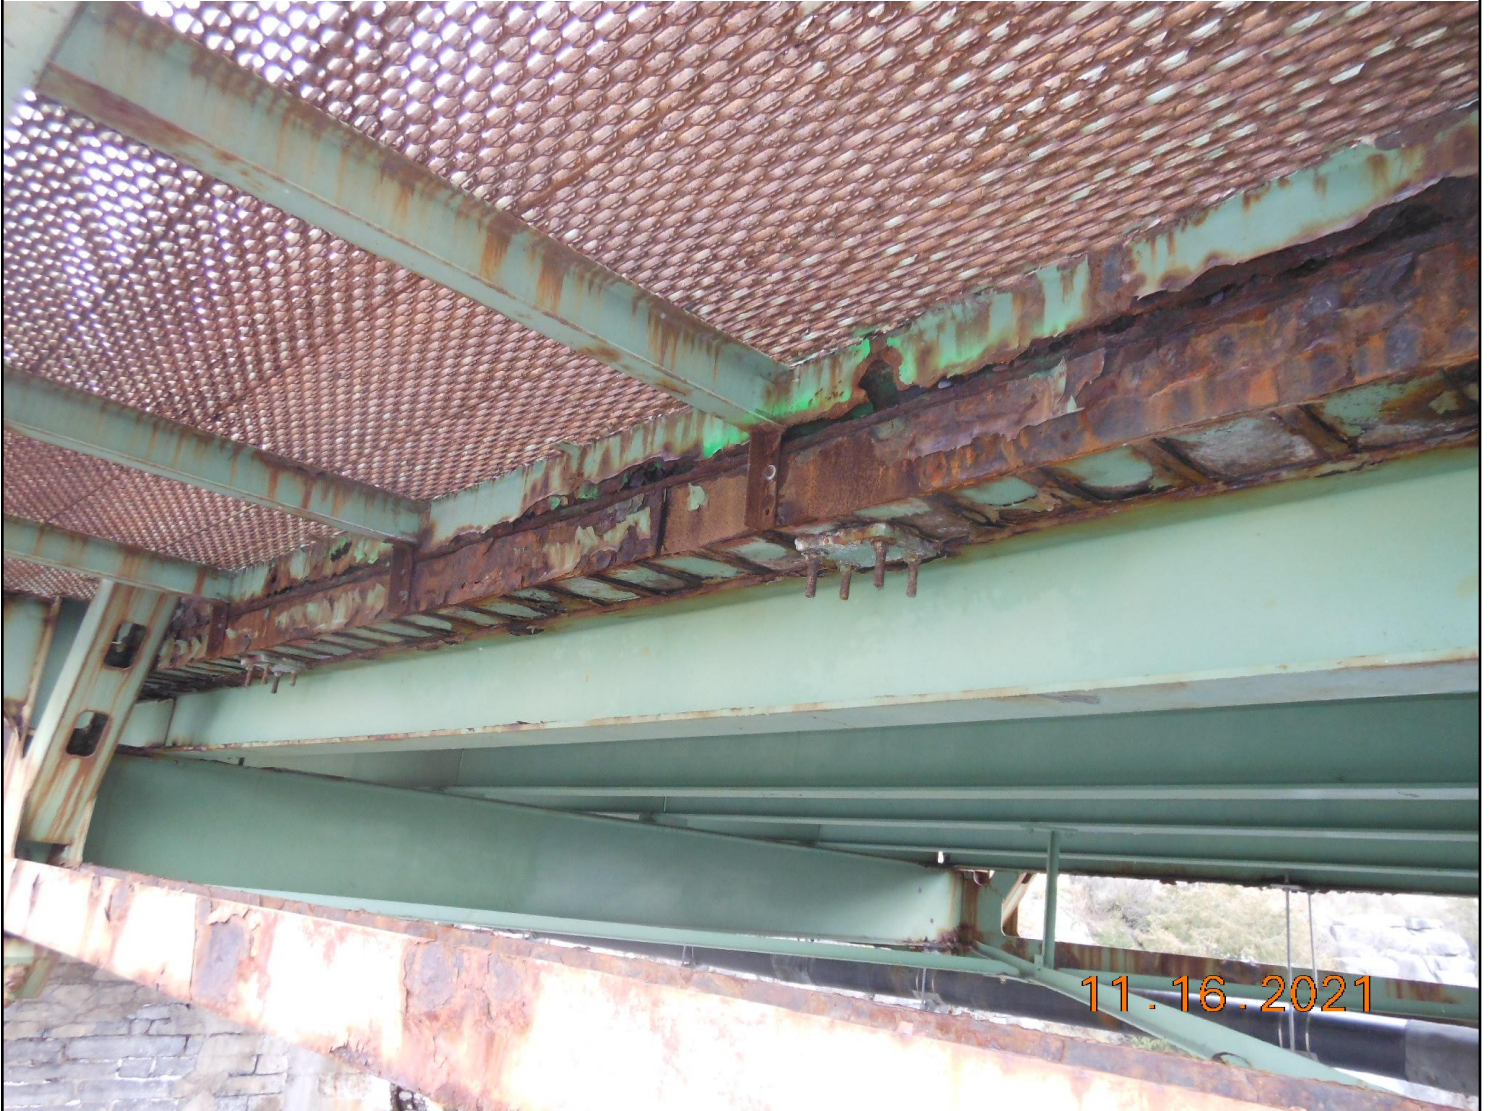
Photo Number: 4

**Attachment Description: Left Fascia Channel between L05 and L06 from Begin**

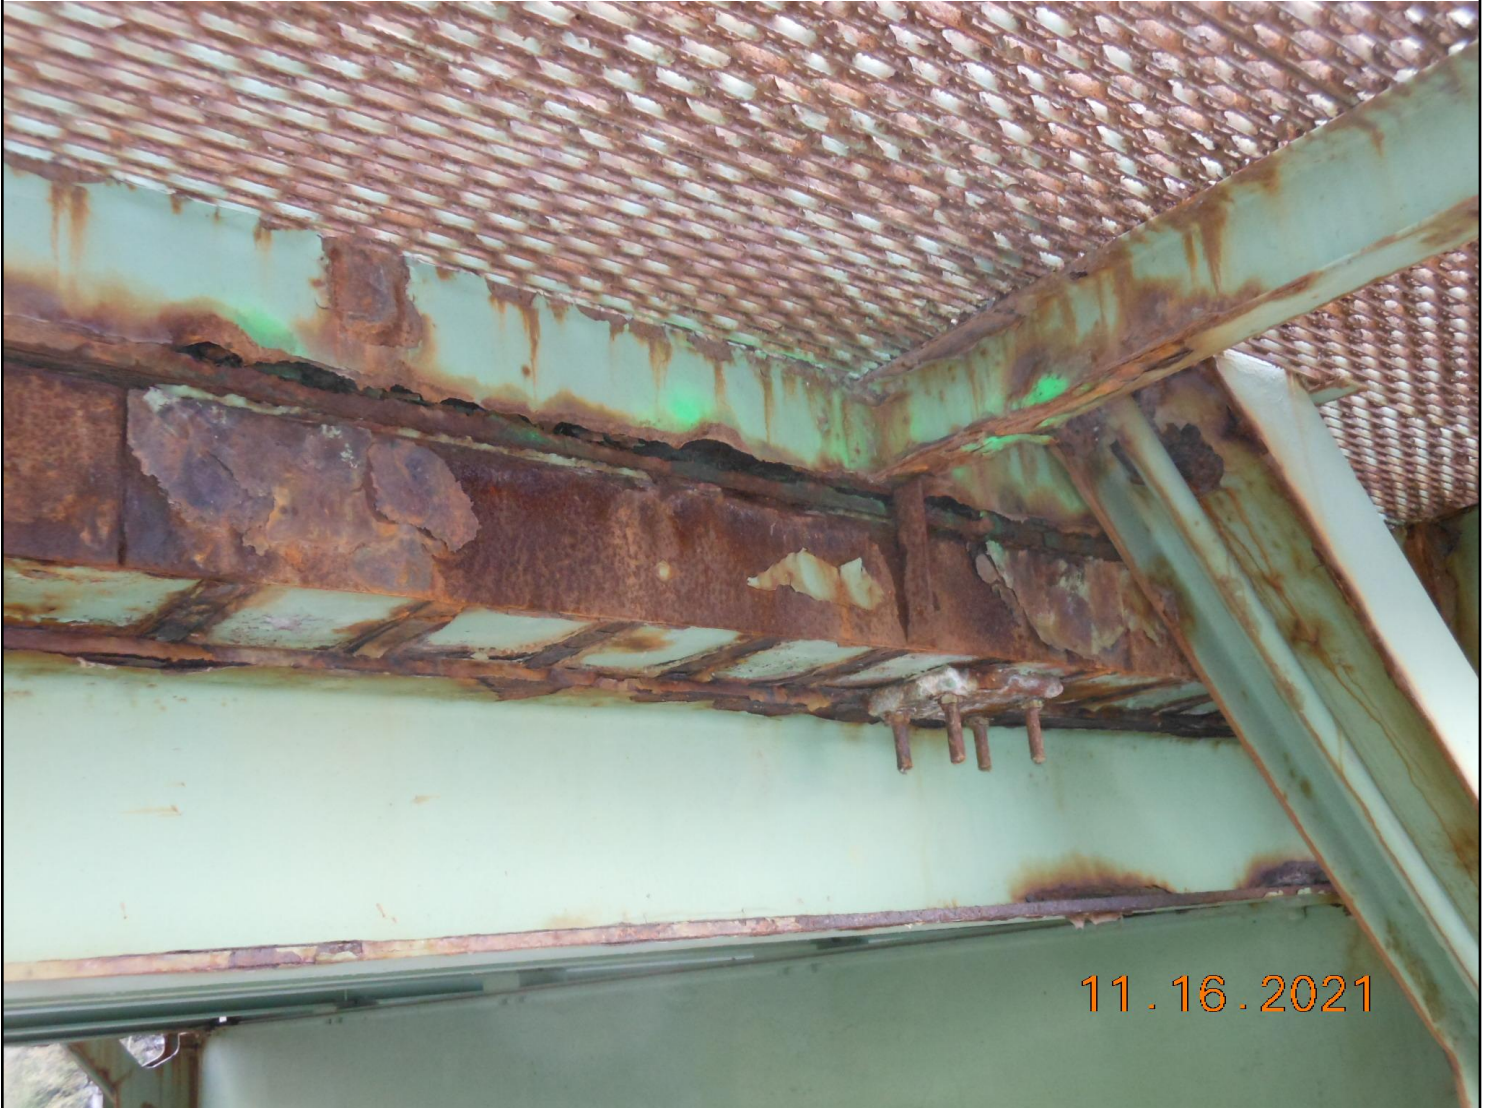
Photo Number: 5

***Attachment Description: Left Fascia Channel betweenL06 and L07 near L06 from End***

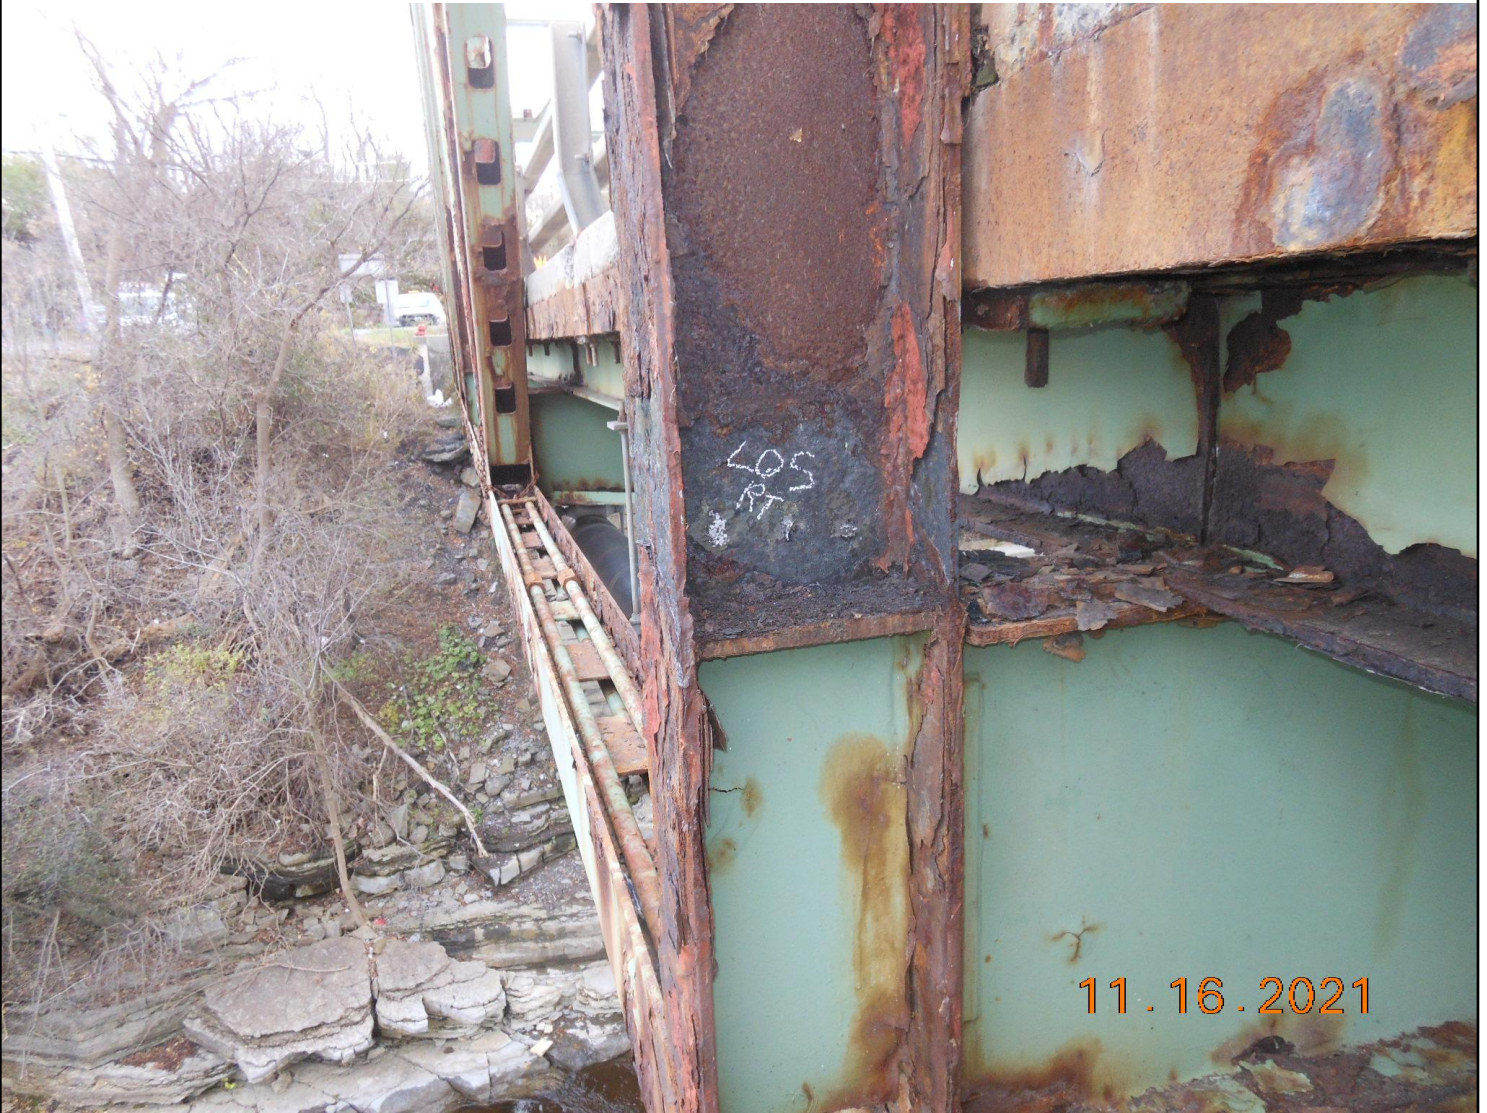
Photo Number: 3

Right truss vertical member L05-U05 has 29% left flange section loss, 23% right flange section loss, and 59% web loss. The total section loss for the member is 35% (flag photo 3). The previous inspection indicates that section loss of flanges was 5% and 17%.

Significance: Section loss of the verticals at the odd panel points, which are fracture-critical members, could affect the load carrying capacity of the bridge as these directly support the ends of the floorbeams.

**Attachment Description: End Face of Right Truss Vertical Member L05\_U05 at Top of Floorbeam**

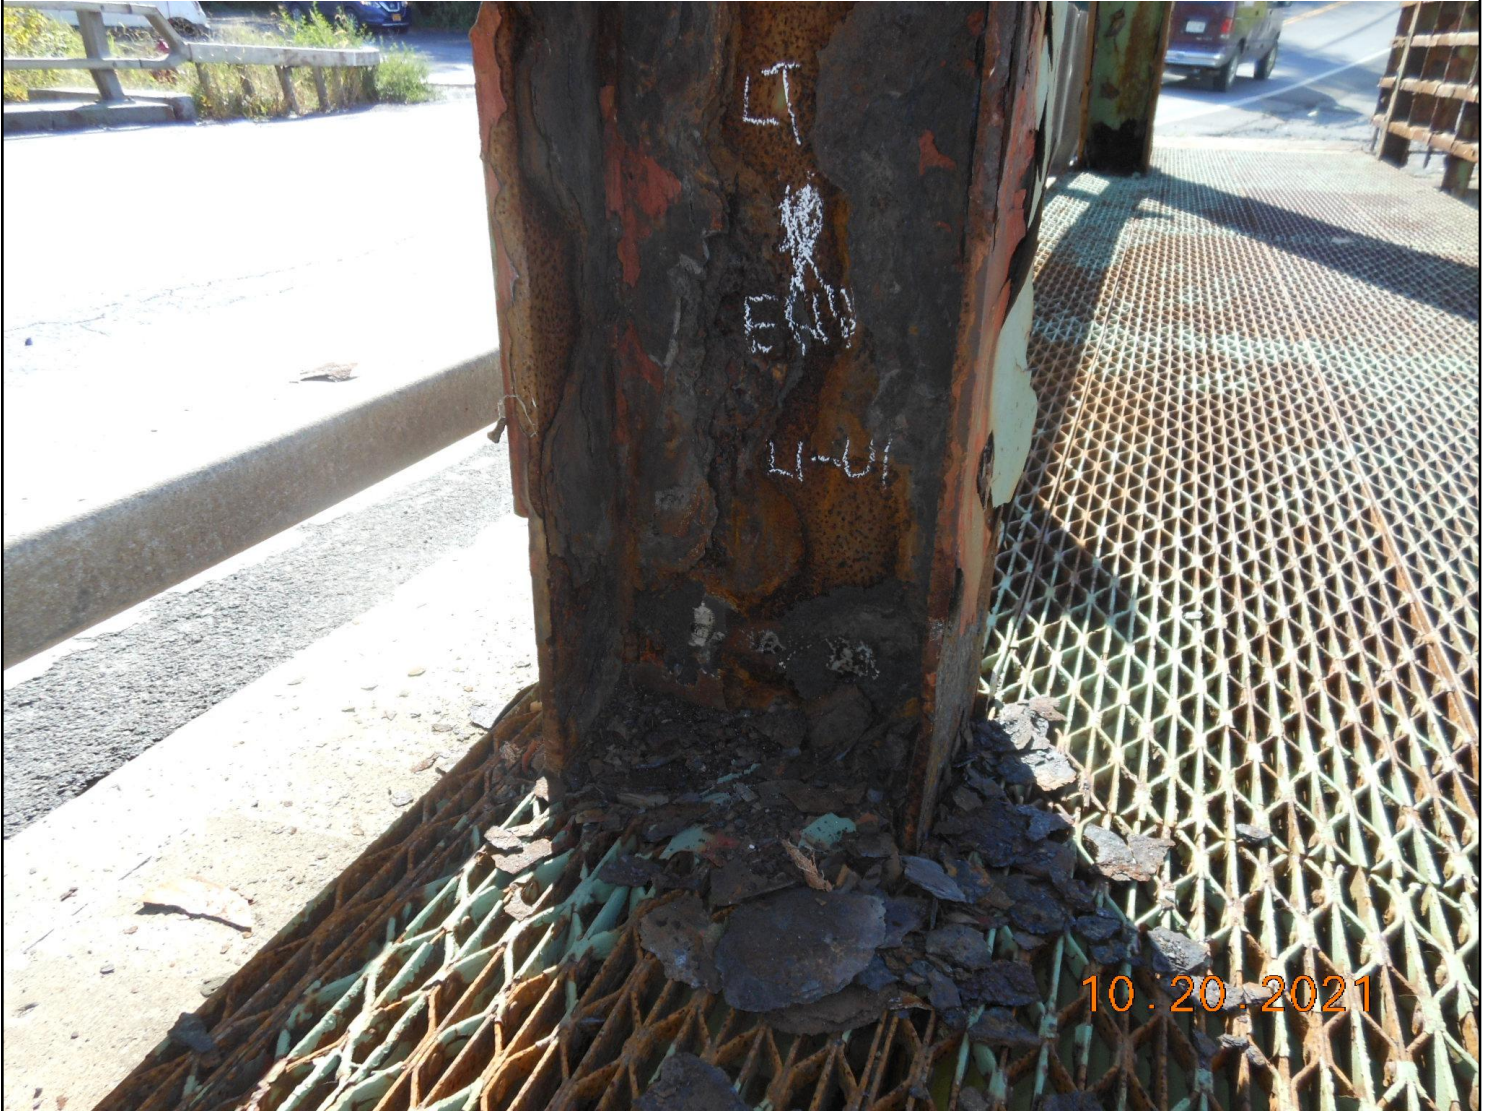
Photo Number: 4

Left Truss L01-U01 vertical member section loss readings were taken just above the sidewalk. The left flange has approximately 30% section loss; the right flange has approximately 32% section loss, the web has approximately 14% section loss. The total section loss for the member is 27% (flag photo 4). Deterioration for this member was previously estimated to have 10% section loss.

**Attachment Description: End Face of Left Truss Vertical Member L01\_U01 at Top of Sidewalk**

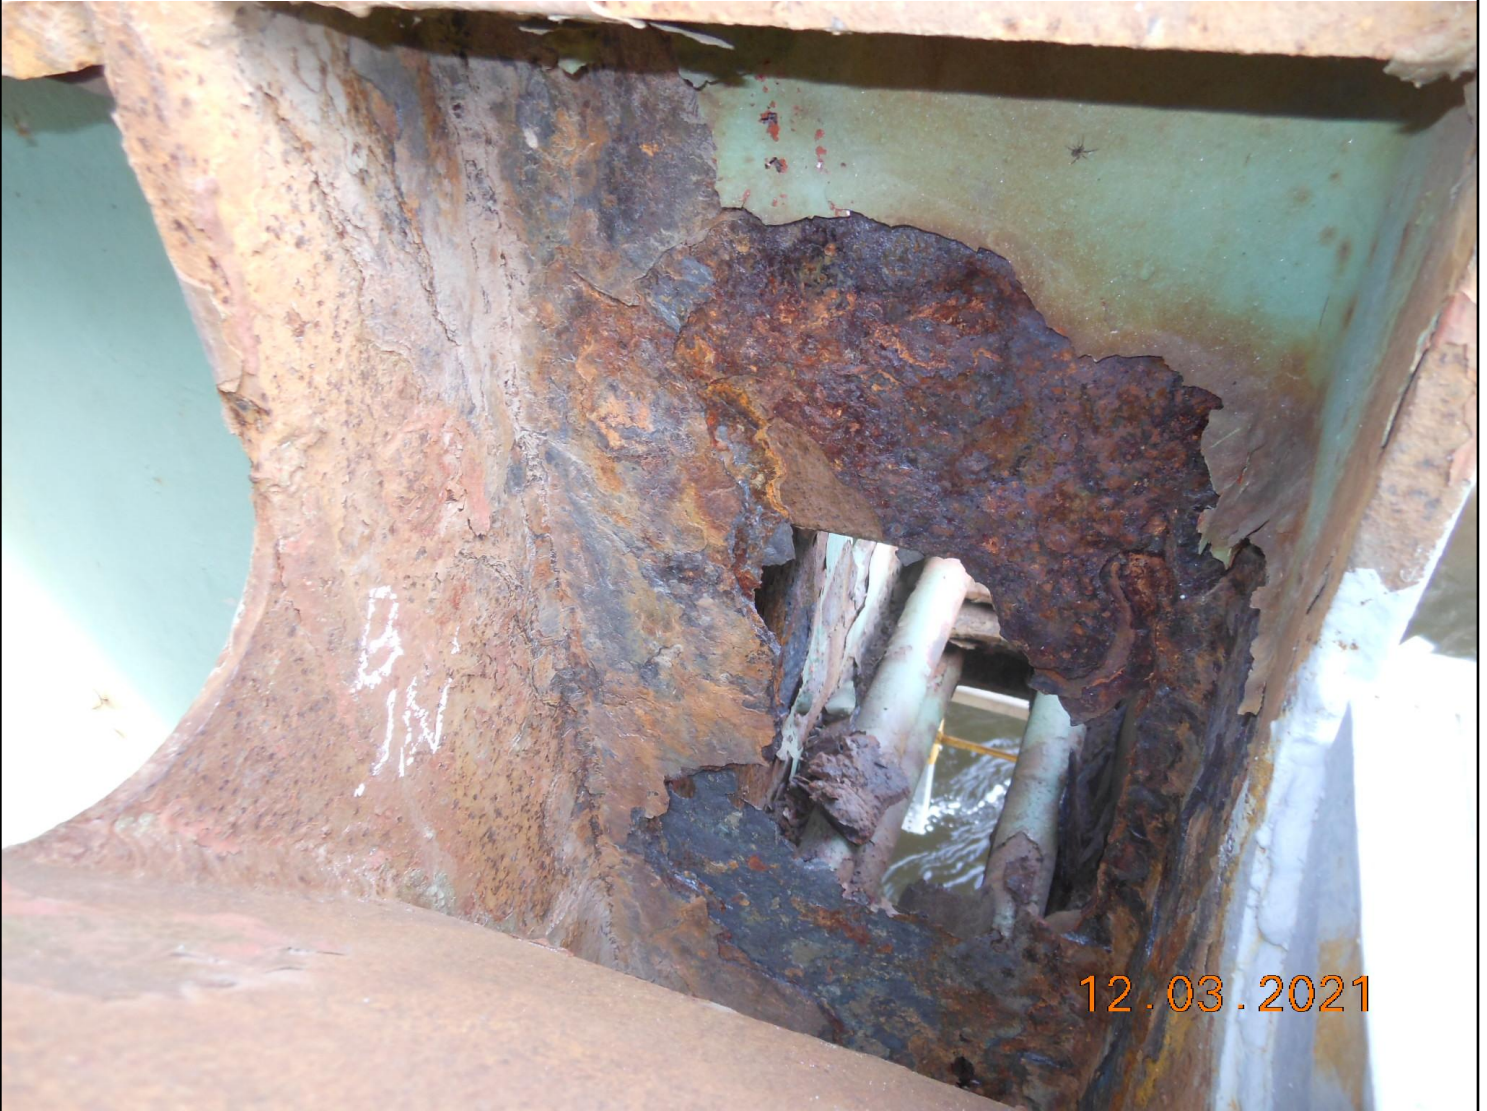
Photo Number: 3

Right truss vertical member L04-U04 has 10% (estimated) inner (left) flange section loss, 30% outer (right) flange section loss, and up to 100% web loss below the elevation of the top of the floorbeam. The total section loss for the member below the top of the floorbeam is 41% (flag photos 3 through 6).

***Attachment Description: Lower Portion of Right Truss Vertical L04-U04\_from Begin***

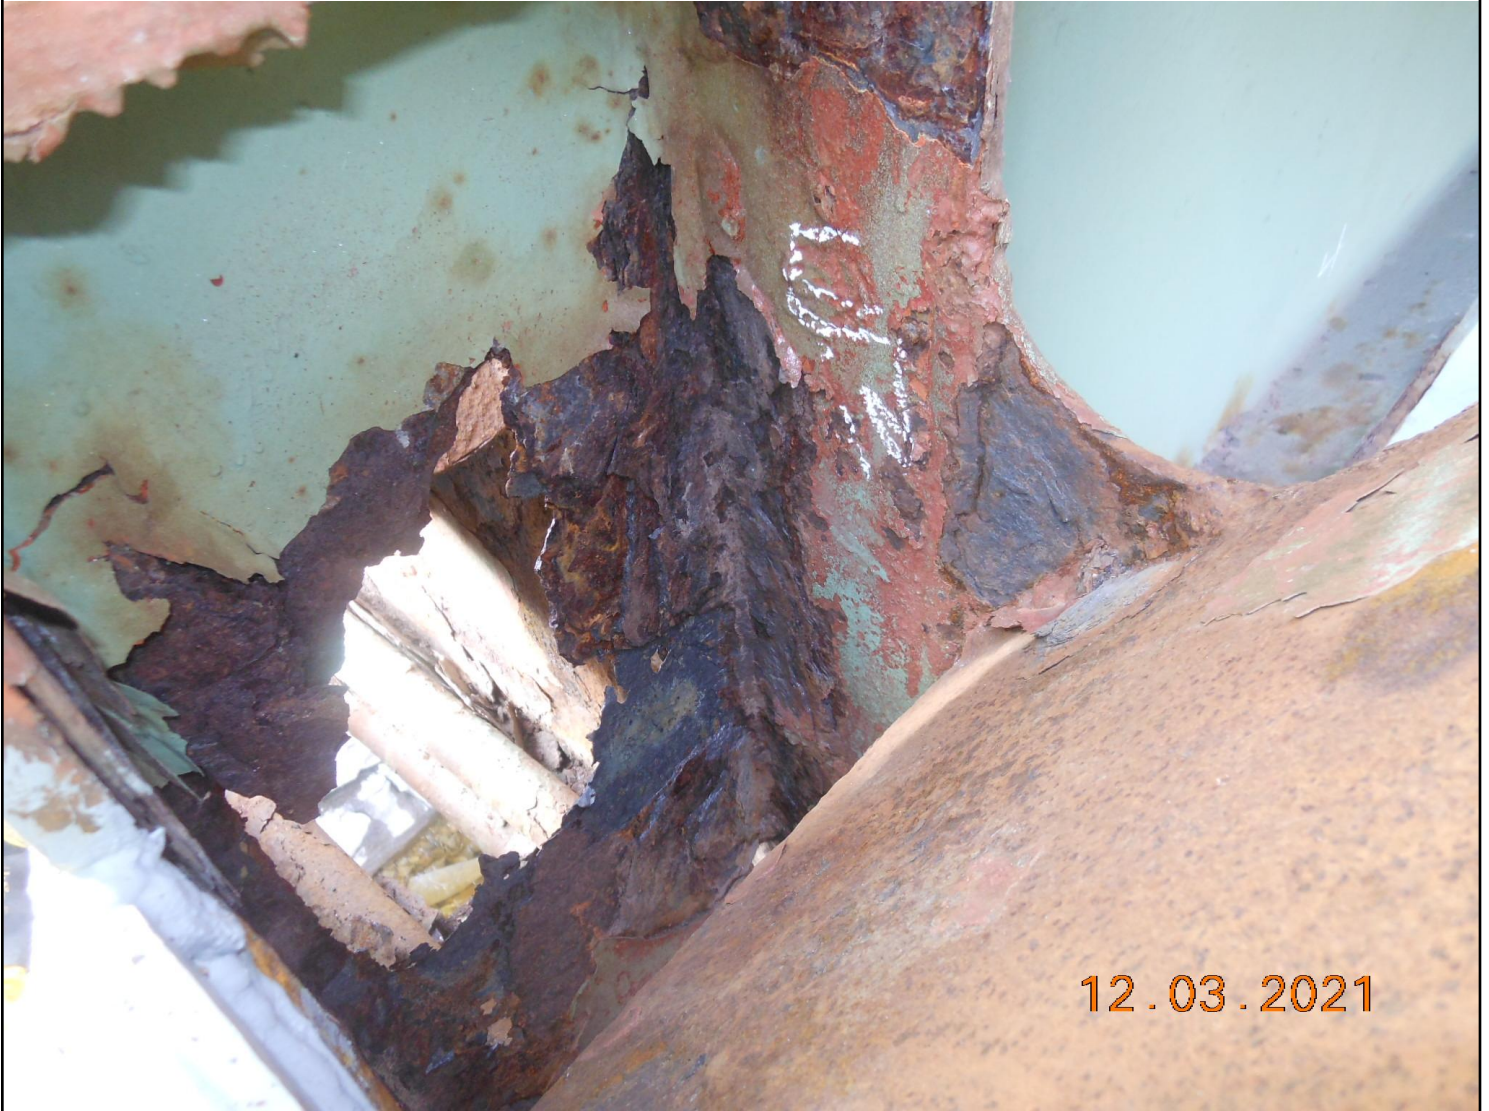
Photo Number: 4

***Attachment Description: Lower Portion of Right Truss Vertical L04-U04 from End***

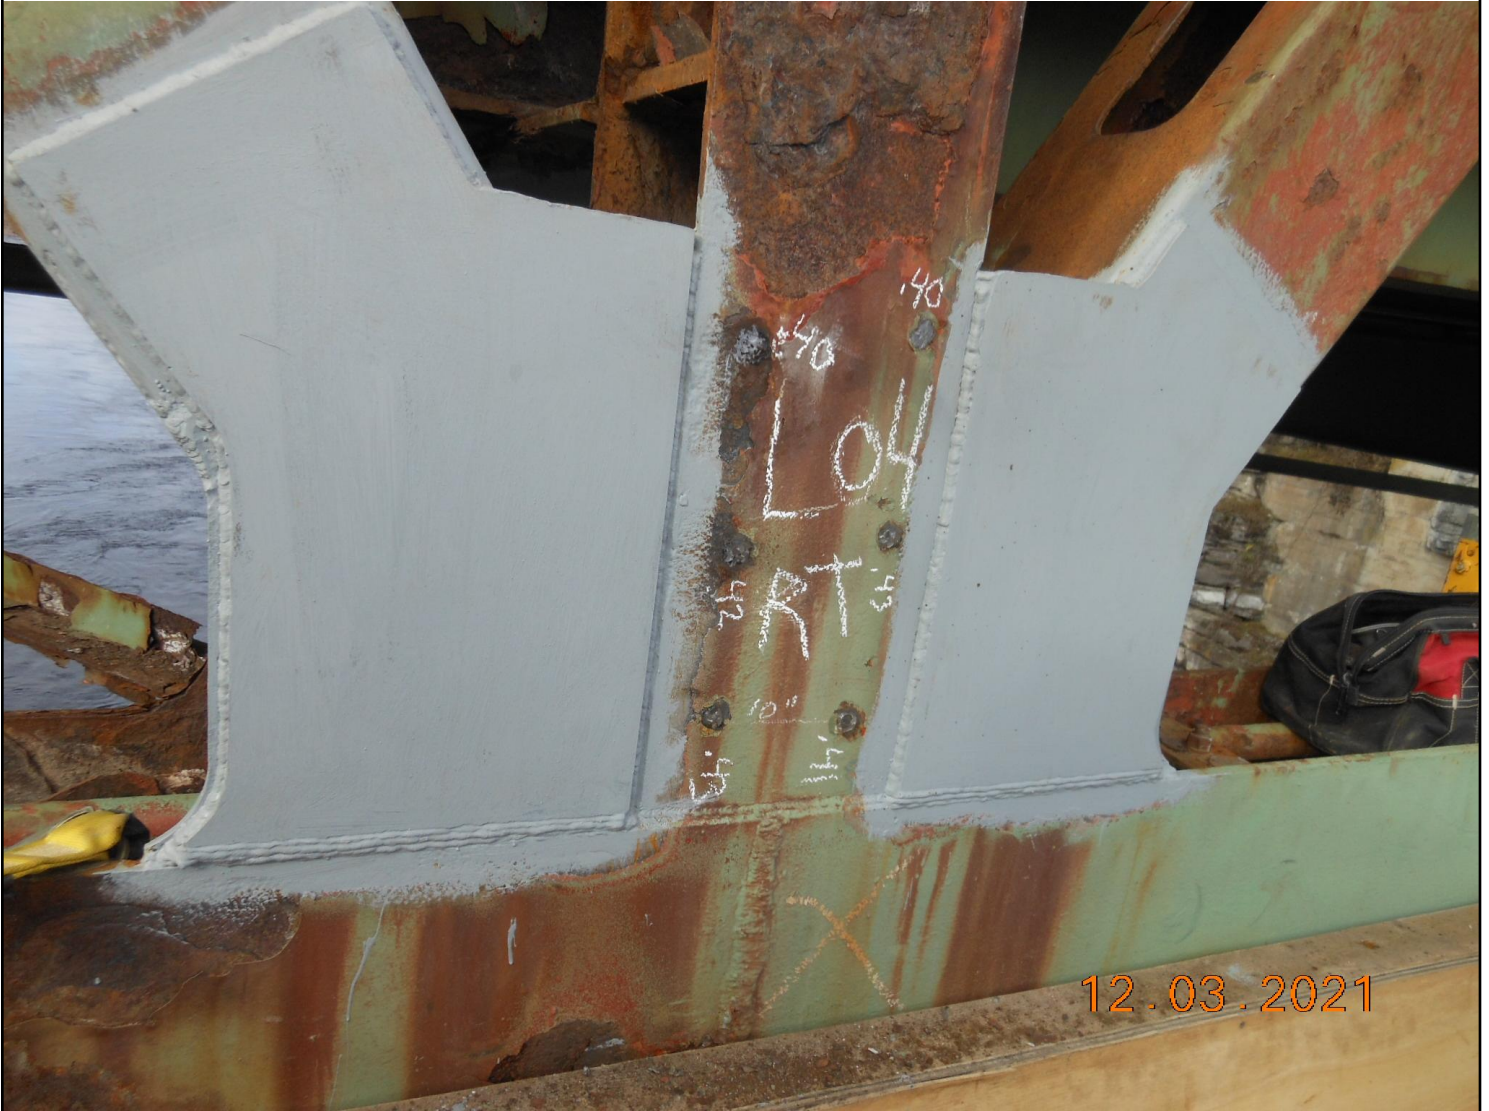
Photo Number: 5

**Attachment Description: Right Truss at L04 from Right**

Mitigating Conditions: The bridge is posted for "No Trucks with R Permits" (flag photo 7). The floorbeam is connected to the inner (left) flange of right truss vertical member L04-U04. The inner (left) flange of L04-U04 has 10% (estimated) section loss where it is connected to the floorbeam. The inner gusset plates at L04 have 10% to 15% section loss. The outer gusset plates at right truss L04 have been repaired (flag photo 5) in response to Red Flag 7B21N6W016.

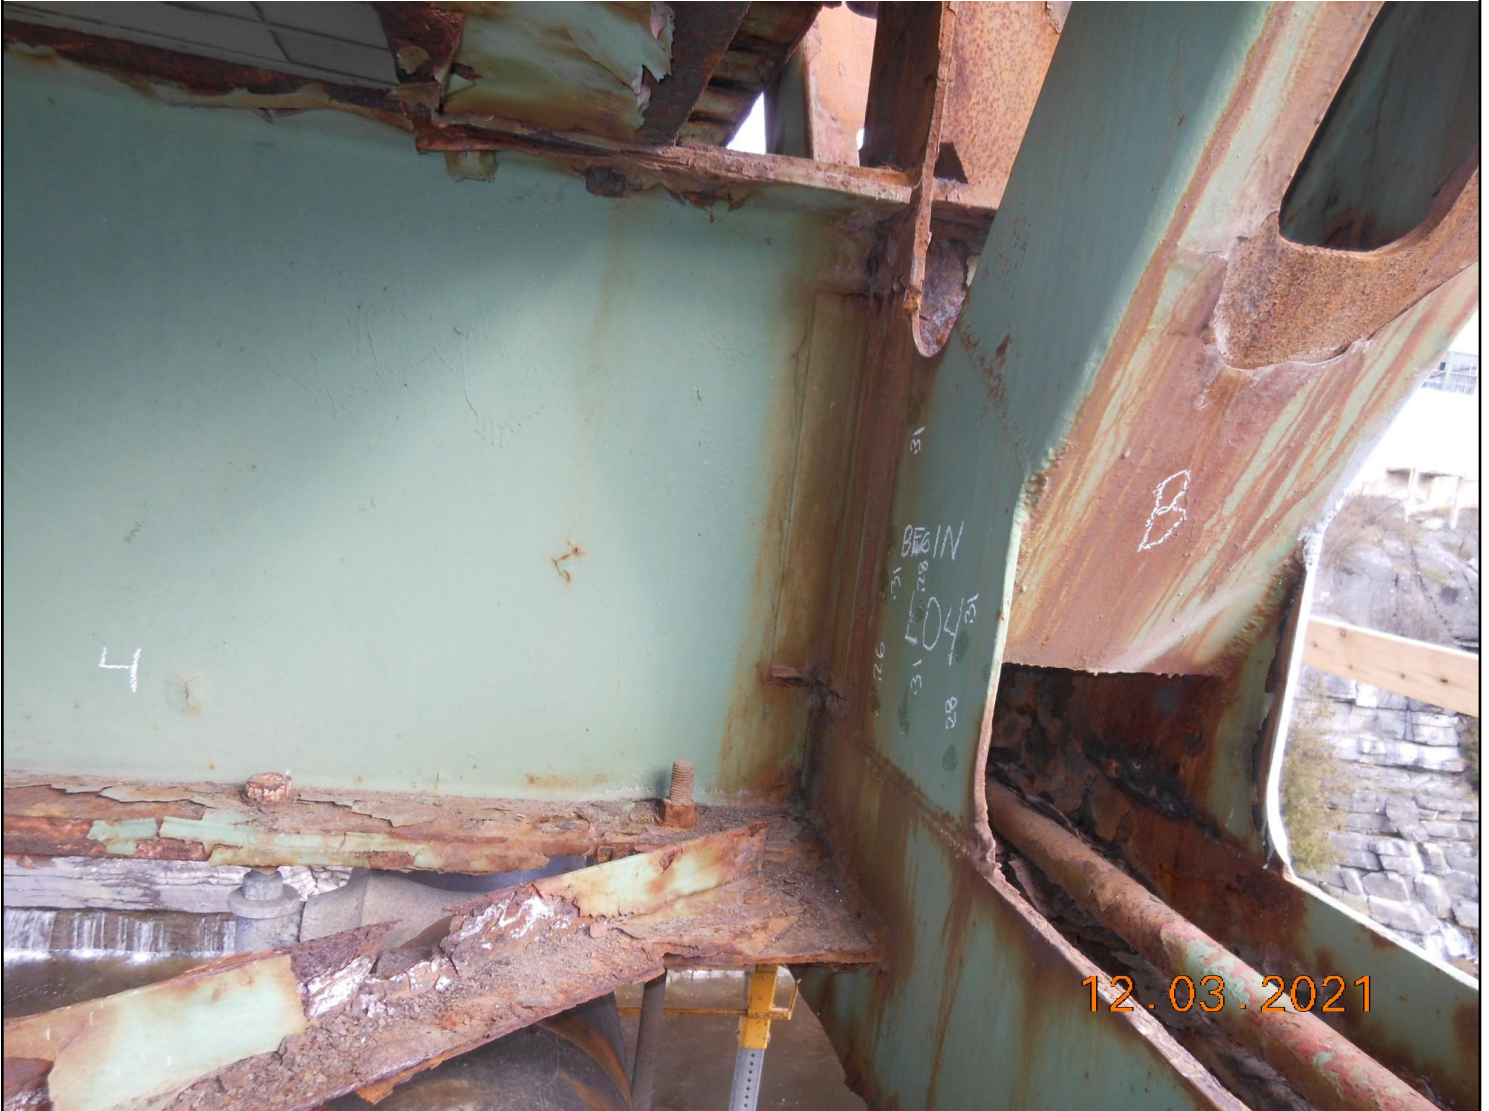
Photo Number: 6

Significance: The lower portion of this minor compression ("zero force") member is connected to the floorbeam and transmits the vertical floorbeam loads to the truss diagonal members (U03-L04 and L04-U05) through the gusset plates (flag photo 6).

**Attachment Description: Begin Face of Floorbeam 4 Connection to Right Truss L04**
