**New York State Department of Transportation
Yellow Flag 7B21N6W021**

BIN: 3338900

Feature Crossed: BLACK RIVER

**New York State Department of Transportation
Red Flag 7B21N6W016**

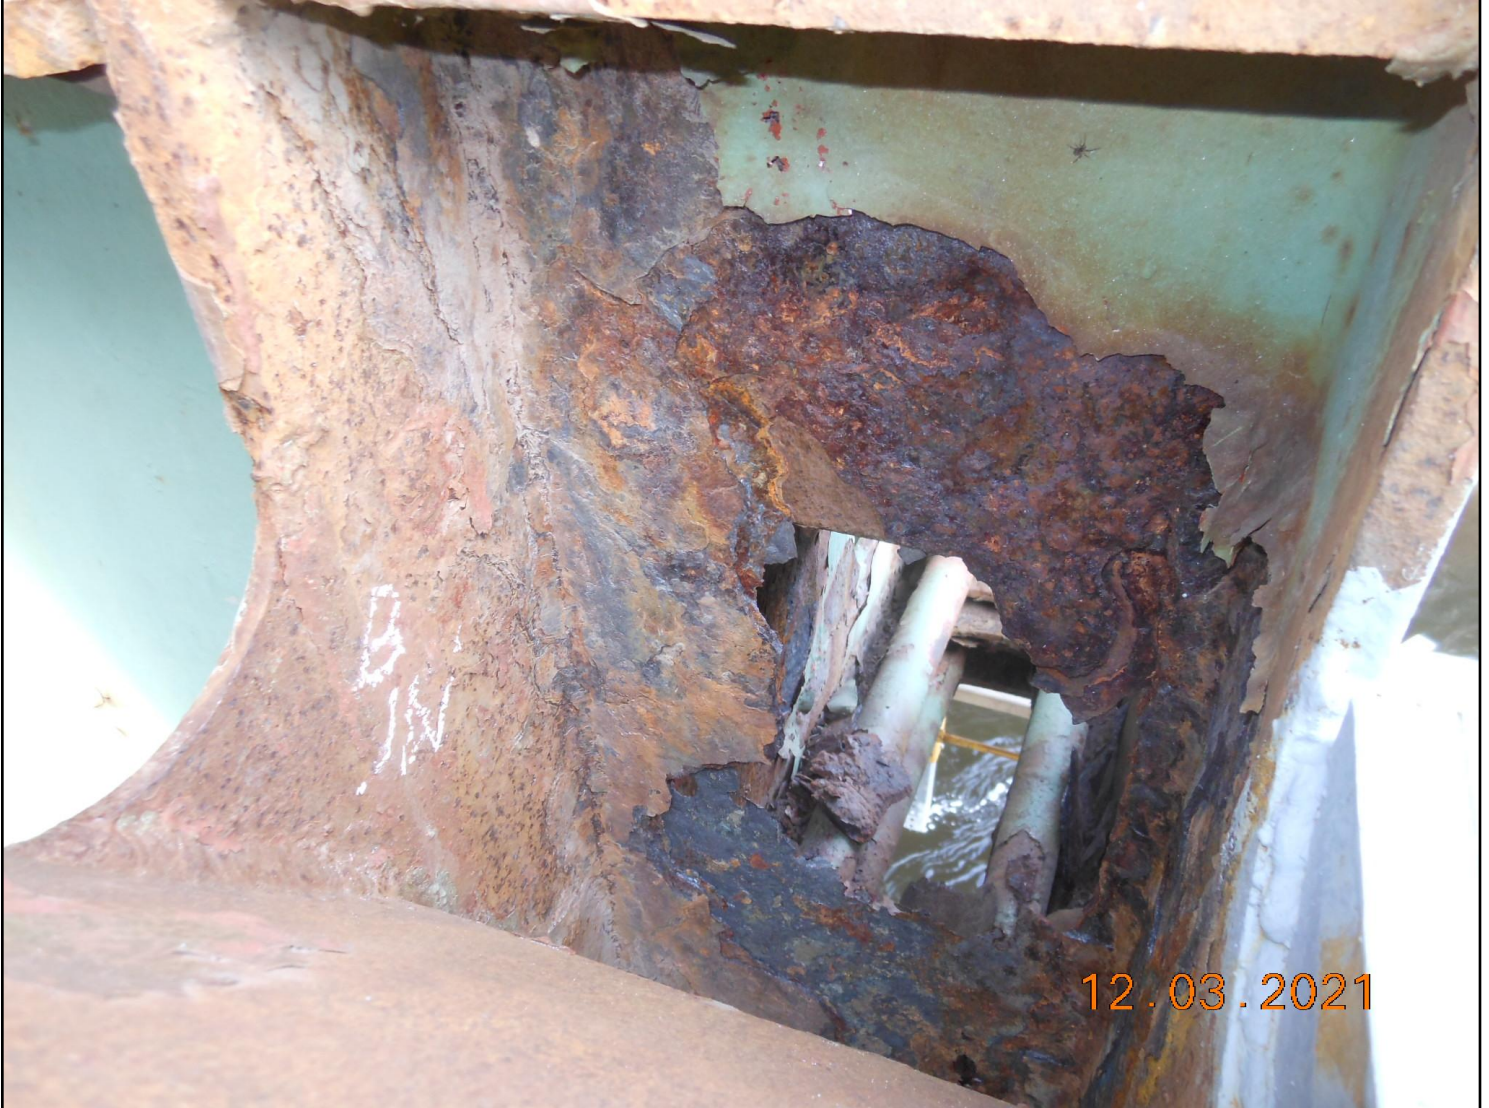
Photo Number: 3

Right truss vertical member L04-U04 has 10% (estimated) inner (left) flange section loss, 30% outer (right) flange section loss, and up to 100% web loss below the elevation of the top of the floorbeam. The total section loss for the member below the top of the floorbeam is 41% (flag photos 3 through 6).

Attachment Description: Lower Portion of Right Truss Vertical L04-U04_from Begin

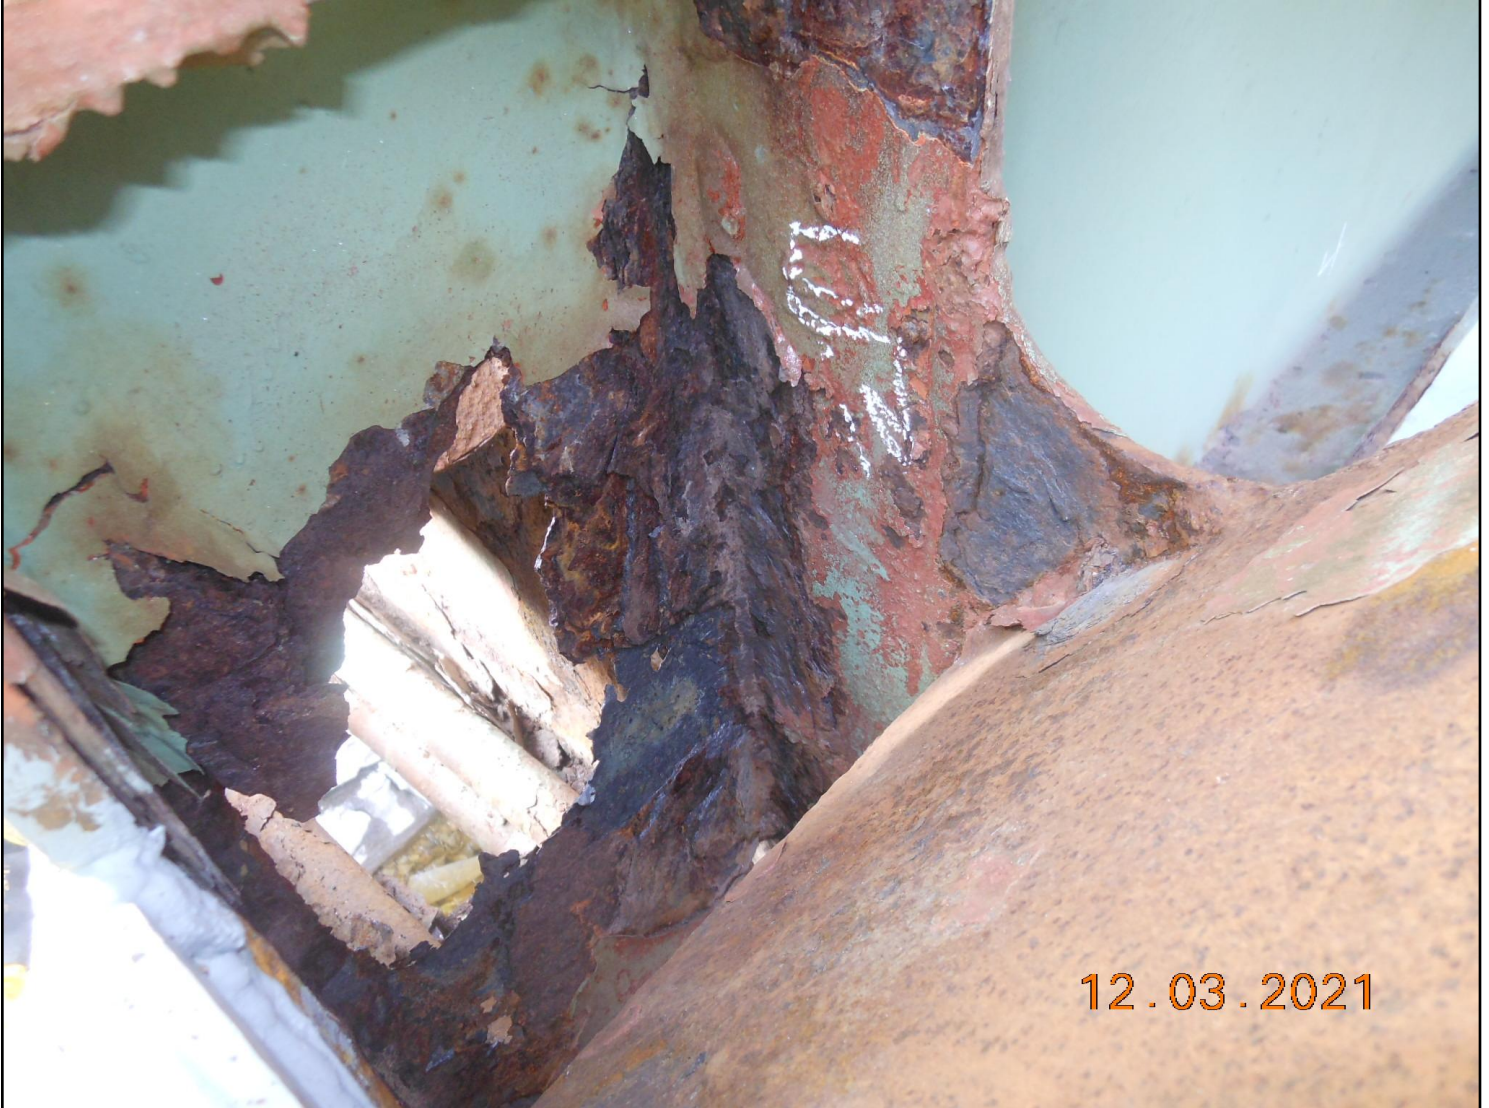
Photo Number: 4

Attachment Description: Lower Portion of Right Truss Vertical L04-U04 from End

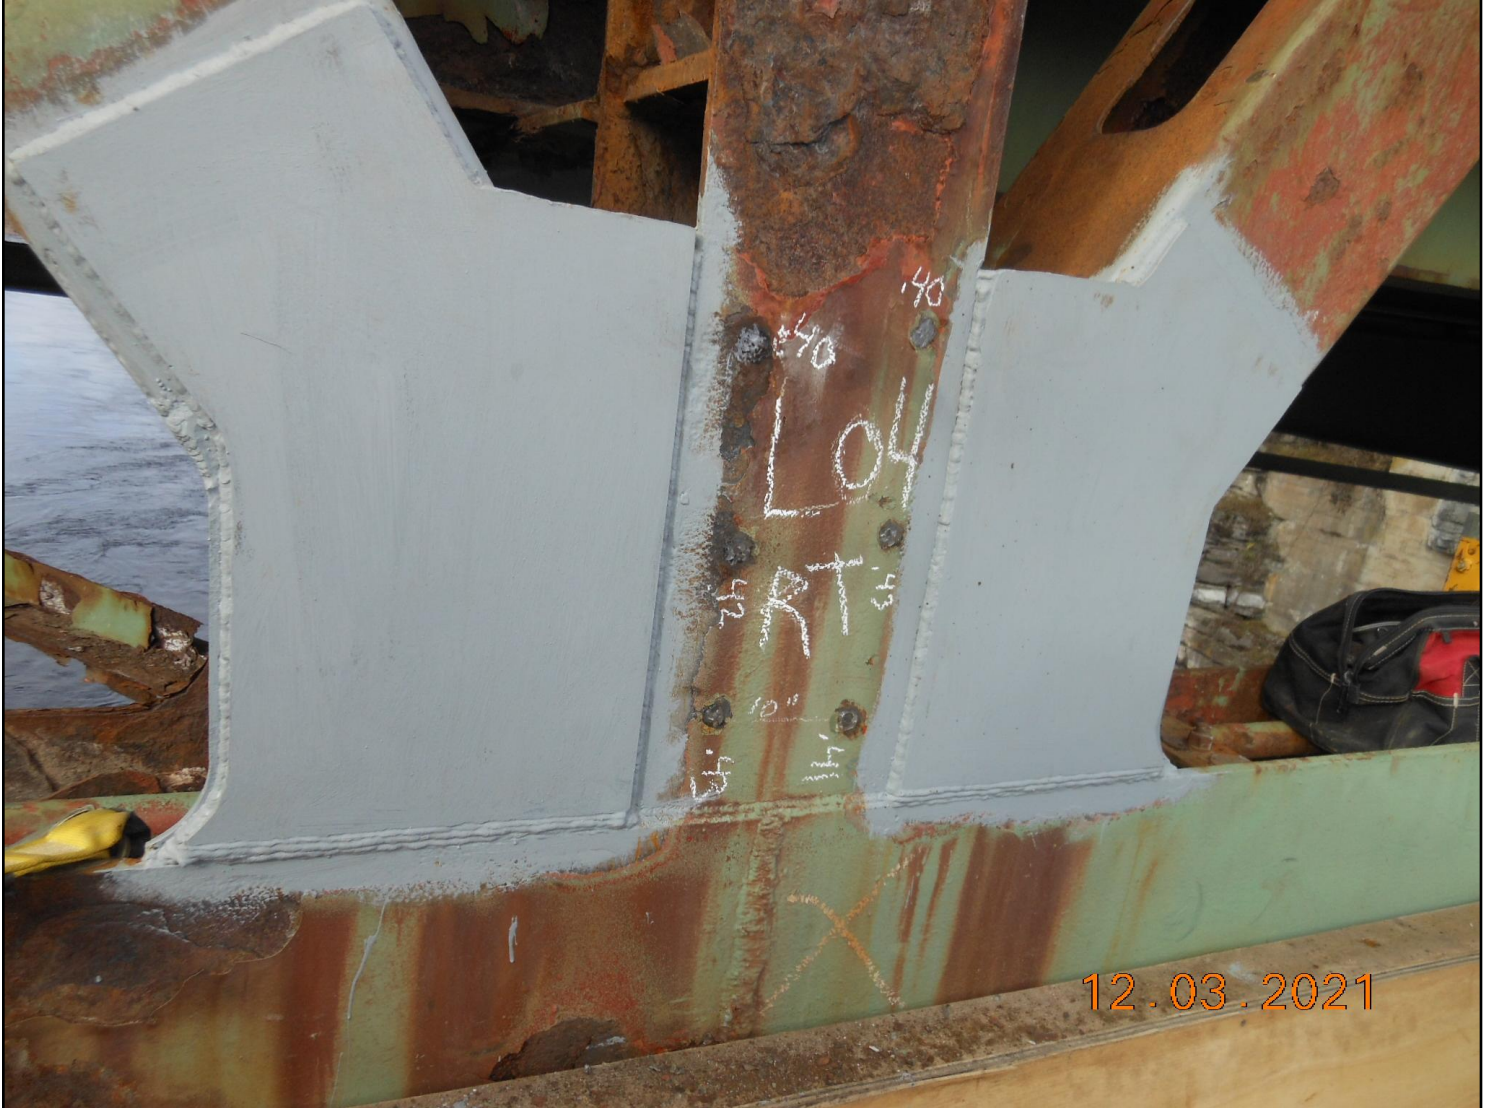
Photo Number: 5

Mitigating Conditions: The bridge is posted for "No Trucks with R Permits" (flag photo 7). The floorbeam is connected to the inner (left) flange of right truss vertical member L04-U04. The inner (left) flange of L04-U04 has 10% (estimated) section loss where it is connected to the floorbeam. The inner gusset plates at L04 have 10% to 15% section loss. The outer gusset plates at right truss L04 have been repaired (flag photo 5) in response to Red Flag 7B21N6W016.

Attachment Description: Right Truss at L04 from Right

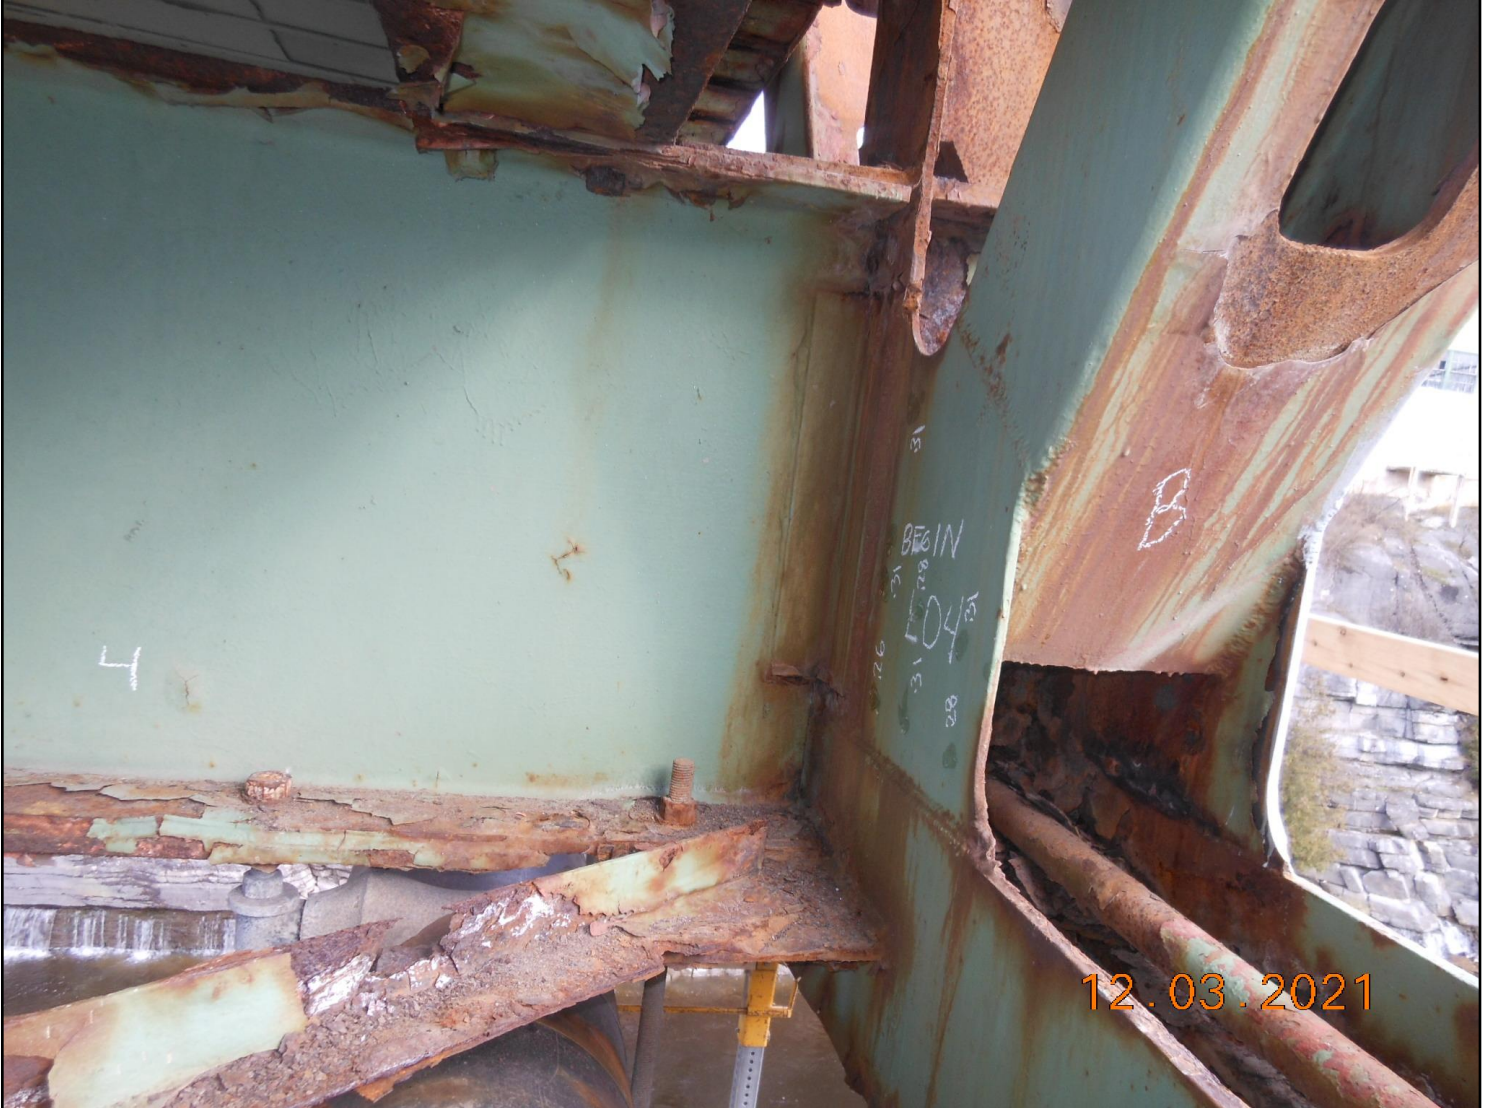
Photo Number: 6

Significance: The lower portion of this minor compression ("zero force") member is connected to the floorbeam and transmits the vertical floorbeam loads to the truss diagonal members (U03-L04 and L04-U05) through the gusset plates (flag photo 6).

Attachment Description: Begin Face of Floorbeam 4 Connection to Right Truss L04

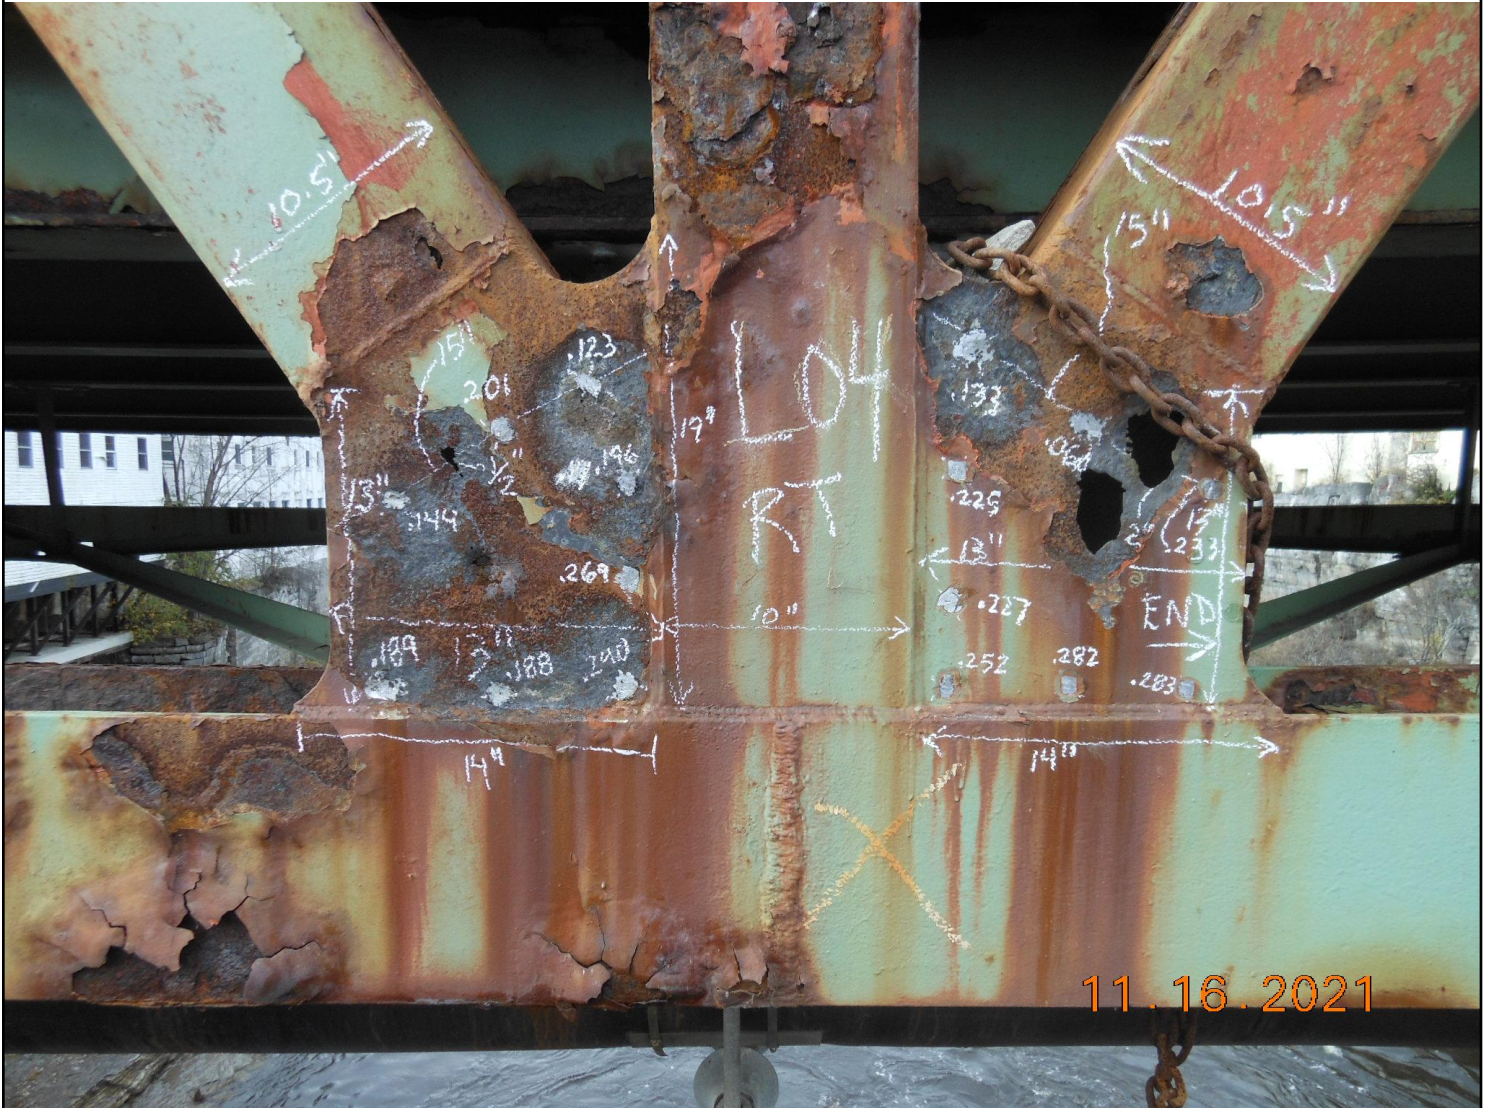
Photo Number: 3

The begin outer gusset plate at L04 (Right Truss) has approximately 52% section loss including a 1/2 inch perforation in a plane perpendicular to diagonal member U03-L04 located approximately 5 inches from the bottom of the diagonal member (flag photo 3).

The end outer gusset plate at L04 (Right Truss) has approximately 61% section loss including a 2-inch diameter perforation in a plane perpendicular to diagonal member L04-U05 located approximately 5 inches from the bottom of the diagonal member (flag photo 3).

Attachment Description: Right Truss at L04 from Right

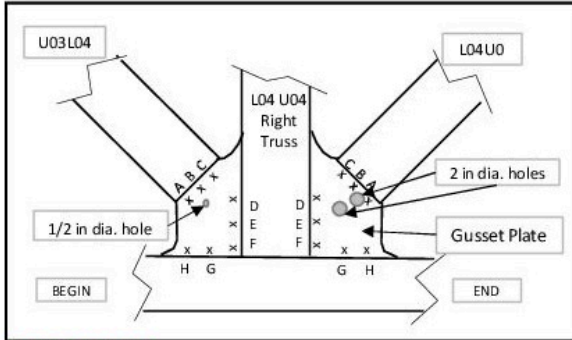
Photo Number: 4

Original Gusset Plate Thickness = 5/16"

Remaining Area Perpendicular to Diagonal Mbr:

Begin: $(15 - 0.5) \times 0.156 = 2.262 \text{ in}^2$

End: $(15 - 2) \times 0.142 = 1.846 \text{ in}^2$

LOCATION	A	B	C	D	E	F	G	H	Section Loss
Plane Perpendicular to Diagonal Member	0.144	0.201	0.123						52% including 1/2" hole
Plane along Vertical Member			0.123	0.196	0.269	0.29			30%
Plane along Top of Bottom Chord						0.29	0.188	0.189	29%

LOCATION	A	B	C	D	E	F	G	H	Section Loss
Plane Perpendicular to Diagonal Member	0.233	0.06	0.133						61% including 2" holes
Plane along Vertical Member			0.133	0.225	0.227	0.252			33%
Plane along Top of Bottom Chord						0.252	0.282	0.283	13%

Attachment Description: Gusset Plate Section Loss Sketch

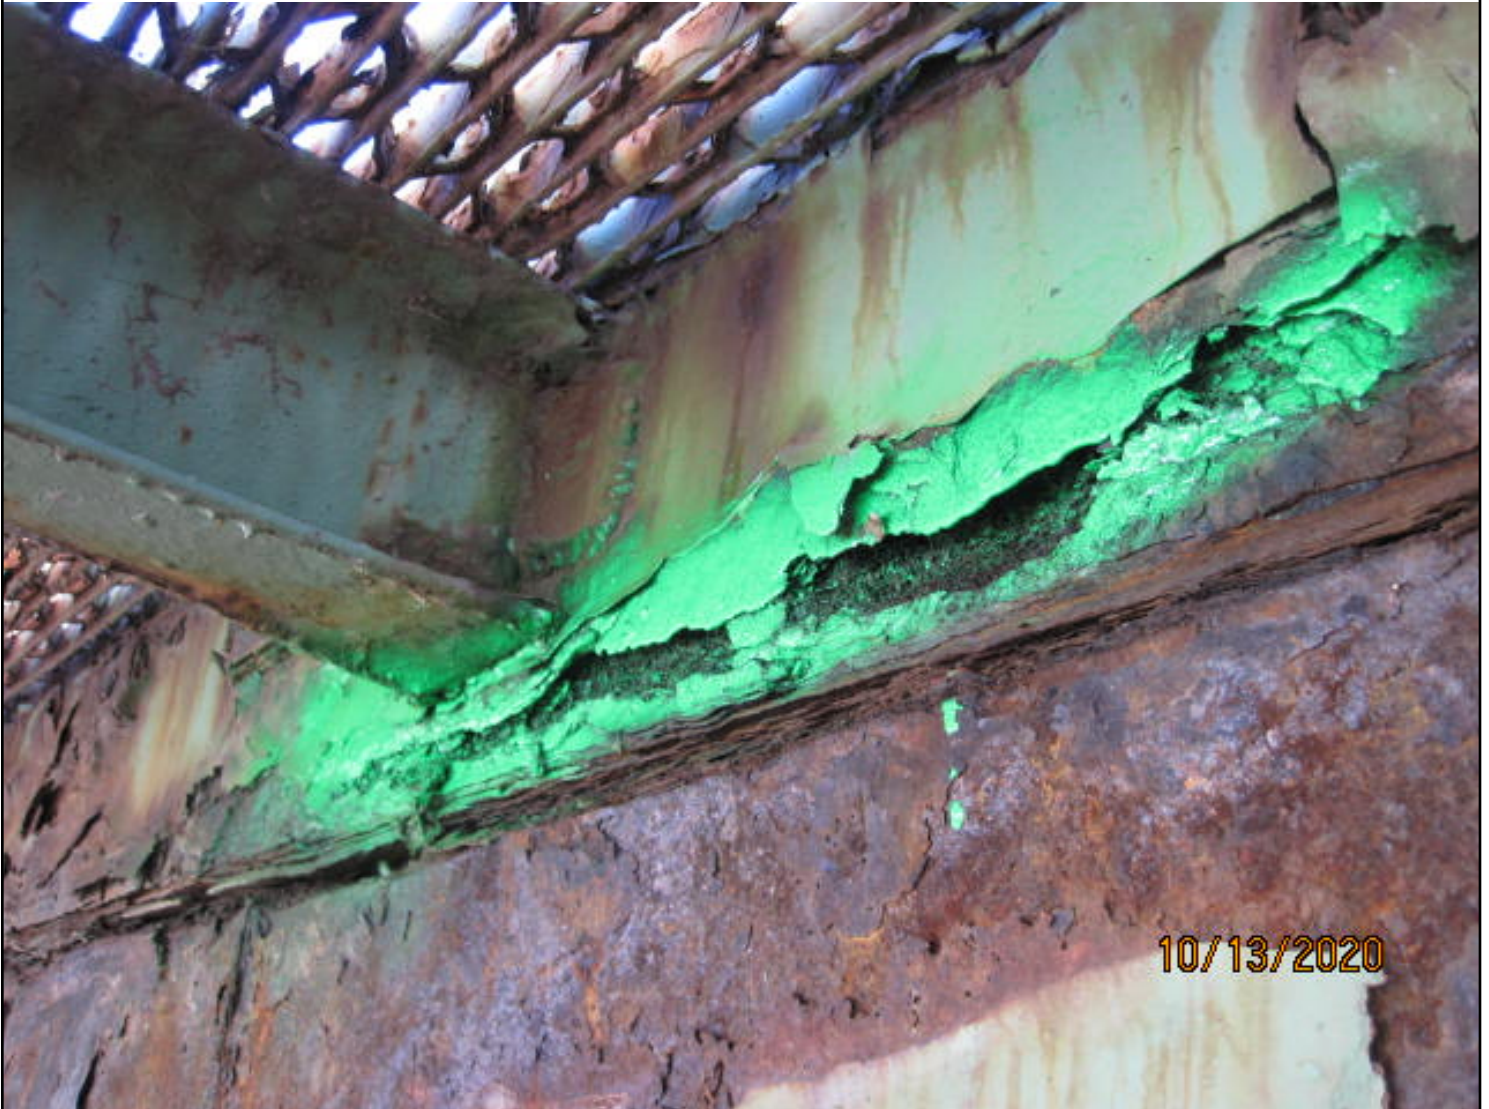
Photo Number: 1

Yellow flag being issued due to the heavy deterioration of the Steel C-Channel at left deck fascia that remains. Steel Channel at left deck fascia typically has heavy deterioration throughout bridge length.

Attachment Description: Lt. Sidewalk fascia C-Channel @ Sidewalk Floor Beam # From L00, looking Rt.

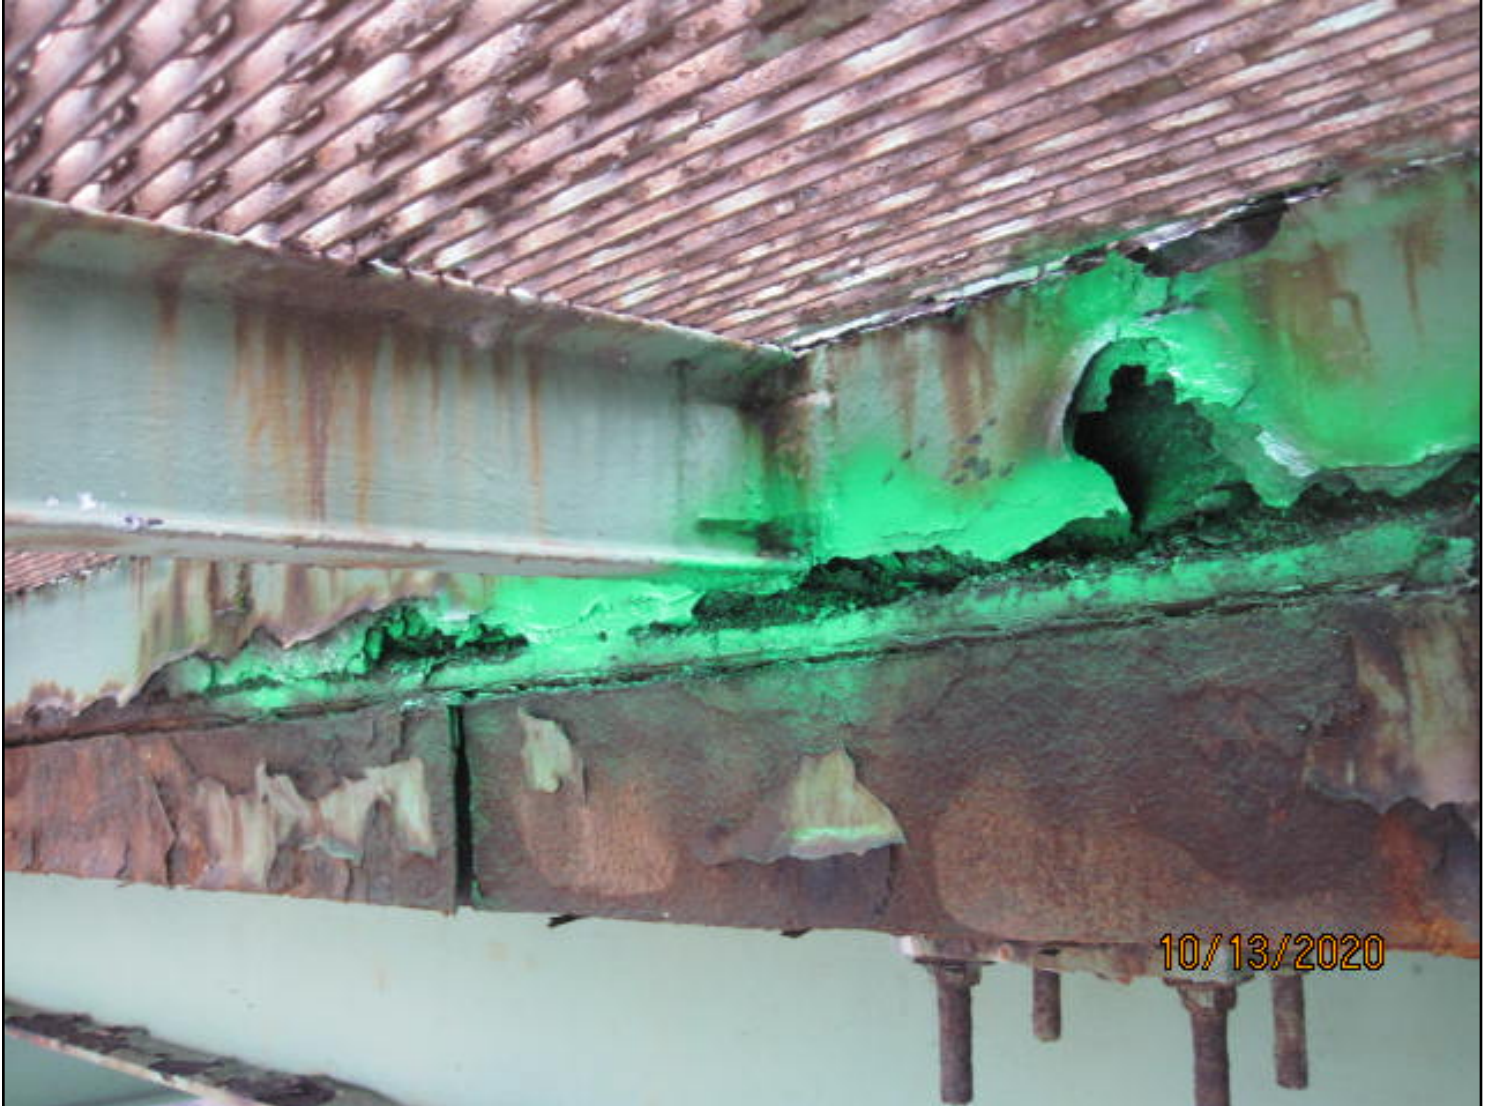
Photo Number: 2

Attachment Description: Lt. Sidewalk fascia C-Channel @ 1st Sidewalk Floor Beam From L05, looking Rt.

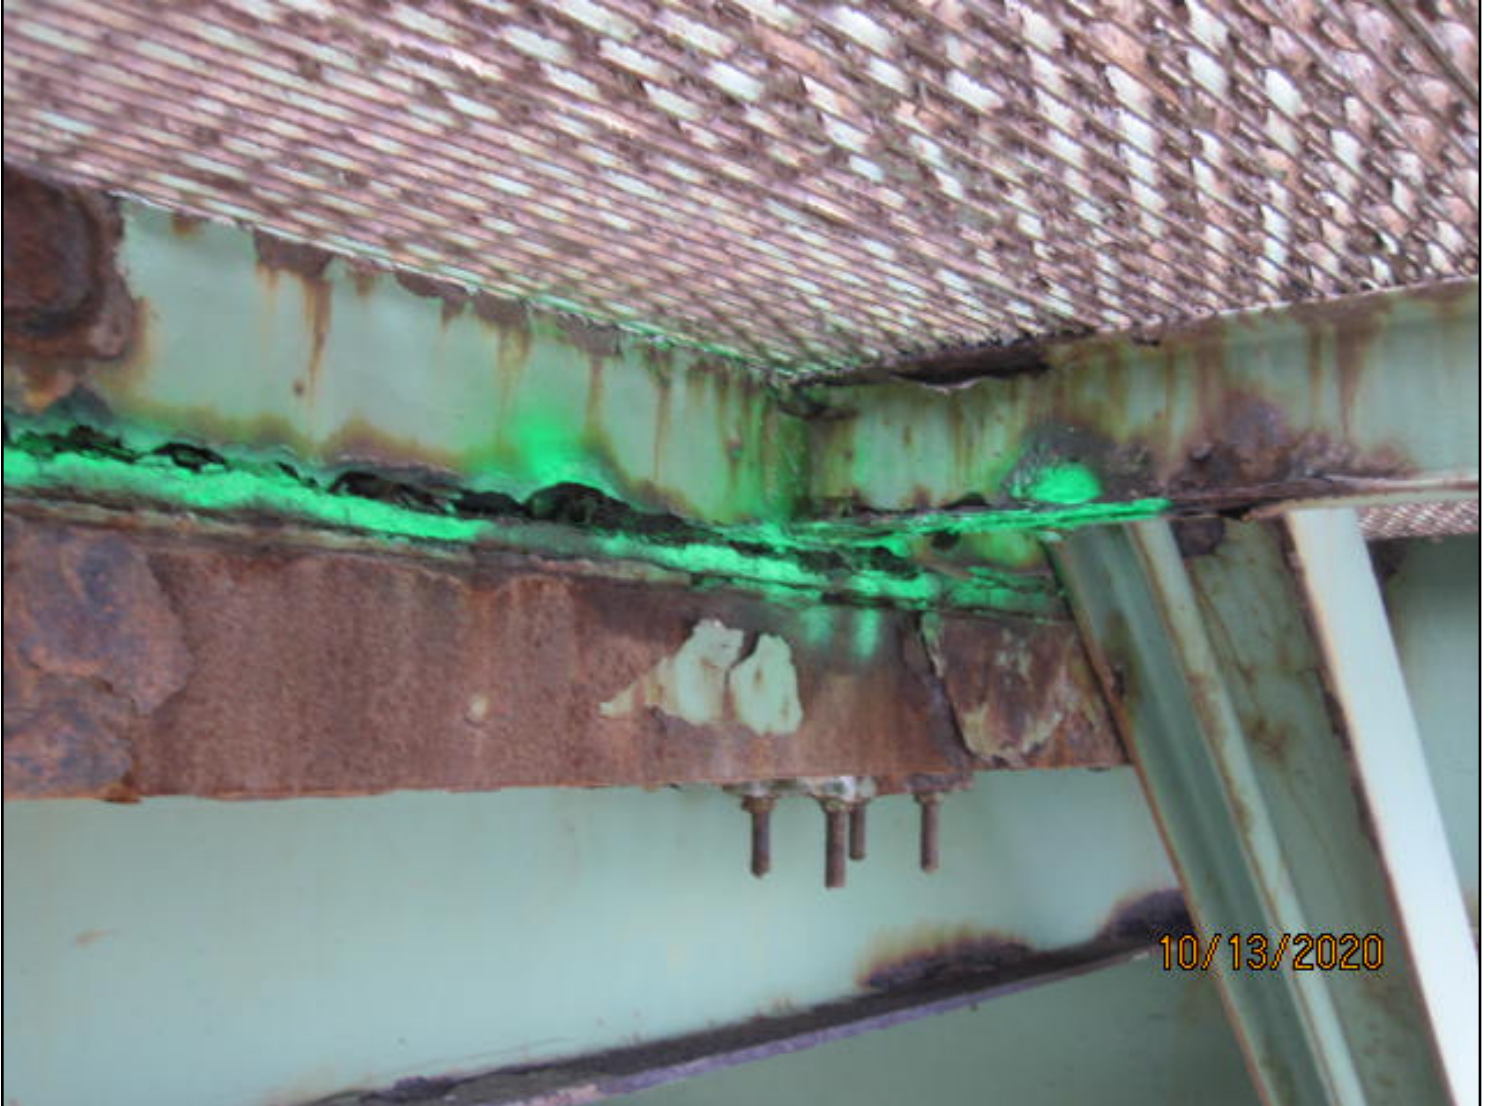
Photo Number: 3

Attachment Description: Lt. Sidewalk fascia C-Channel @ 1st Sidewalk Floor Beam From L06, E-B

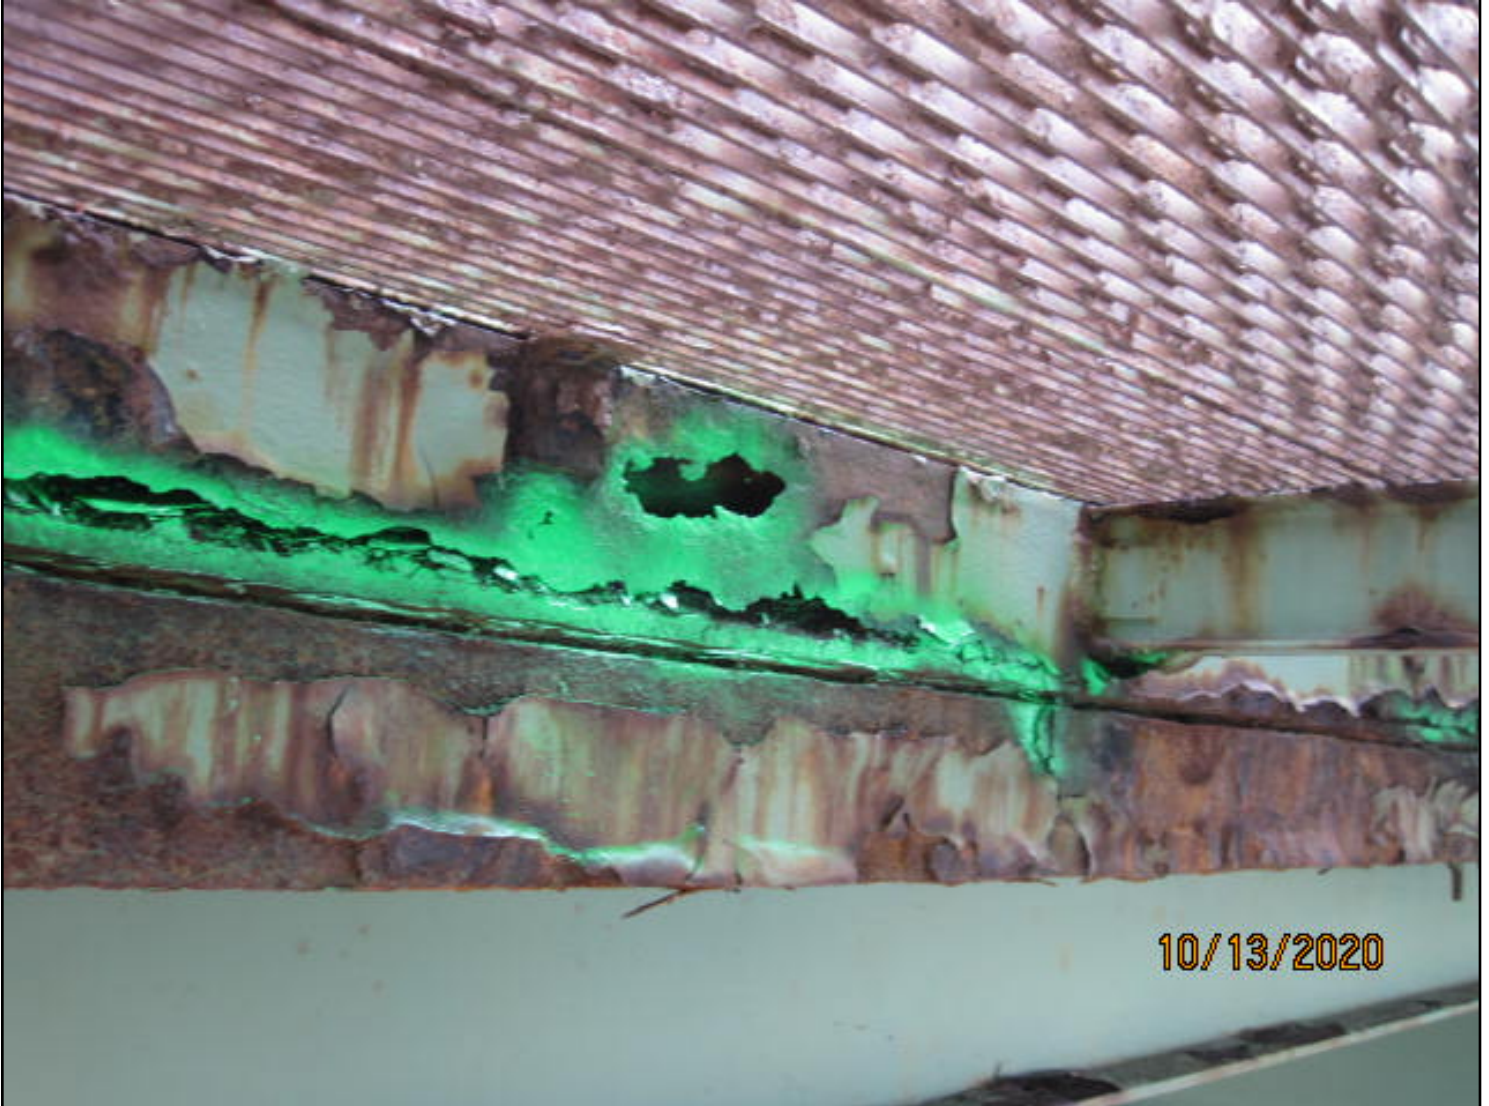
Photo Number: 4

Attachment Description: Lt. Sidewalk fascia C-Channel @ Sidewalk Floor Beam #2-#3 From L05, looking Rt.

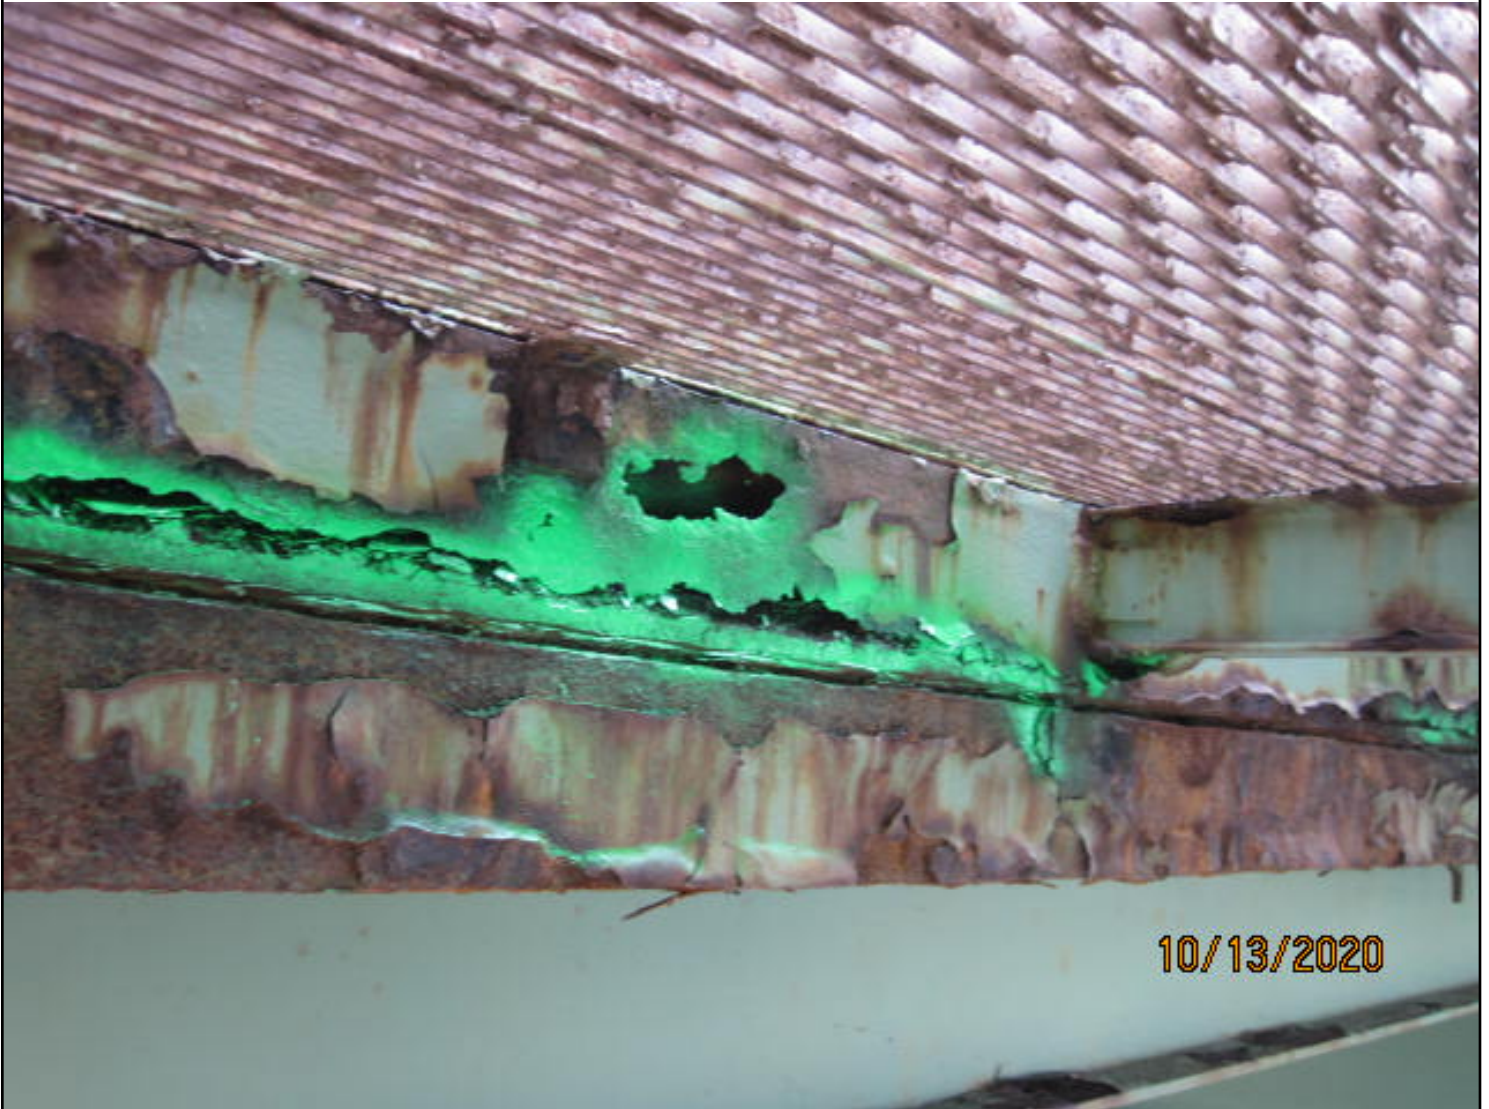
Photo Number: 1

Steel Channel at left deck fascia typically had heavy deterioration throughout bridge length. Worst Conditions were noted by Red Flag 7B20M8W026 between lower truss nodes L05 – L07 where web of c-channel had significant deterioration throughout length between truss nodes. Upon further review of locations outside Lt. Truss nodes L05 – L07, it was determined fascia steel along left side of deck fascia appears to be a box section or a built up section to act like a box section. Corrosion appears to be occurring from the inside of the section, thus areas of the section that appear to have some integrity have rusted through with a simple tap of the hammer. Deterioration of channel between all left truss nodes was considered to significantly compromise the structural integrity of the channel. Therefore, a Red Structural Flag was re-issued for Left side C-Channel at deck fascia supporting sidewalk between all Lt. Truss Nodes, superseding flag 7B20M8W026.

Attachment Description: Lt. Sidewalk fascia C-Channel @ Sidewalk Floor Beam #2-#3 From L05, looking Rt.

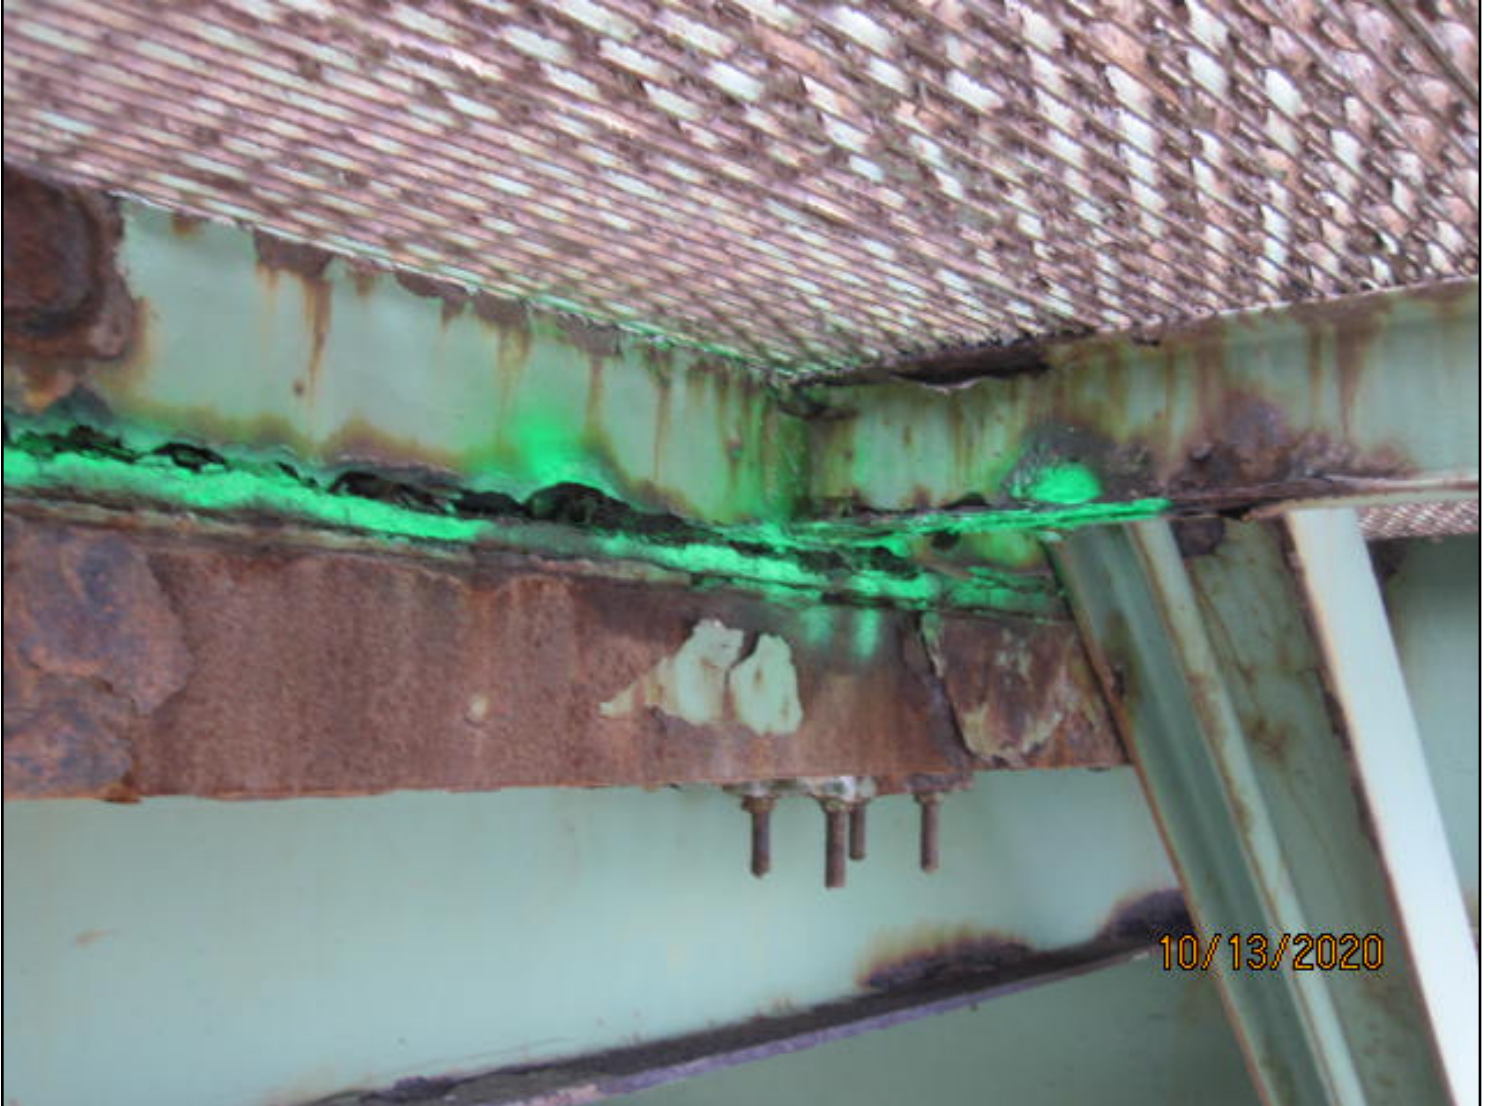
Photo Number: 2

Attachment Description: Lt. Sidewalk fascia C-Channel @ 1st Sidewalk Floor Beam From L06, E-B

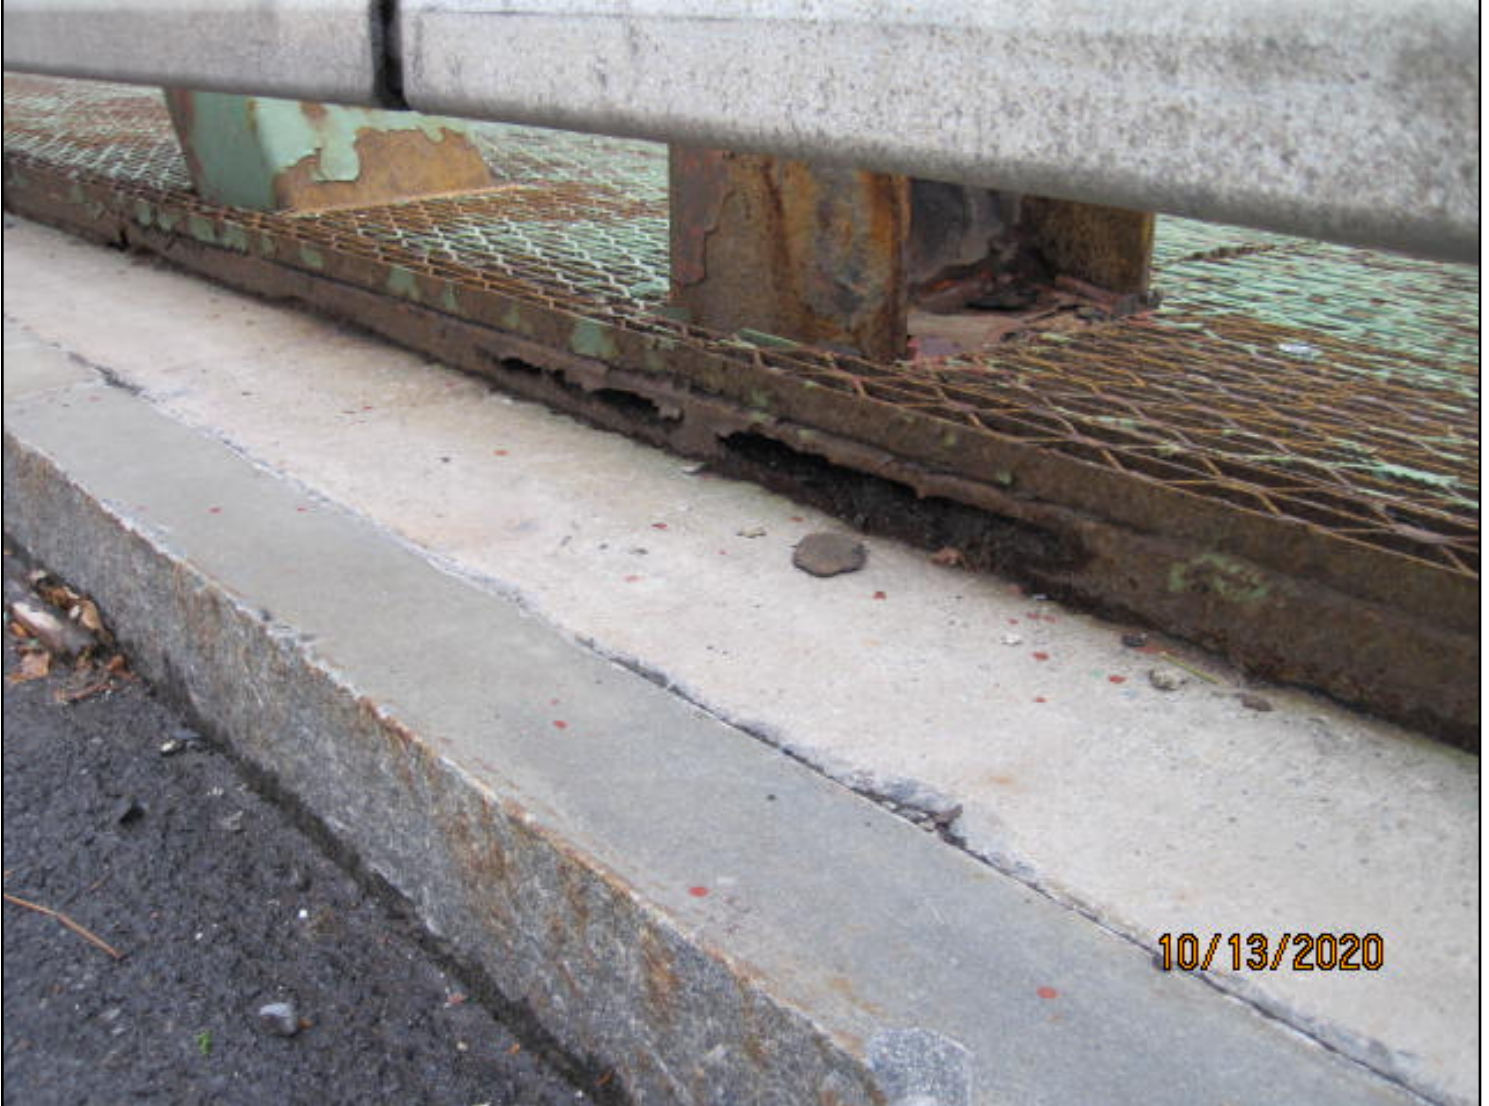
Photo Number: 3

Attachment Description: Lt. Sidewalk fascia C-Channel @ L06 above curb line, E-B

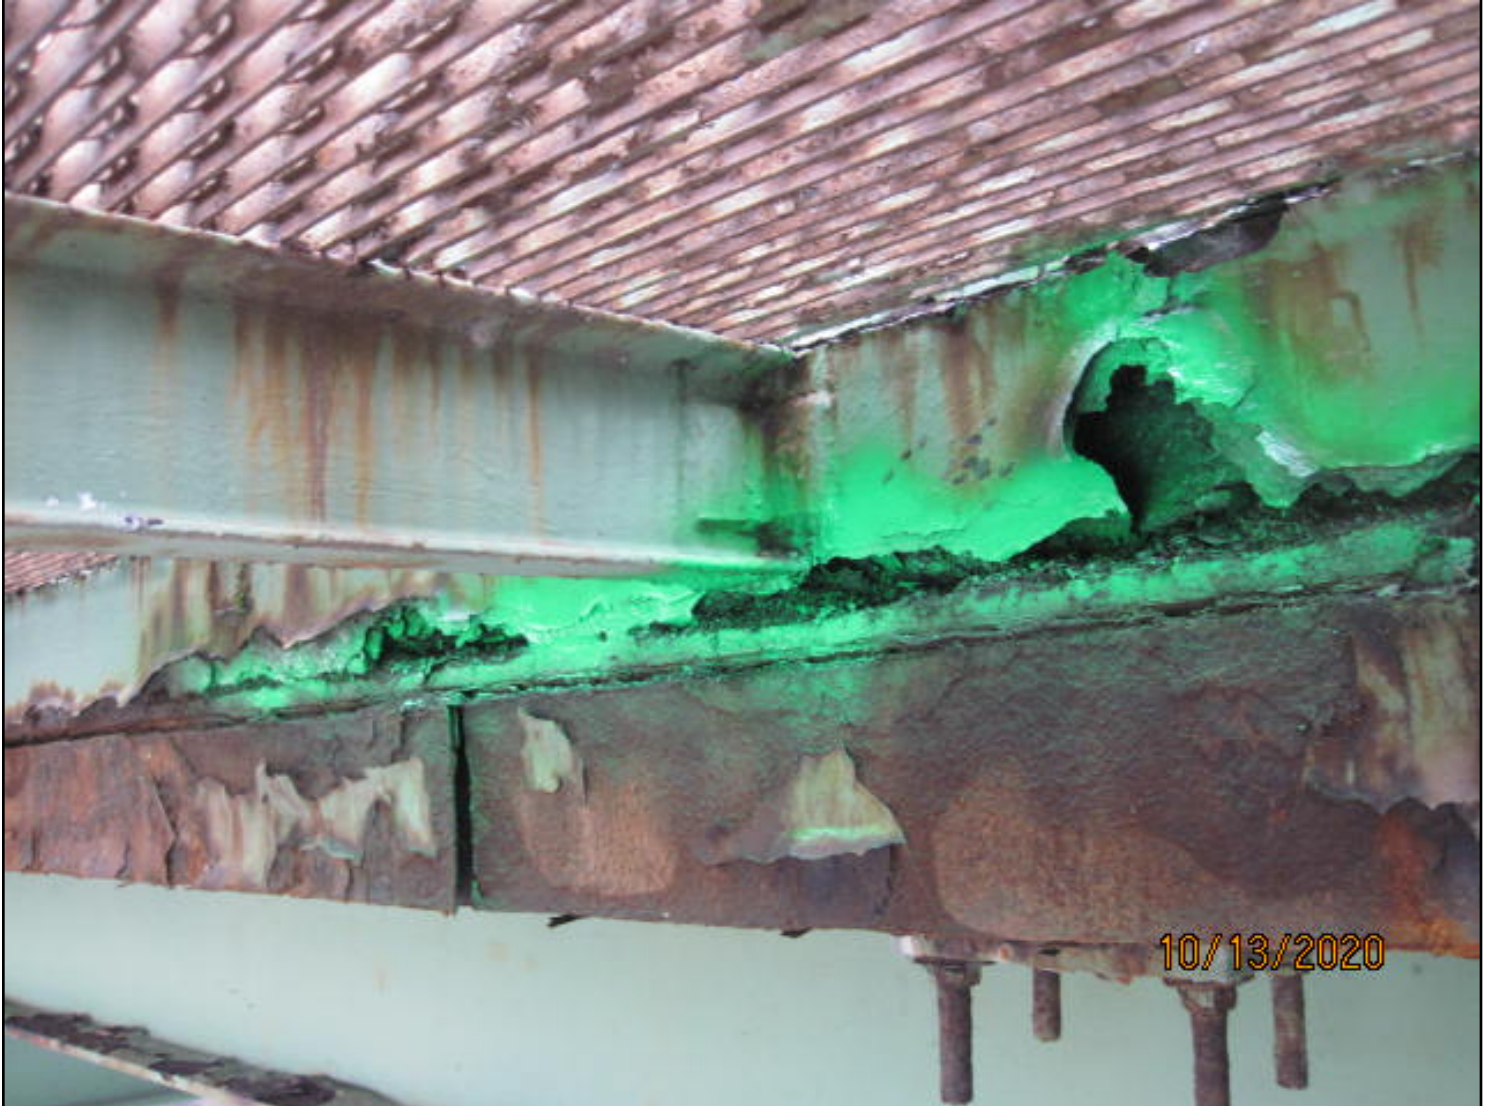
Photo Number: 4

Attachment Description: Lt. Sidewalk fascia C-Channel @ 1st Sidewalk Floor Beam From L05, looking Rt.
