**New York State Department of Transportation
Yellow Flag 7B21N6W021**

BIN: 3338900

Feature Crossed: BLACK RIVER

**New York State Department of Transportation
Red Flag 7B21N6W016**

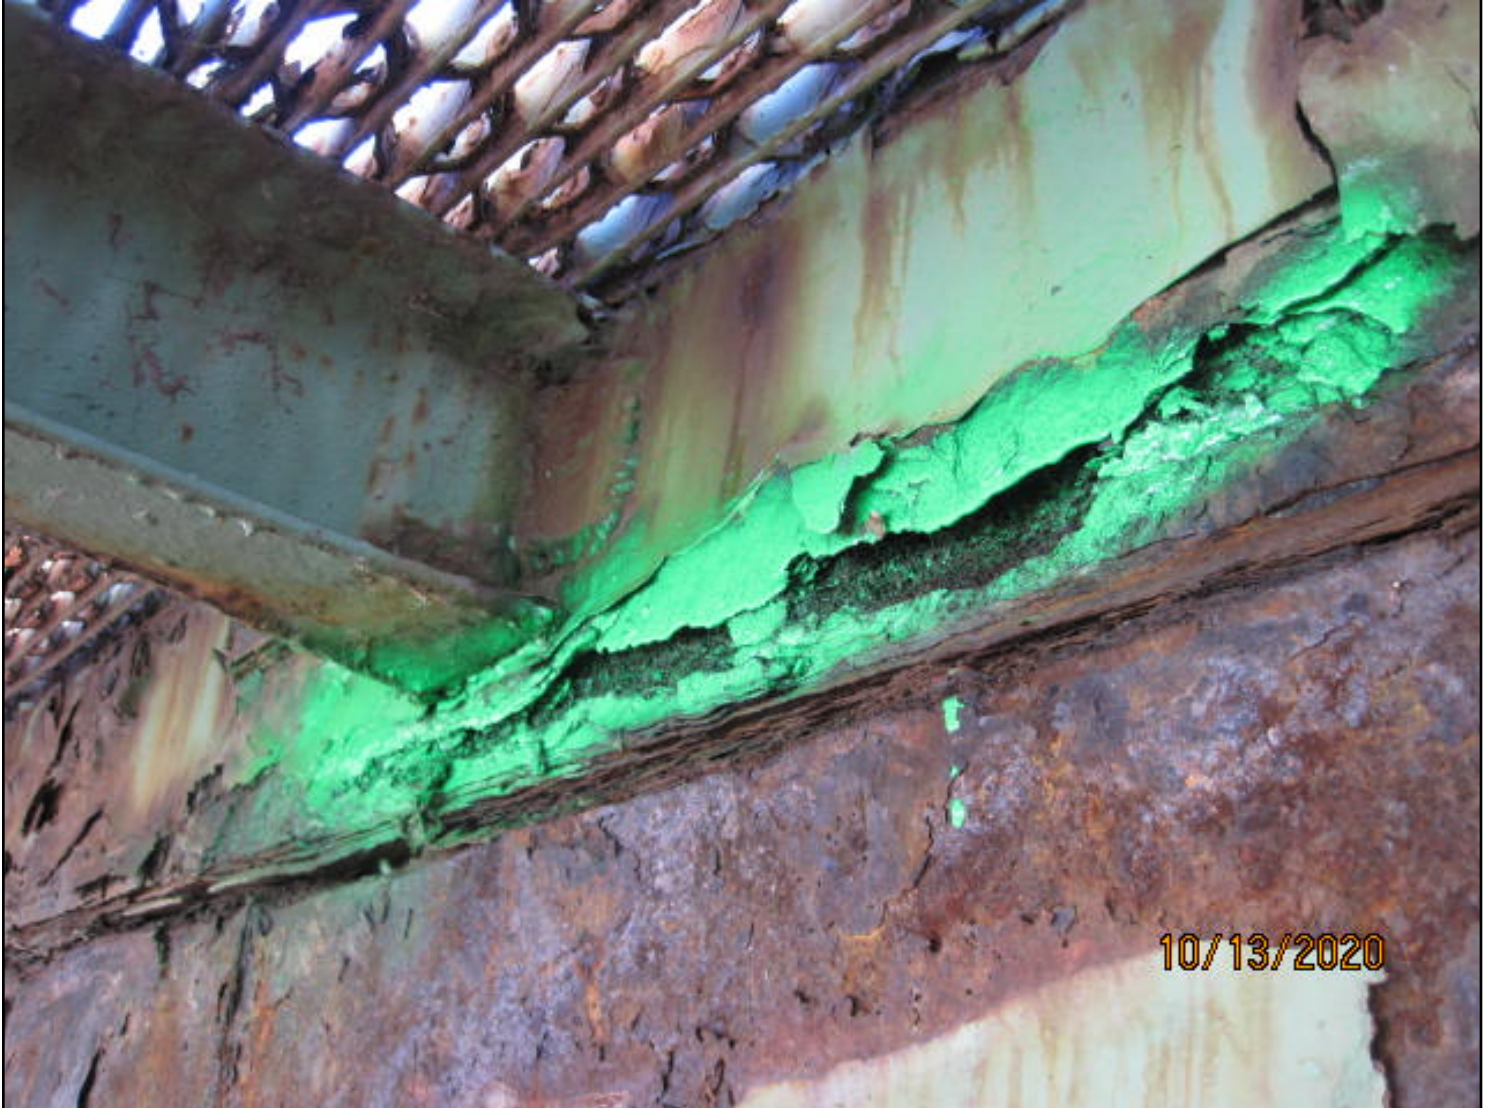
Photo Number: 5

Attachment Description: Lt. Sidewalk fascia C-Channel @ Sidewalk Floor Beam # From L00, looking Rt.
