PIN 7780.09 – New York Route 12E over Black River Bridge Replacement  
Town of Brownville and Town of Hounsfield, New York

# New York State Department of Transportation General Bridge Inspection Report

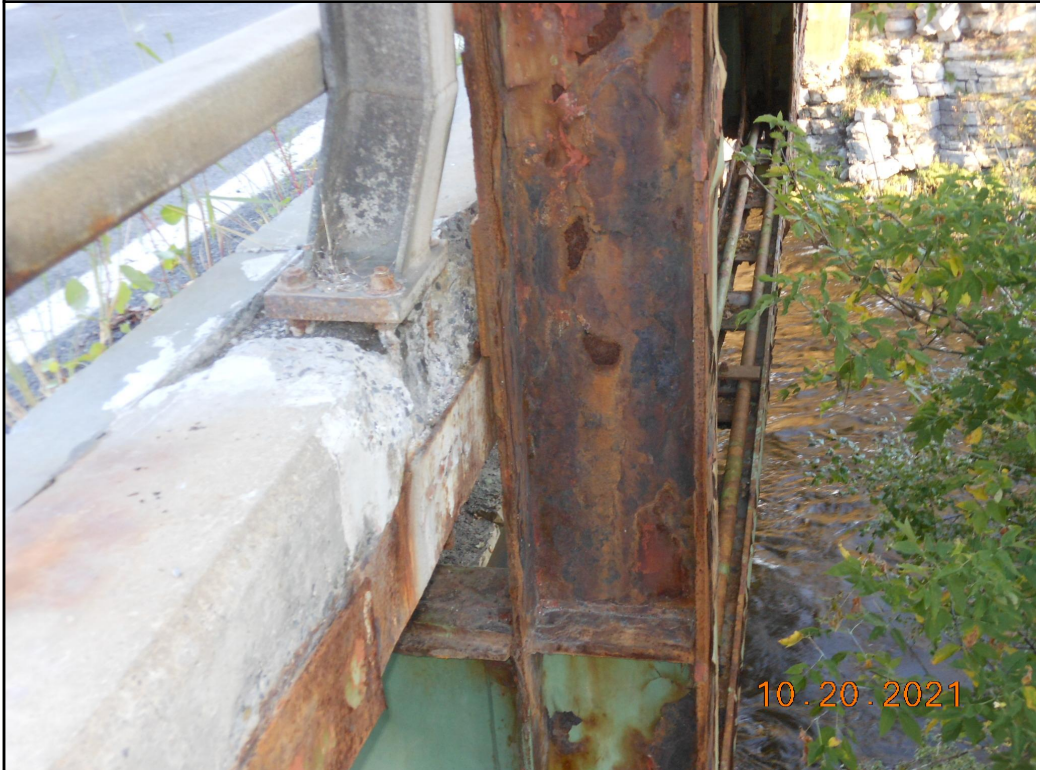
Photo Number: 4 Photo Filename: 04\_Begin Right Bridge Railing Post

2021 – The safety sidewalk has an isolated spall at the begin right exposing railing post anchor bolts (photo 4). In addition, a few random locations are missing 2 anchor bolt nuts on the underside of the railing anchorage plate (photo 30). Approximately 10 linear feet of the railing is affected.

**Attachment Description:**  
Begin Right Bridge Railing  
Post Anchorage at Deck  
Fascia from Begin Right

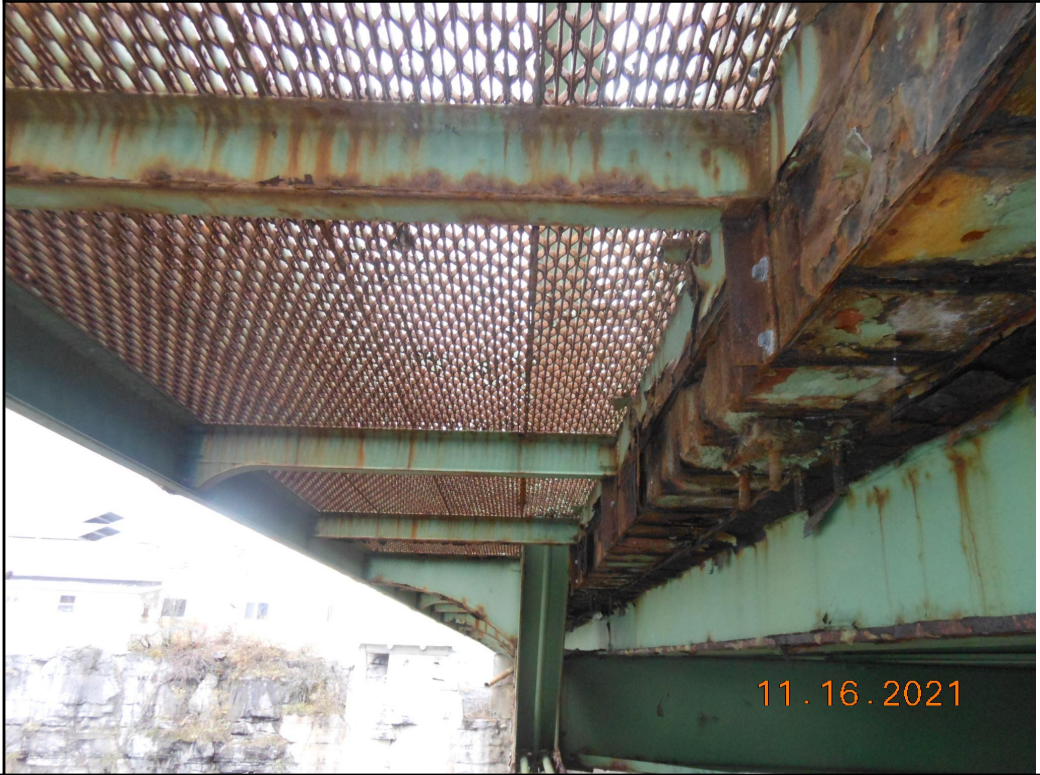
Photo Number: 5 Photo Filename: 05\_Left Deck Fascia and Stringer 1 between

2021 – The underside of the concrete filled steel deck grating as several isolated random areas of spalled concrete exposing the steel deck grating with corrosion and minor section losses evident. This condition is the worst in the fascia bays and near the abutments (photos 1 through 3).  
 Both edges of the deck (fascia) have spalling with the worst conditions occurring on the right fascia. The right edge of the deck and brush curb have isolated areas of heavy spalling around isolated bridge railing posts at the begin right exposing railing anchorage (photo 4).  
 In addition, both deck fascia have steel armoring/plates/channels with varying degrees of corrosion with some perforations and with the steel peeling away from the deck fascia at some locations (photos 5 and 6).  
 Approximately 25% of the overall area is affected.

2021 – The fascia stringers (S1 and S5) have laminated corrosion with up to 15% section loss to the flanges and webs (photos 5, 12 and 13). Approximately 5% of the overall stringer quantity is affected.

2021 – (Condition State 4) – Approximately 5% of the paint on the stringers has failed allowing corrosion to occur (photos 5, 12 and 13).  
 (Condition State 3) – Approximately 5% of the paint on the stringers is starting to fail.

**Attachment Description:**  
Left Deck Fascia and  
Stringer 1 between Floor  
Beams 1 and 2 from Begin

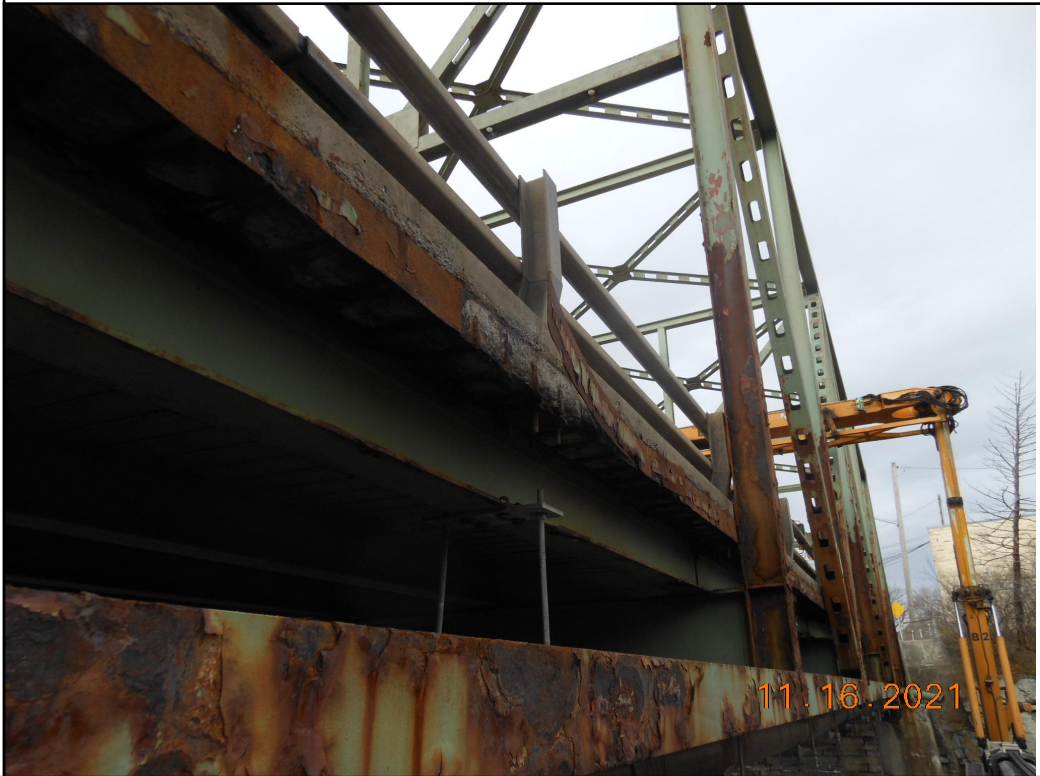
Photo Number: 6 Photo Filename: 06\_Right Deck Fascia between L02\_L03 from

**Attachment Description:**  
Right Deck Fascia between  
L02\_L03 from Begin

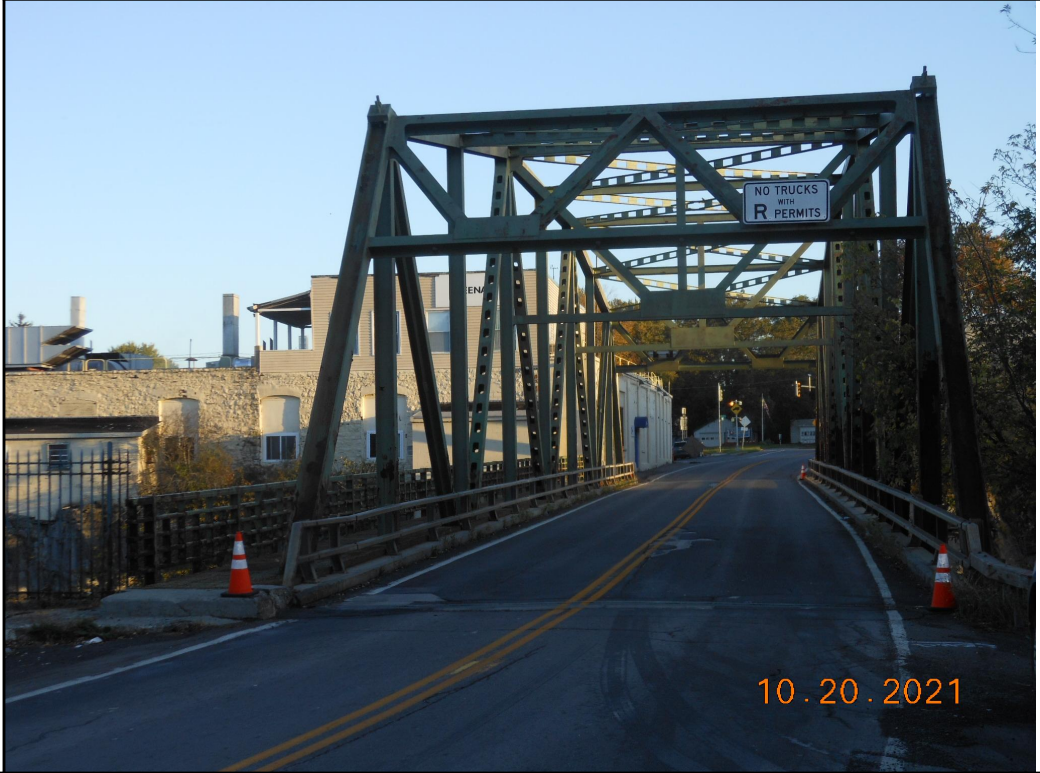
Photo Number: 7 Photo Filename: 07\_Begin Approach\_21\_DSCN4836.JPG

2021 – No bats were observed during this inspection.  
 Wingwalls are not considered integral with the abutments.  
 The plans have been reviewed. No changes have been made to the plans.  
 The Stream Channel consists of bedrock and water is flowing fast in the Black River. Channel cross-section readings along the fascia were not taken.  
 “No Trucks with R Permits” signs are present at the beginning and end of the bridge. Both sides are in good condition and are visible to the traveling public (photos 7 and 8).  
 The 2020 Electrical Hazard form was verified.

**Attachment Description:**  
Begin Approach

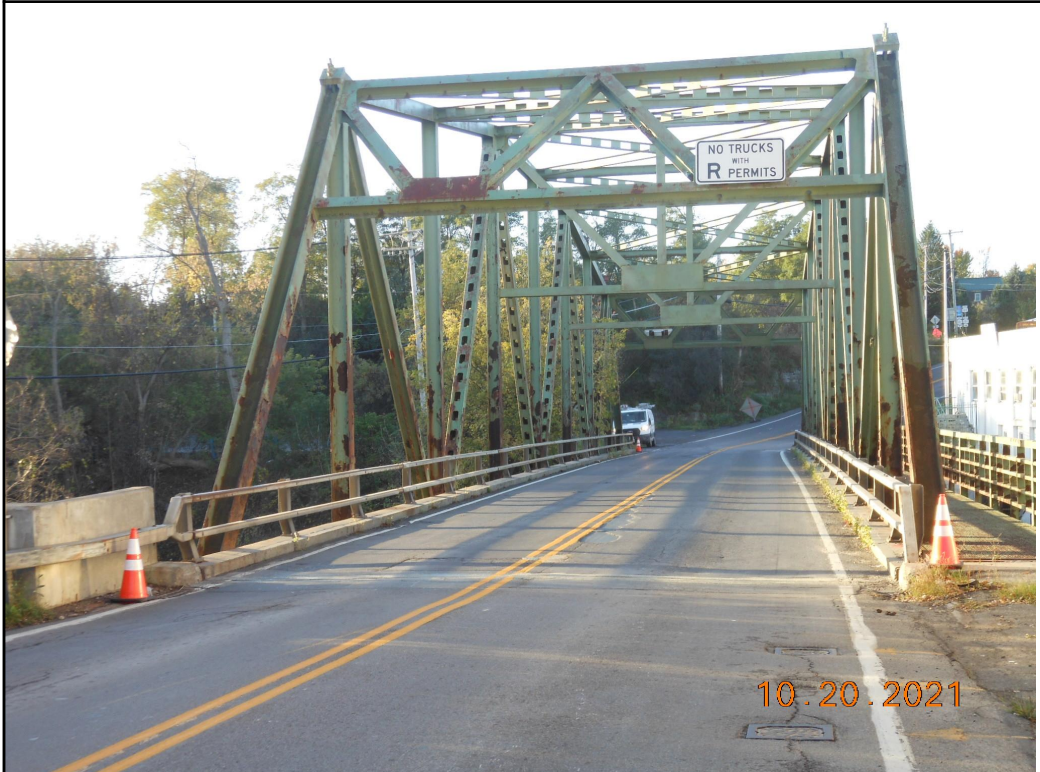
Photo Number: 8 Photo Filename: 08\_End Approach\_21\_DSCN4857.JPG

**Attachment Description:**  
End Approach

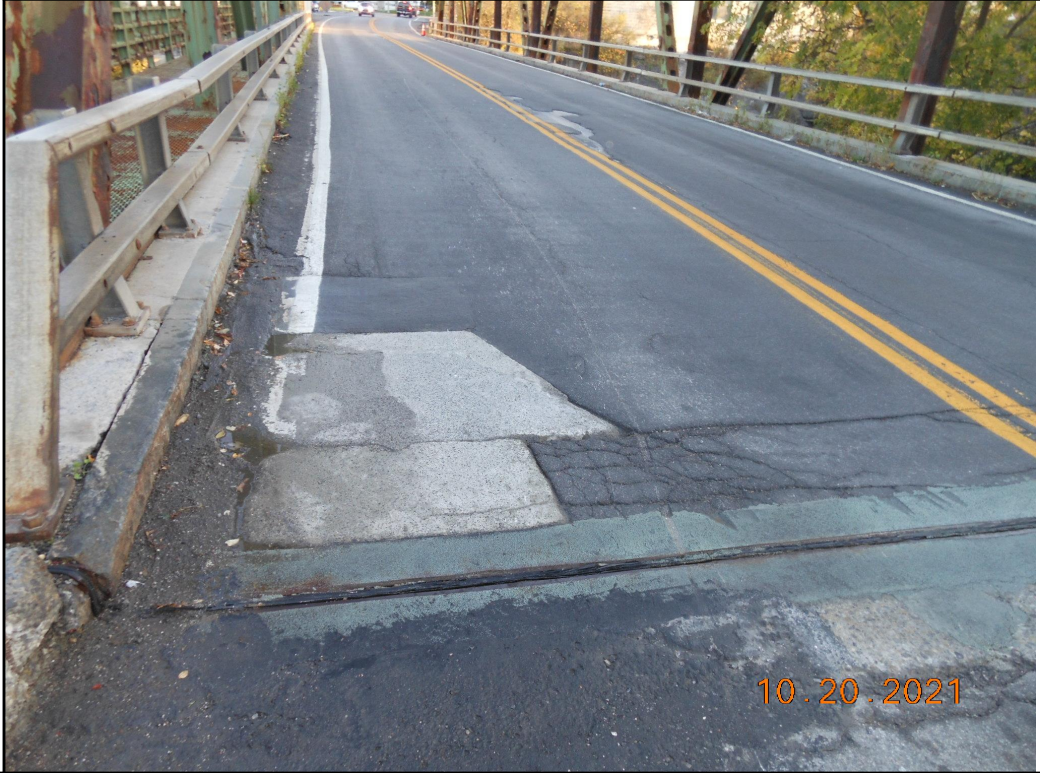
Photo Number: 9 Photo Filename: 09\_Wearing Surface from Begin Left Corner

2021 – The asphalt wearing surface is cracked/raveled with potholes developing in various locations. Conditions are worse near the beginning of the bridge (photos 9 and 10) and in the right lane (photo 11). The top 1 inch layer of asphalt is worn/raveled away in a few locations (most notably adjacent to the centerline).  
 Approximately 25% of the overall wearing surface area is affected.

2021 – (Condition State 4) – Approximately 30% of the steel protective coating on the railings has failed allowing corrosion to occur (photos 9 and 31).  
 (Condition State 3) – Approximately 30% of the steel protective coating on the railings is starting to fail.  
 Most of the steel protective coating deterioration is has occurred on the left sidewalk railing.

**Attachment Description:**  
Wearing Surface from Begin  
Left Corner of Bridge  
Looking toward End

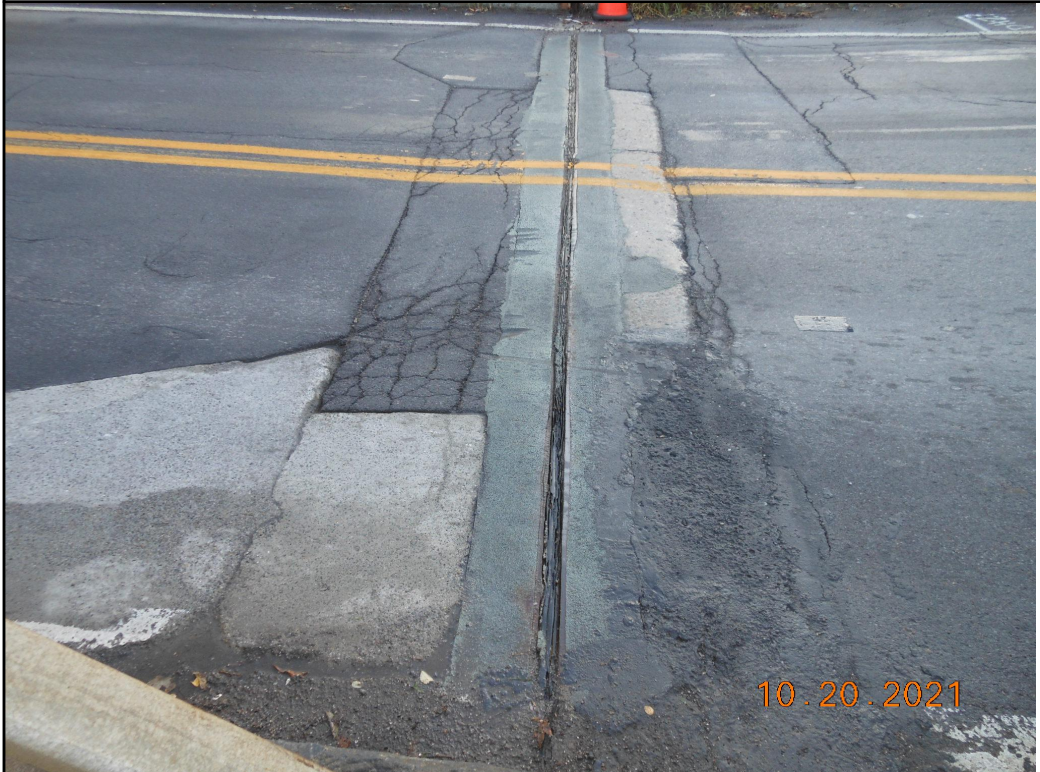
Photo Number: 10 Photo Filename: 10\_Begin Abutment Joint and Wearing

2021 – The begin abutment joint seal is torn/shredded for most of its length and is depressed in some areas (photo 10). The joint leaks lightly for most of its length.

**Attachment Description:**  
Begin Abutment Joint and  
Wearing Surface from Left

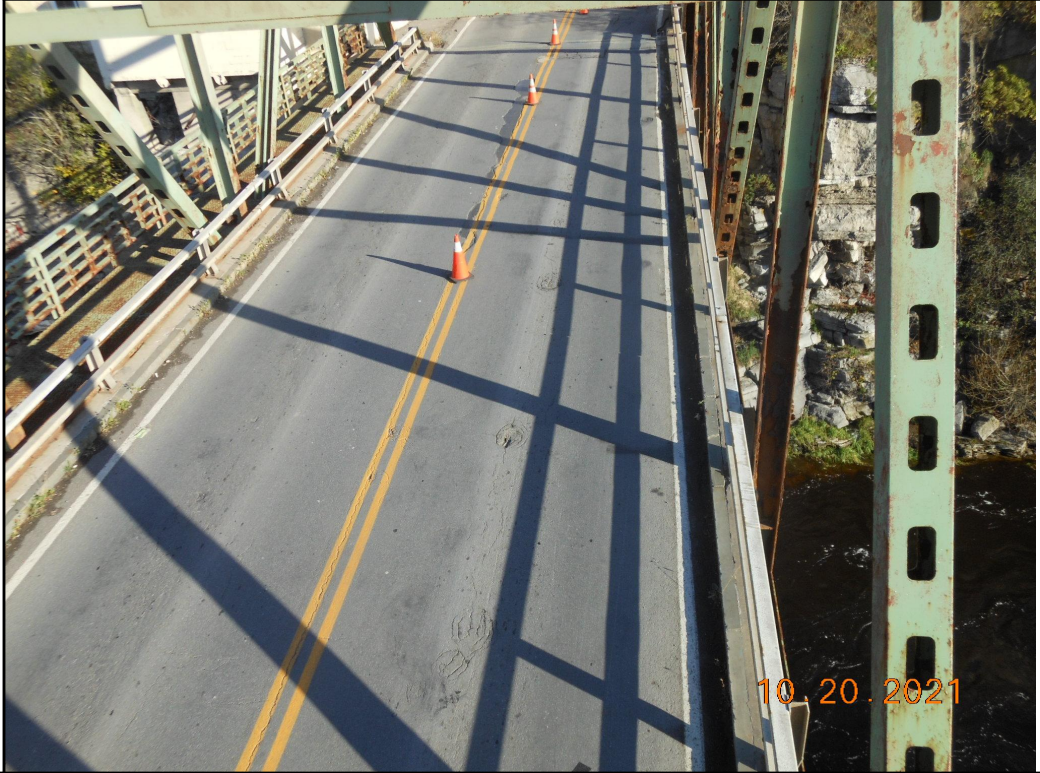
Photo Number: 11 Photo Filename: 11\_Wearing Surface at the End Half of Span

**Attachment Description:**  
Wearing Surface at the End  
Half of Span from Midspan

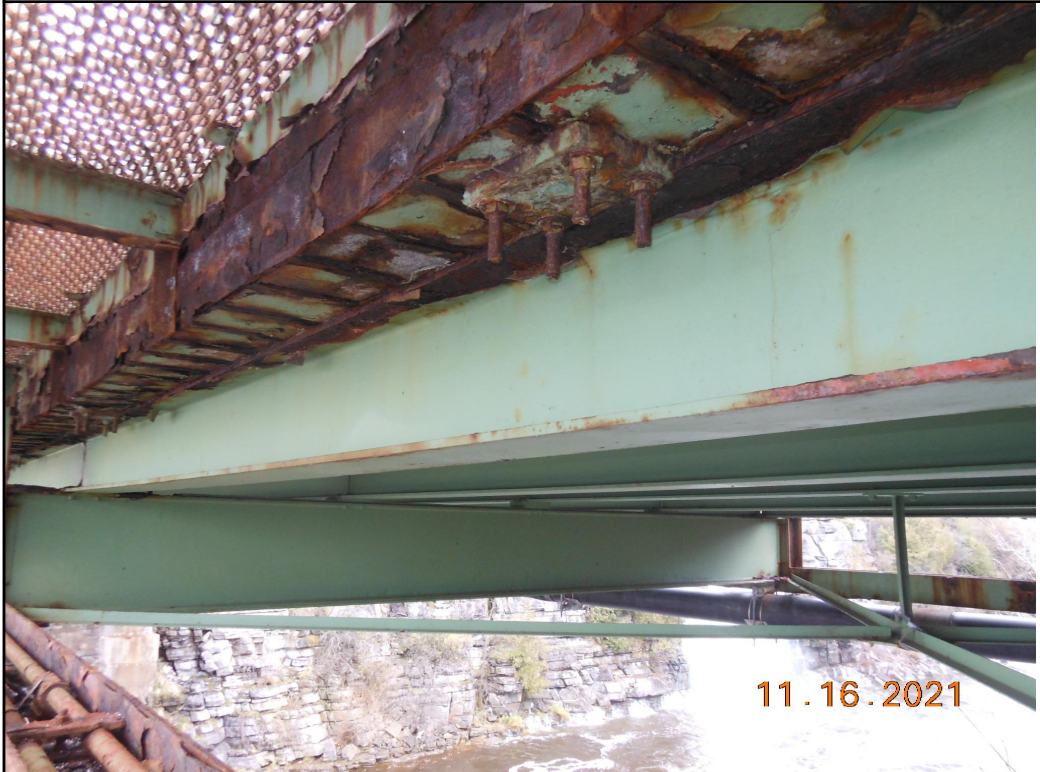
Photo Number: 12 Photo Filename: 12\_Stringer 1 between L02\_L03 from

**Attachment Description:**  
Stringer 1 between L02\_L03  
from Begin

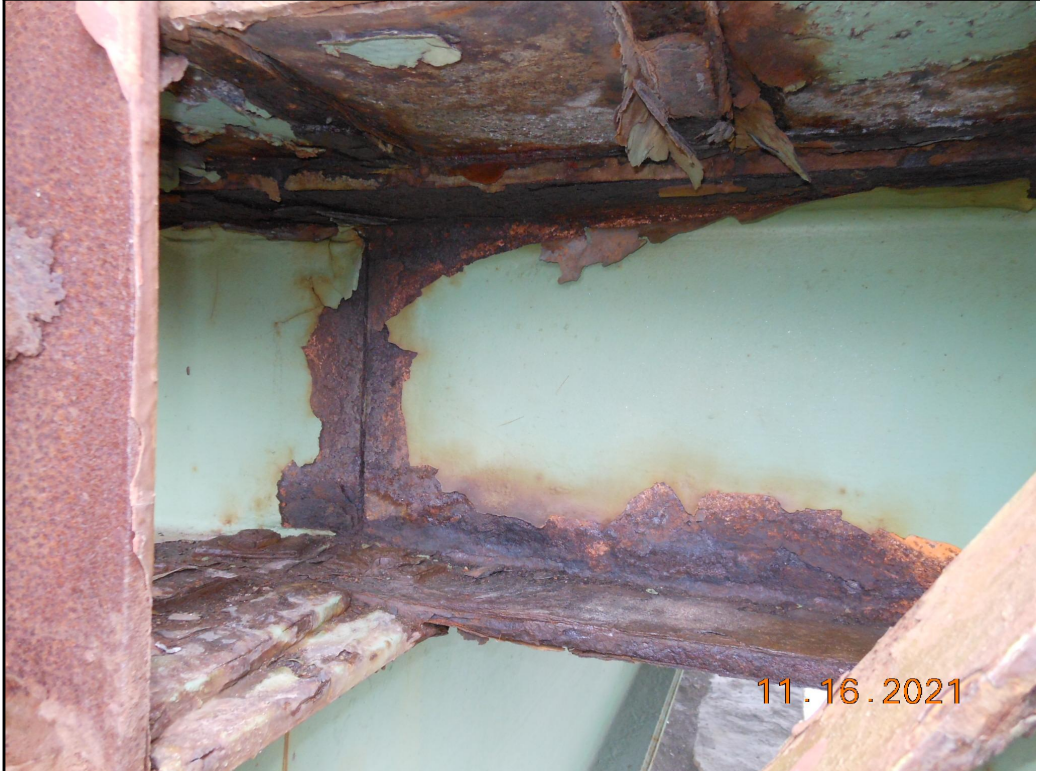
Photo Number: 13 Photo Filename: 13\_Stringer 5 at L02From

**Attachment Description:**  
Stringer 5 at L02From Right

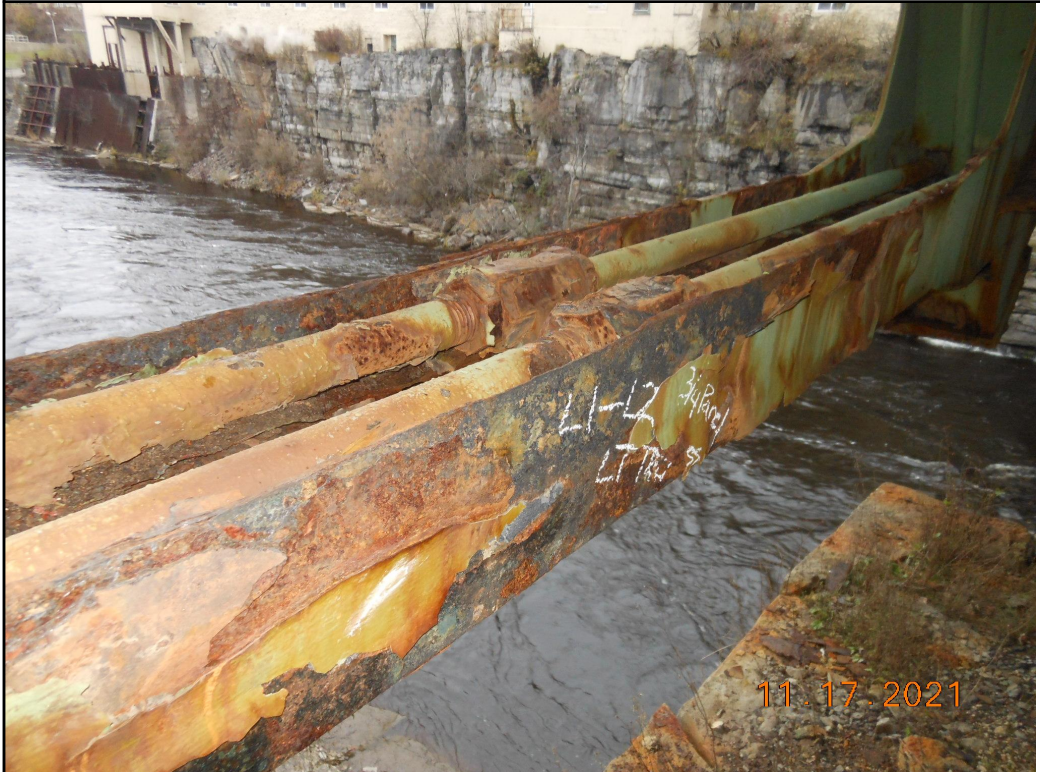
Photo Number: 14 Photo Filename: 14\_Left Bottom Chord L01\_L02 from Begin

(CS3) - Left Truss bottom chord member L01-L02 has 28% section loss to the left flange, 33% section loss to the right flange and 25% section loss to the web. The total section loss for the member is 30% (photo 14). The previous inspection indicates that bottom chord section loss was estimated at 30%. No flag is issued for this condition due to the presence of the steel tension rods that were added in the past and since the bridge is posted for “No Trucks with R Permits”. See Truss Member Section Loss Sketch. Bottom truss section loss is similar throughout the full length of both bottom chords.

2021 – (Condition State 4) – Approximately 40% of the paint on the truss members has failed allowing corrosion to occur (photos 14, 16, 19, 20 and 21).

**Attachment Description:**  
Left Bottom Chord L01\_L02  
from Begin Right

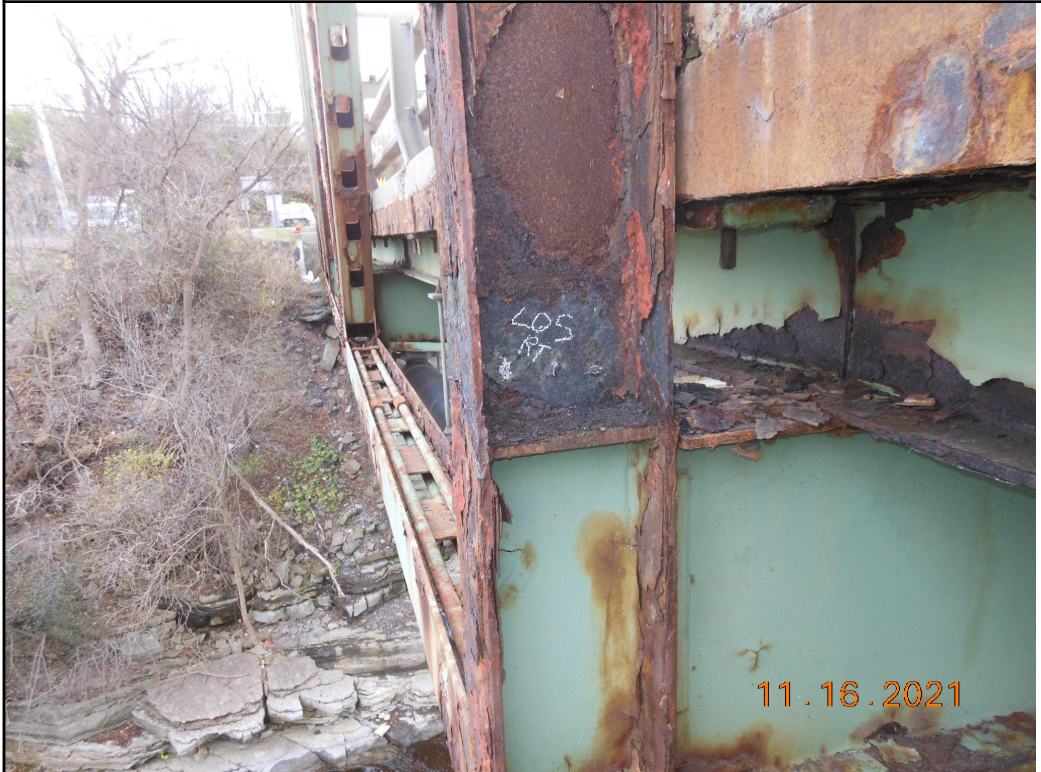
Photo Number: 16 Photo Filename: 16\_End Face of Right Truss Vertical Member

**Attachment Description:**  
End Face of Right Truss  
Vertical Member L05\_U05  
at Top of Floorbeam
