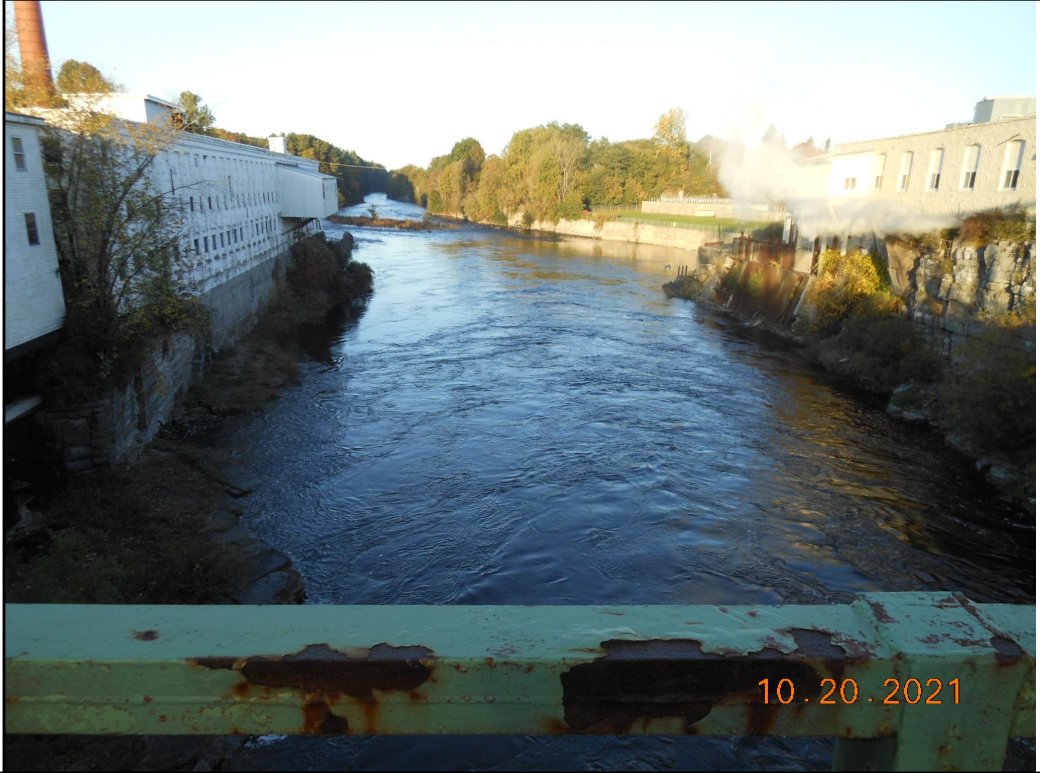
Photo Number: 41 Photo Filename: 41_Left_Downstream Channel_21_DSCN4849.

Attachment Description:
Left_Downstream Channel

2021 – Channel Scour – The Stream Channel consists of bedrock and water is flowing fast in the Black River. Channel cross-section readings along the fascia were not taken.

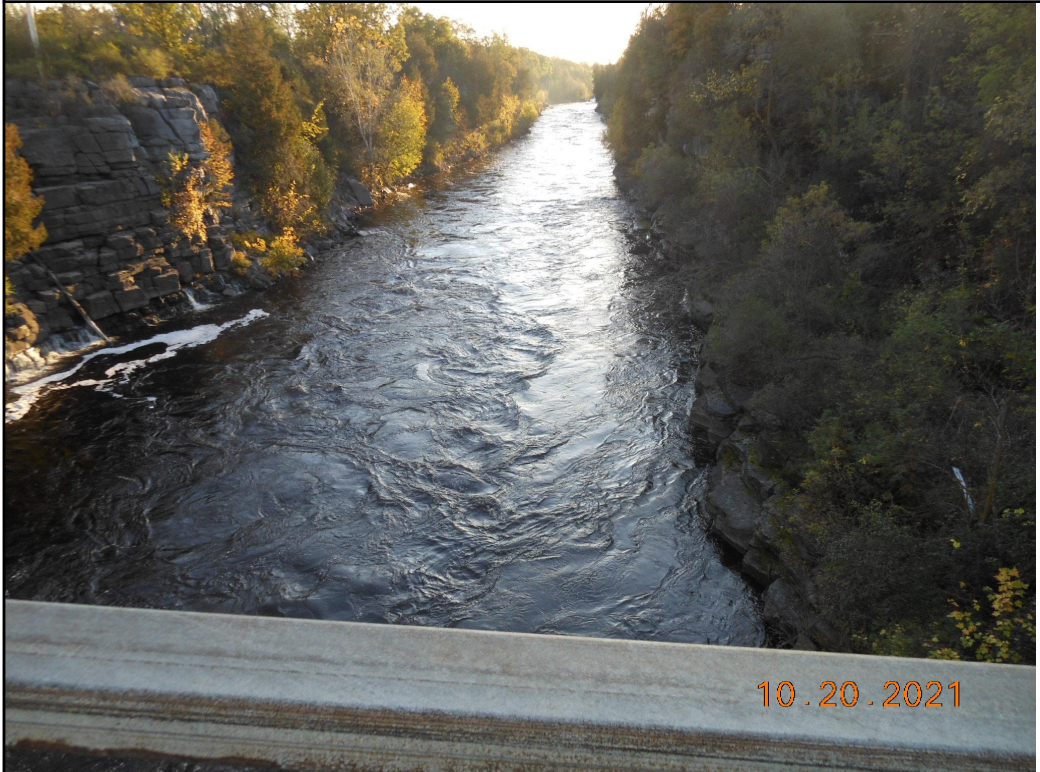
Photo Number: 42 Photo Filename: 42_Right_Upstream Channel_21_DSCN4850.

Attachment Description:
Right_Upstream Channel

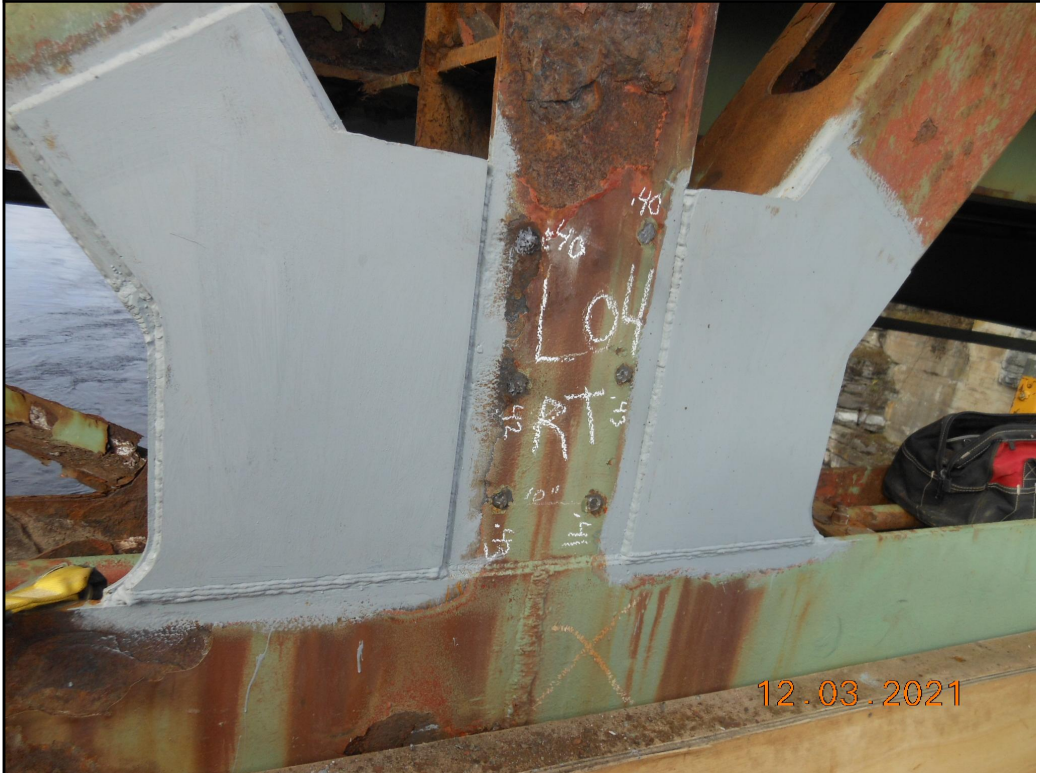
Photo Number: 43

Attachment Description:
Right Truss at L04 from
Right

Right truss vertical member L04-U04 has 10% (estimated) left flange section loss, 30% right flange section loss, and up to 100% web loss below the elevation of the top of the floorbeam. The total section loss for the member below the top of the floorbeam is 41% (photos 43 and 44). Deterioration for this member was previously estimated to have 10% section loss. Also, See Right Truss L04-U04 Section Loss Sketch and Yellow Flag 7B21N6W021.

Red Flag 7B21N6W016 (new flag) was issued during this inspection due to heavy section loss with perforations to the outer gusset plates at right truss L04 (not previously reported). See Red Flag 7B21N6W016, the Gusset Plate Section Loss Sketch and photo 18. The outer gusset plates for the right truss at L04 were repaired (certified by NYSPE) and Red Flag 7B21N6W016 was removed on 12/2/21 (photo 43). The inner gusset plates at L04 have 10% to 15% section loss (photos 45 through 48).

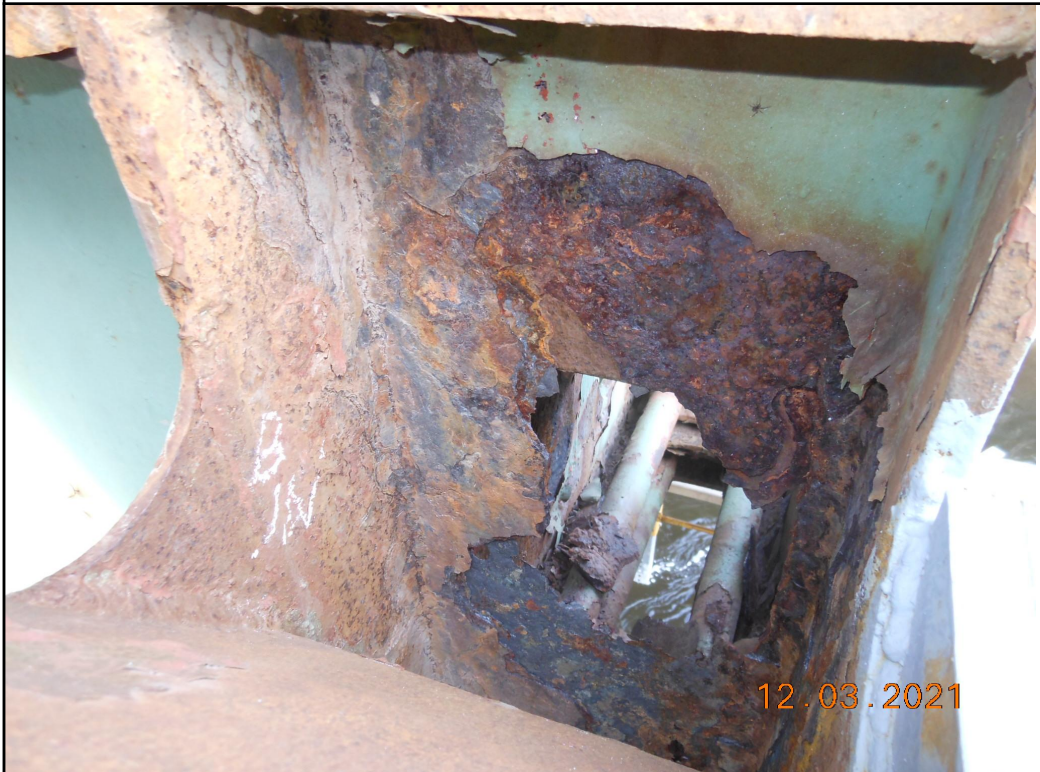
Photo Number: 44

Attachment Description:
Lower Portion of Right
Truss Vertical
L04_U04_from Begin

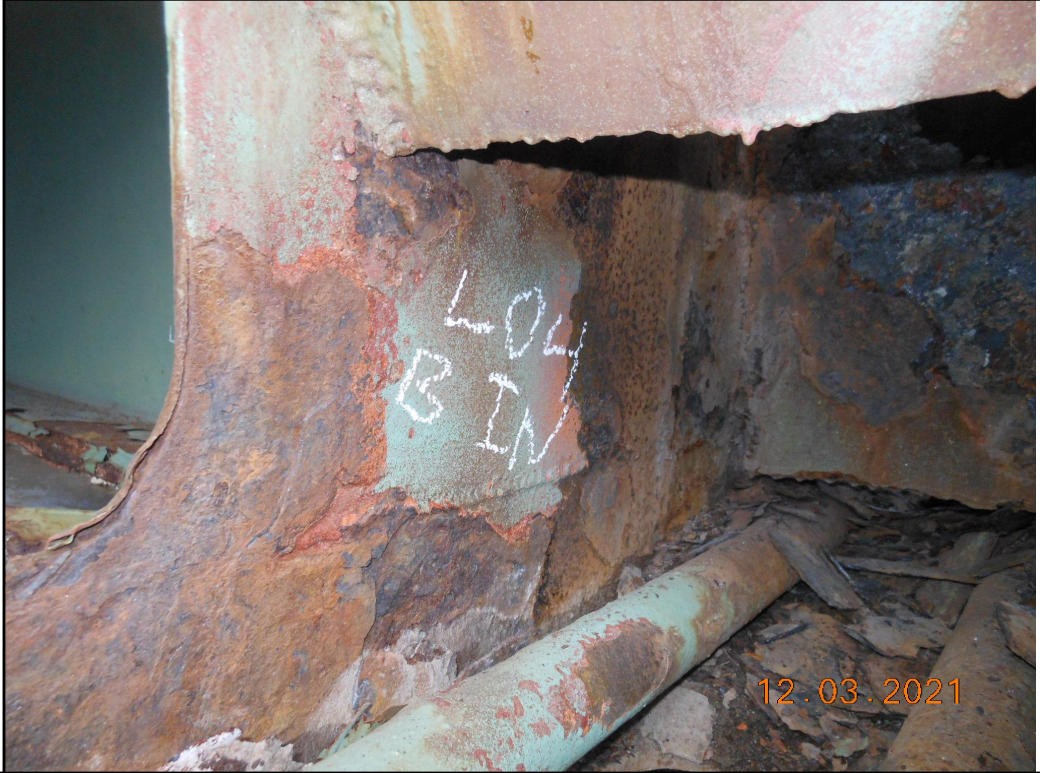
Photo Number: 45 Photo Filename: 45_Right Face of Inner Gusset Plate at Begin

Attachment Description:
Right Face of Inner Gusset
Plate at Begin of Right
Truss L04

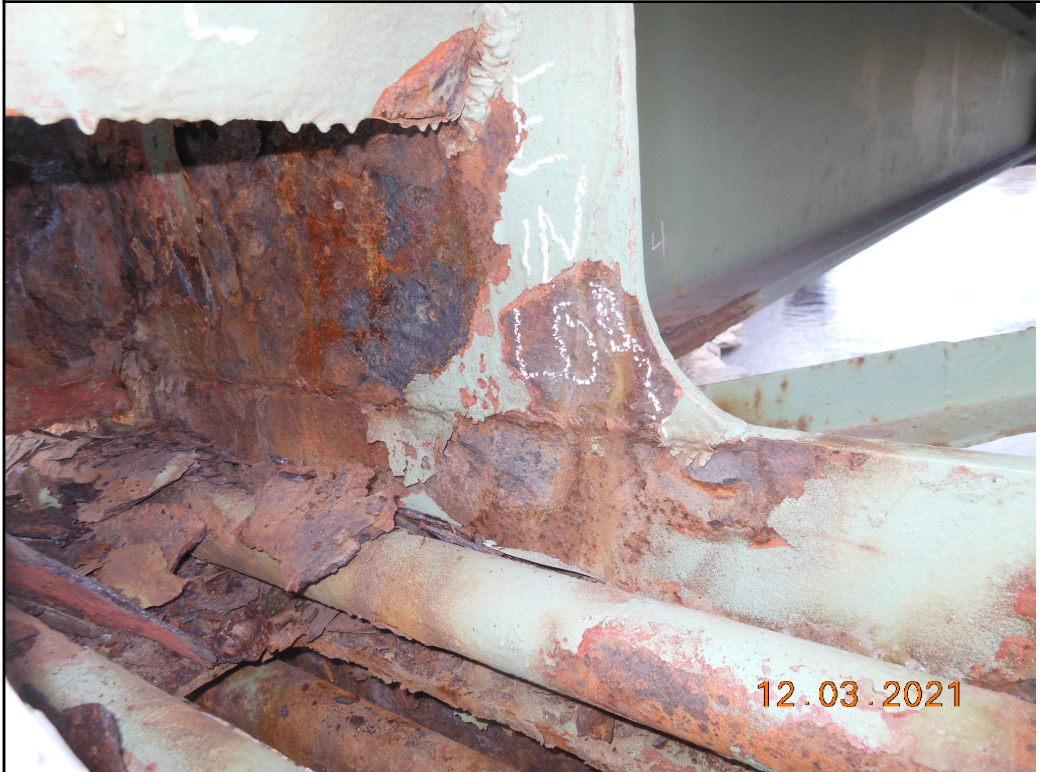
Photo Number: 46 Photo Filename: 46_Right Face of Inner Gusset Plate at End of

Attachment Description:
Right Face of Inner Gusset
Plate at End of Right Truss
L04

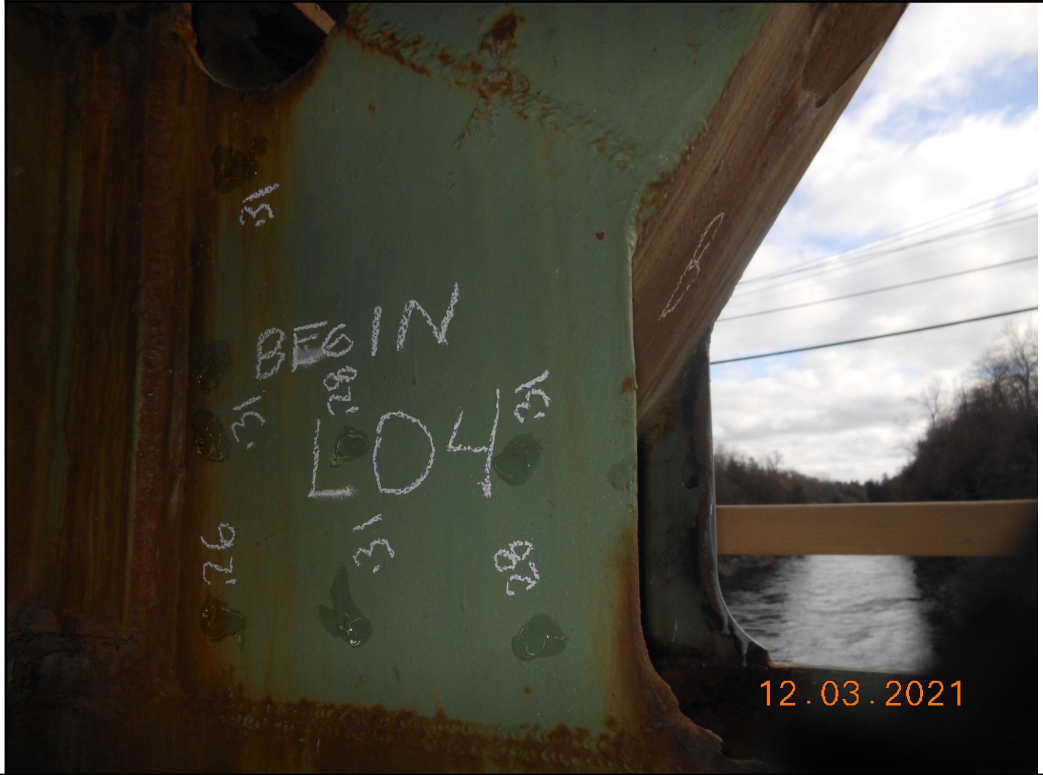
Photo Number: 47 Photo Filename: 47_Left Face of Begin Inner Gusset Plate at

Attachment Description:
Left Face of Begin Inner
Gusset Plate at Right Truss
L04

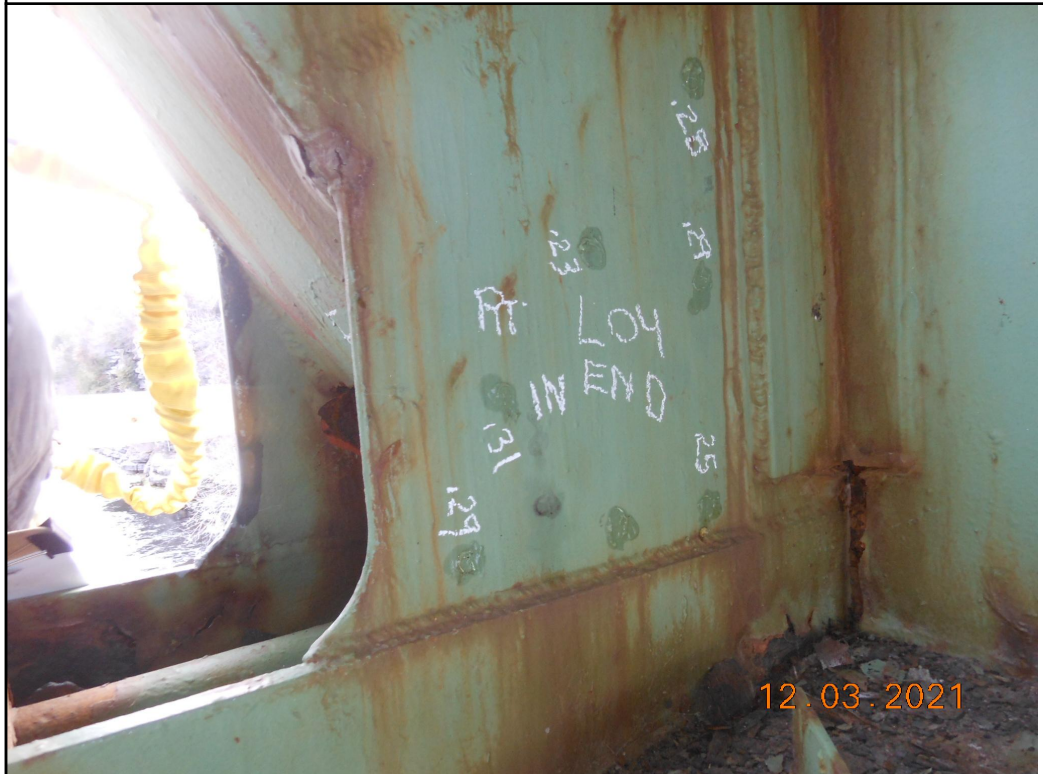
Photo Number: 48 Photo Filename: 48_Left Face of End Inner Gusset Plate at

Attachment Description:
Left Face of End Inner
Gusset Plate at Right Truss
L04

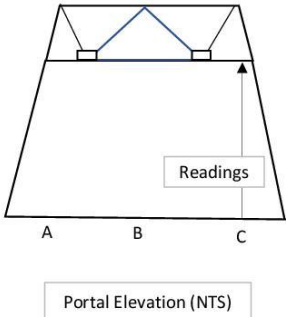
Sketch Number: 5

Readings taken to lowest edge of the lower cross channel @ the travel lane paint lines.				
					2021 Readings initiated.				
Year	2021				Year	2021			
Location	ft.	ft.	ft.	ft.	Location	ft.	ft.	ft.	ft.
PORTAL 1 (Begin)					PORTAL 2				
A	15.1				A	15.1			
B	15.0				B	15.1			
C	15.2				C	15.1			
PORTAL 3					PORTAL 4 (End)				
A	15.0				A	15.1			
B	15.0				B	15.1			
C	15.2				C	15.2

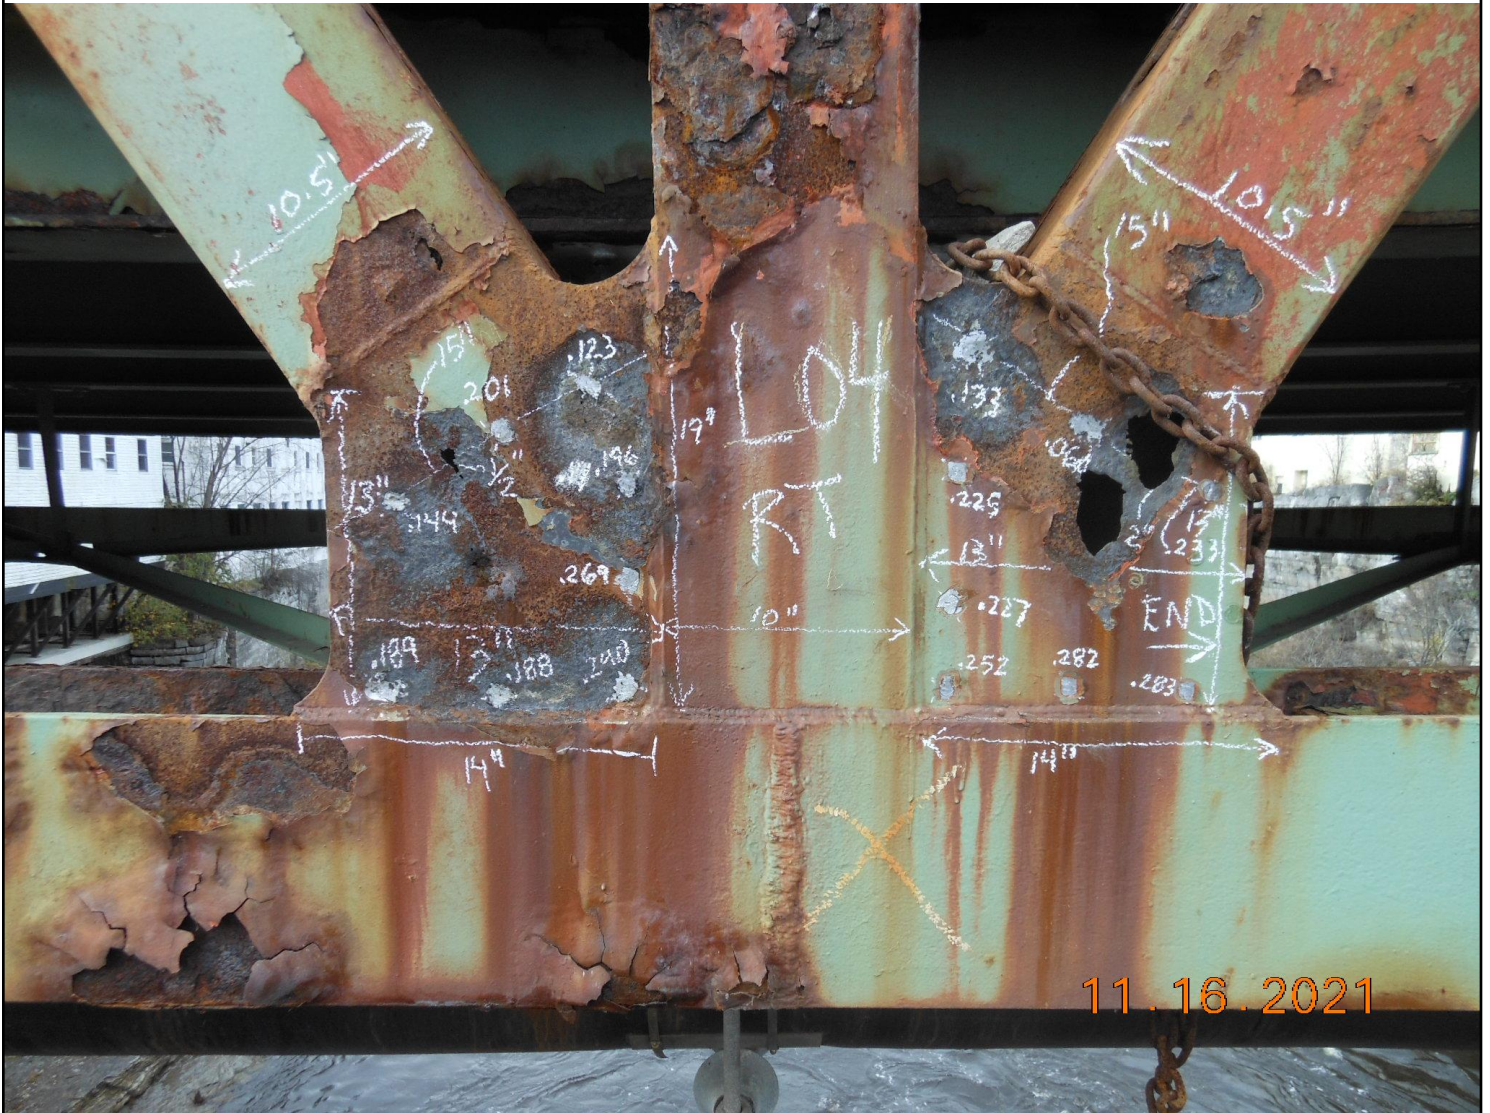
Photo Number: 3

2021 Flag Conditions: The right truss outer gusset plates at L04 have heavy section loss with perforations. This is a new flag with no flags superseded.

The begin outer gusset plate at L04 (Right Truss) has approximately 52% section loss including a 1/2 inch perforation in a plane perpendicular to diagonal member U03-L04 located approximately 5 inches from the bottom of the diagonal member (flag photo 3).

The end outer gusset plate at L04 (Right Truss) has approximately 61% section loss including a 2-inch diameter perforation in a plane perpendicular to diagonal member L04-U05 located approximately 5 inches from the bottom of the diagonal member (flag photo 3).

Significance: The affected gusset plates serve to connect the diagonal members of the truss with the bottom chord. Should the plates fail along the band of section loss in tension (tear-out) or compression (buckling) the integrity of the panel point will be compromised.

Attachment Description: Right Truss at L04 from Right

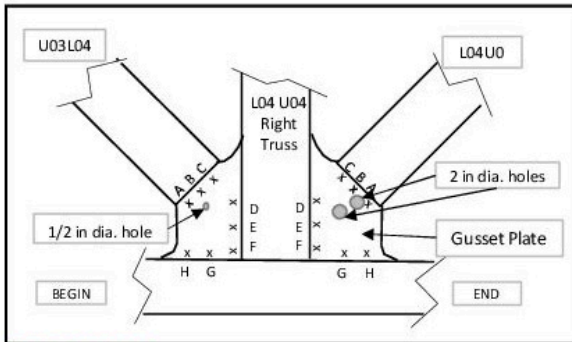
Photo Number: 4

Original Area Along Plane Perpendicular to Diagonal Mbr:
 $15 \times 0.313 = 4.695 \text{ in}^2$

Remaining Area Perpendicular to Diagonal Mbr:

Begin: $(15 - 0.5) \times 0.156 = 2.262 \text{ in}^2$

End: $(15 - 2) \times 0.142 = 1.846 \text{ in}^2$

Begin Outer Gusset Plate @L04									
LOCATION	A	B	C	D	E	F	G	H	Section Loss
Plane Perpendicular to Diagonal Member	0.144	0.201	0.123						52% including 1/2" hole
Plane along Vertical Member			0.123	0.196	0.269	0.29			30%
Plane along Top of Bottom Chord						0.29	0.188	0.189	29%

End Outer Gusset Plate @L04									
LOCATION	A	B	C	D	E	F	G	H	Section Loss
Plane Perpendicular to Diagonal Member	0.233	0.06	0.133						61% including 2" holes
Plane along Vertical Member			0.133	0.225	0.227	0.252			33%
Plane along Top of Bottom Chord						0.252	0.282	0.283	13%
