PIN 7780.09 – New York Route 12E over Black River Bridge Replacement  
Town of Brownville and Town of Hounsfield, New York

# New York State Department of Transportation General Bridge Inspection Report

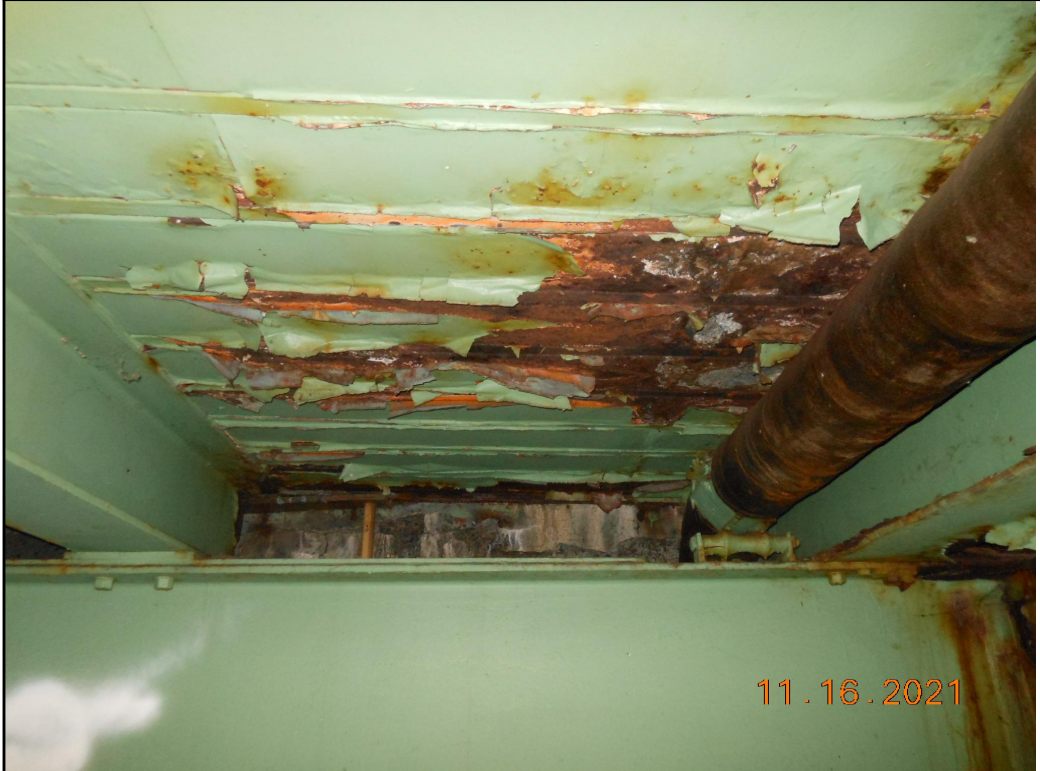
Photo Number: 1 Photo Filename: 01\_Underside of Deck in Stringer Bay 1 above

2021 – The underside of the concrete filled steel deck grating as several isolated random areas of spalled concrete exposing the steel deck grating with corrosion and minor section losses evident. This condition is the worst in the fascia bays and near the abutments (photos 1 through 3).  
 Both edges of the deck (fascia) have spalling with the worst conditions occurring on the right fascia. The right edge of the deck and brush curb have isolated areas of heavy spalling around isolated bridge railing posts at the begin right exposing railing anchorage (photo 4).  
 In addition, both deck fascia have steel armoring/plates/channels with varying degrees of corrosion with some perforations and with the steel peeling away from the deck fascia at some locations (photos 5 and 6).  
 Approximately 25% of the overall area is affected.

**Attachment Description:**  
Underside of Deck in  
Stringer Bay 1 above  
Floorbeam 0 Looking  
toward Begin

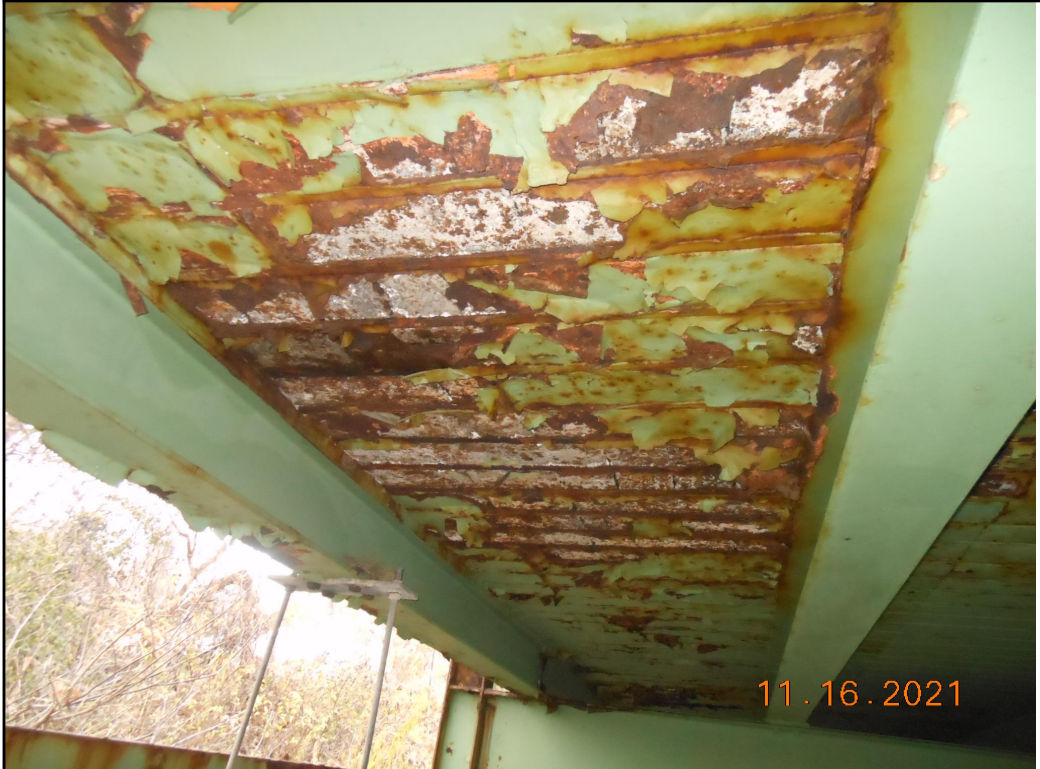
Photo Number: 2 Photo Filename: 02\_Underside Of Deck In Stringer Bay 4

**Attachment Description:**  
Underside Of Deck In  
Stringer Bay 4 Between  
Floor Beams 1 And 2 from  
End

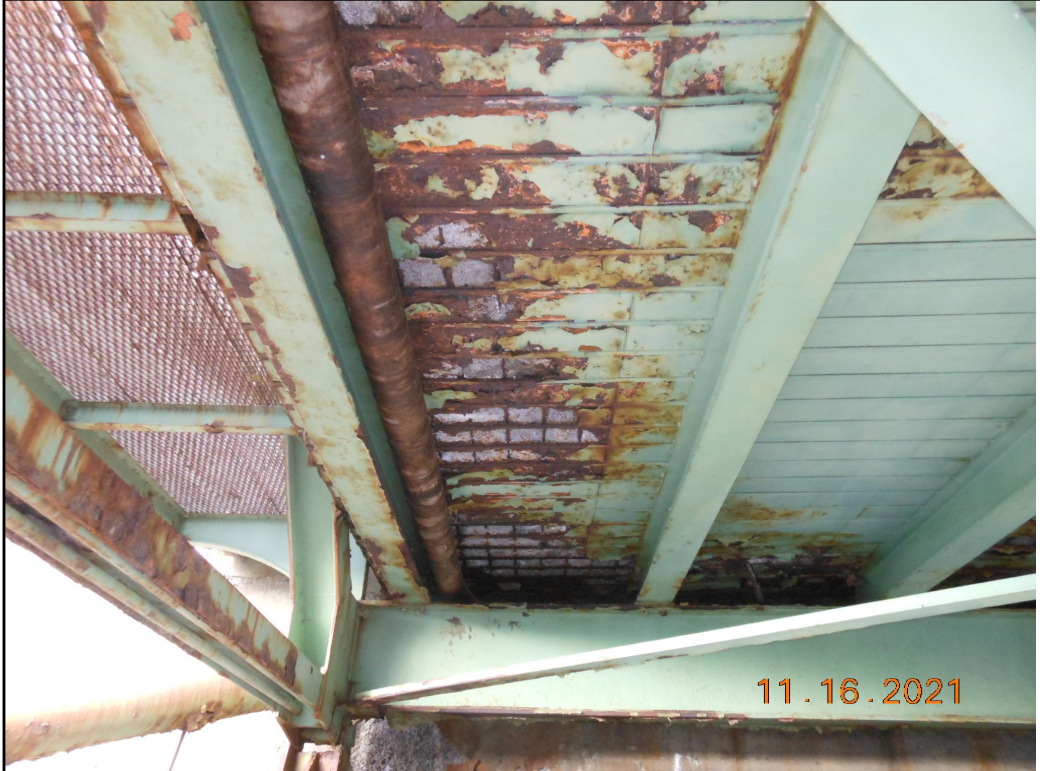
Photo Number: 3 Photo Filename: 03\_Underside of Deck in Stringer Bay 1 near

**Attachment Description:**  
Underside of Deck in  
Stringer Bay 1 near End  
Abutment from Begin

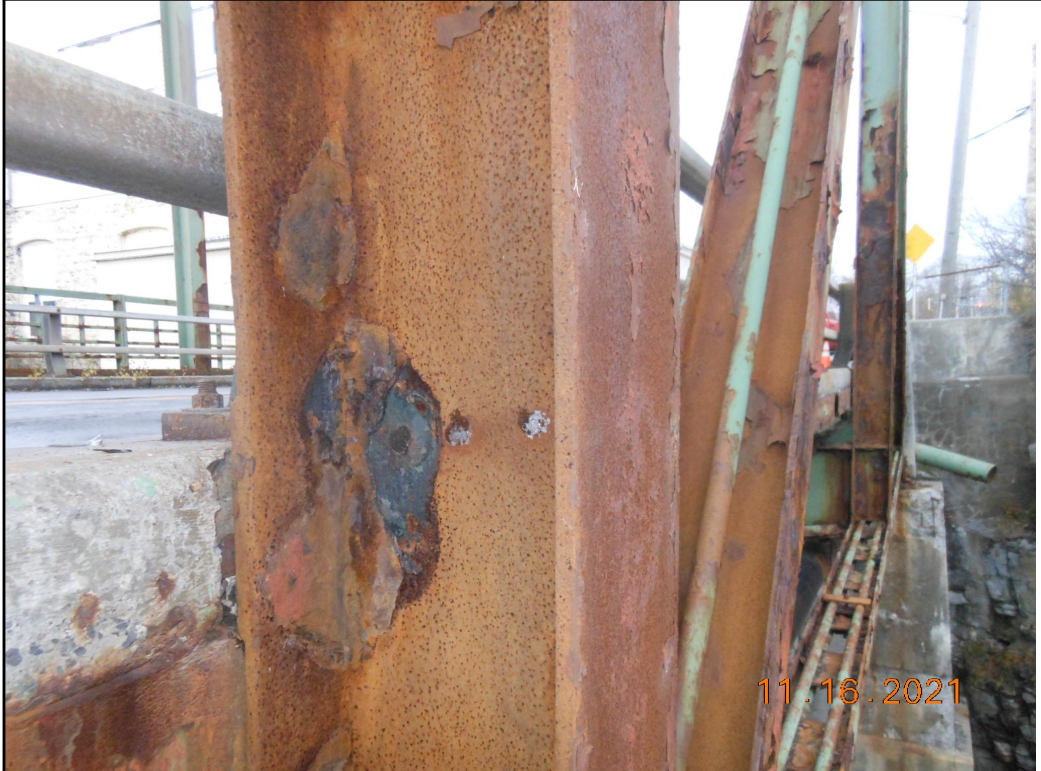
Photo Number: 15 Photo Filename: 15\_Begin Face of Right Truss Member

**Attachment Description:**  
Begin Face of Right Truss  
Member L06\_U06 at Deck  
Level
