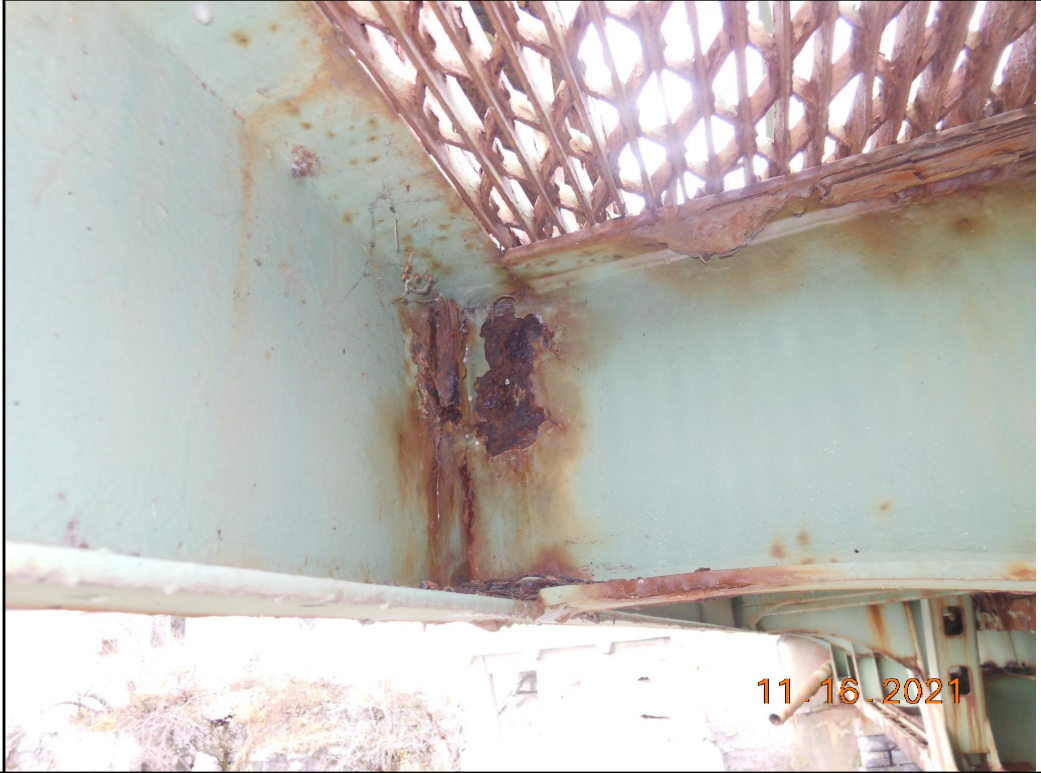
Photo Number: 35

Attachment Description:
Begin Face of Left Sidewalk
Cantilever_Angle Welded to
Outer Fascia Channel for
Sidewalk at L05

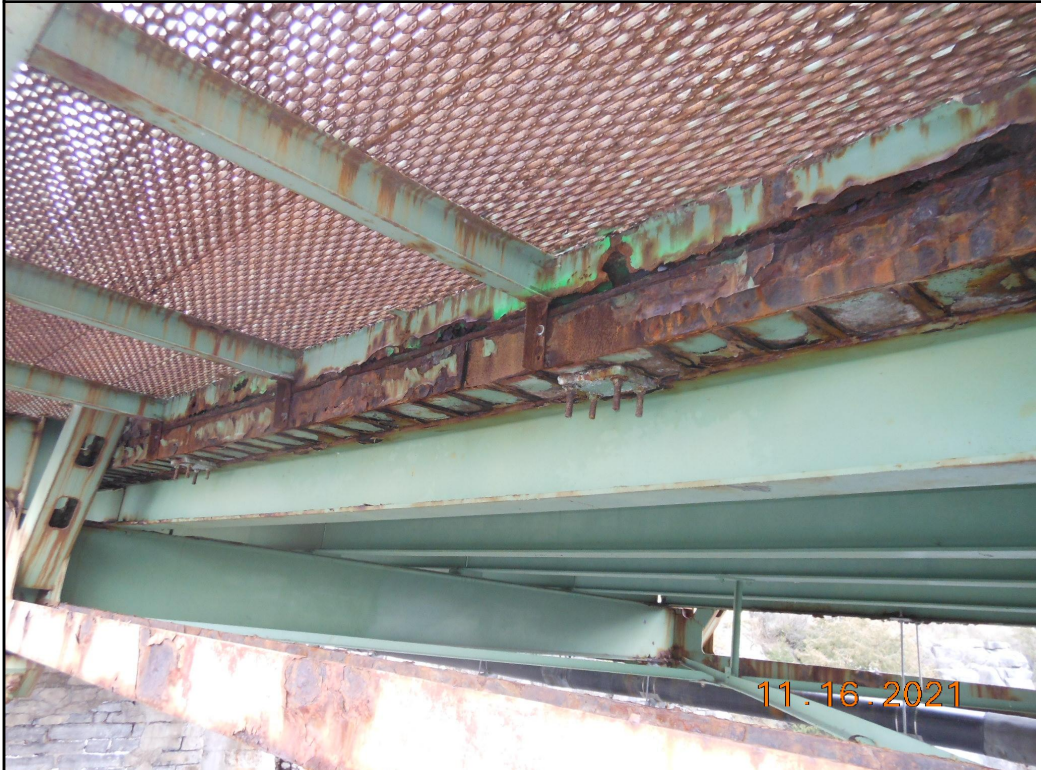
Photo Number: 36

Attachment Description:
Left Fascia Channel
between L05 and L06 from
Begin

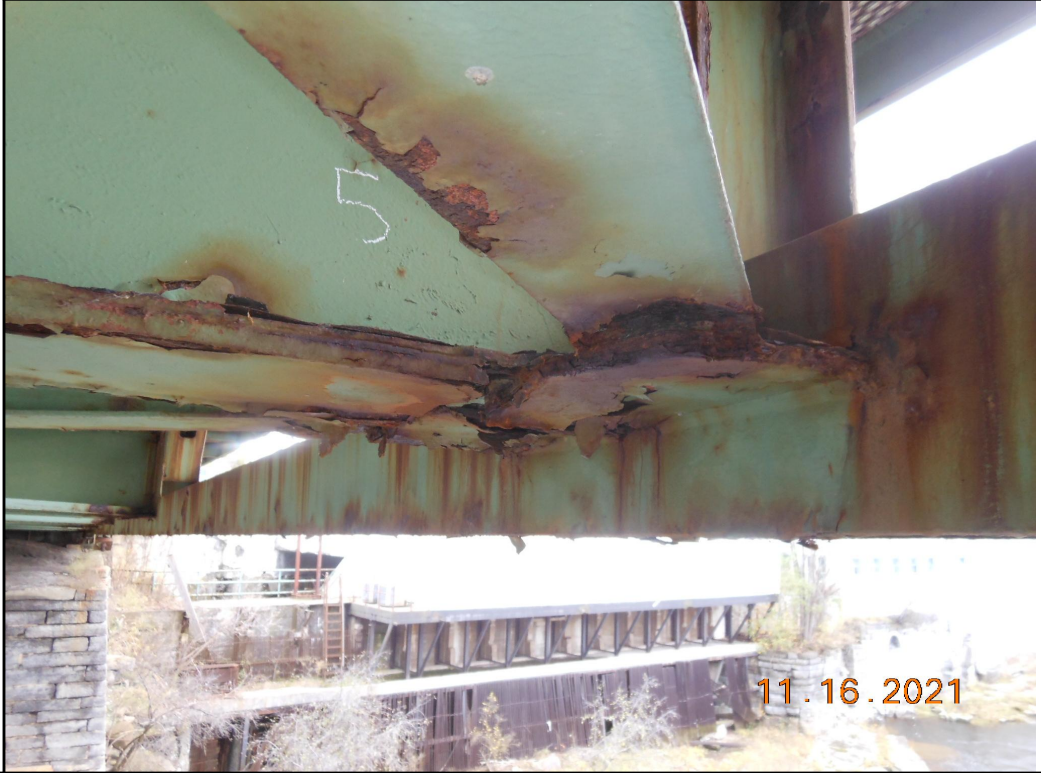
Photo Number: 37 Photo Filename: 37_Bottom Lateral Bracing Connection to Left

Attachment Description:
Bottom Lateral Bracing
Connection to Left Truss at
End Face of Floorbeam 5

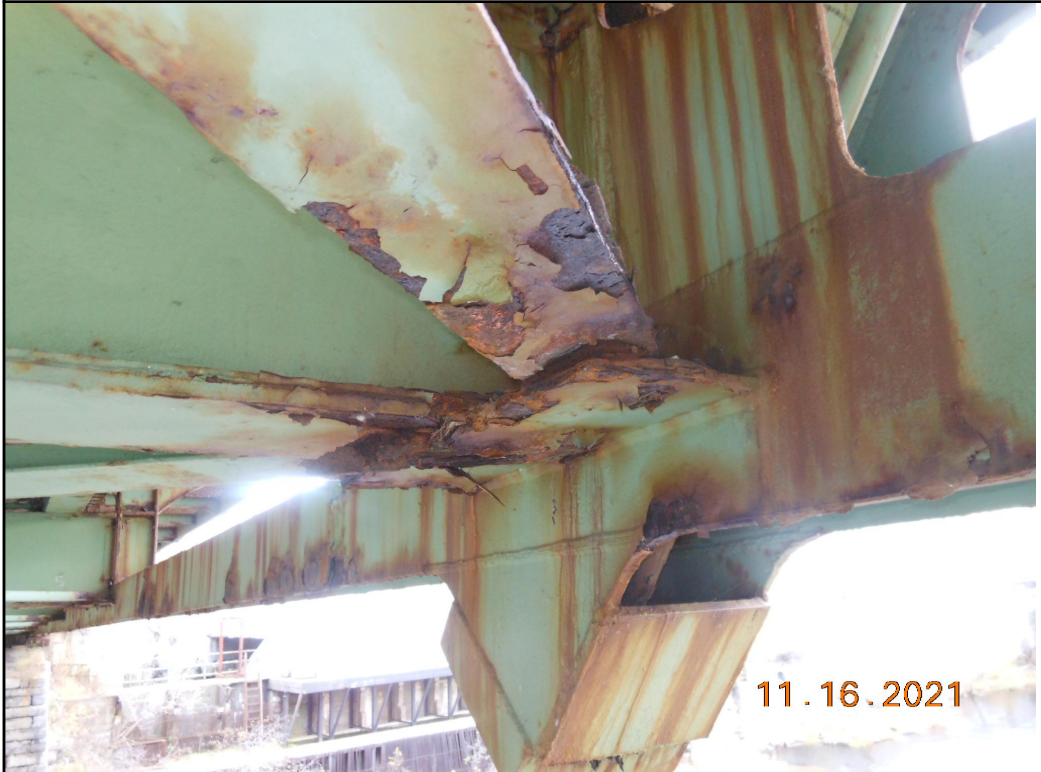
Photo Number: 38 Photo Filename: 38_Bottom Lateral Bracing Connection to Left

Attachment Description:
Bottom Lateral Bracing
Connection to Left Truss at
End Face of Floorbeam 6

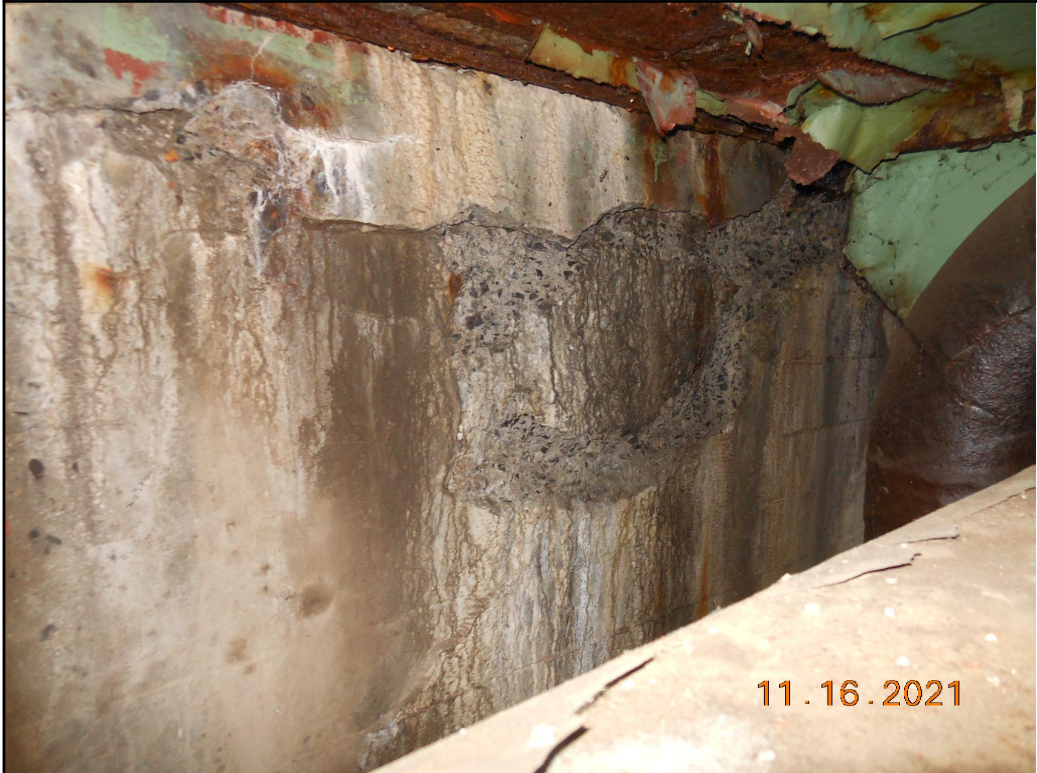
Photo Number: 39 Photo Filename: 39_Begin Abutment Backwall in Bay

Attachment Description:
Begin Abutment Backwall in Bay 1

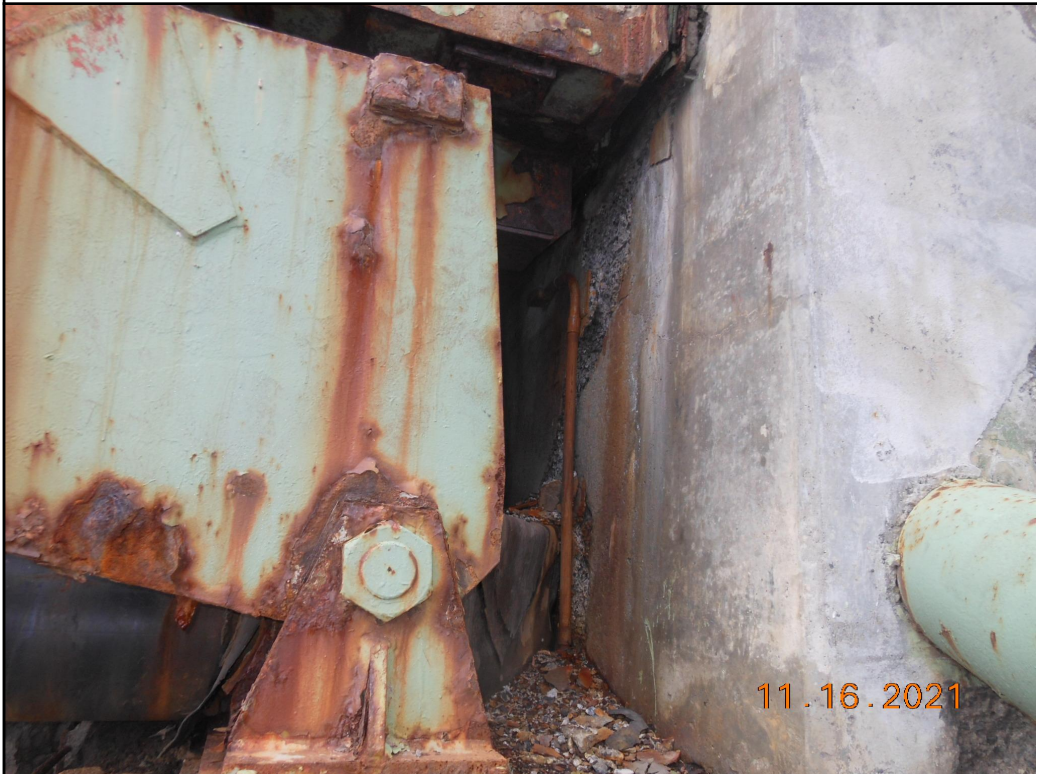
Photo Number: 40 Photo Filename: 40_End Abutment Backwall from

Attachment Description:
End Abutment Backwall from Right

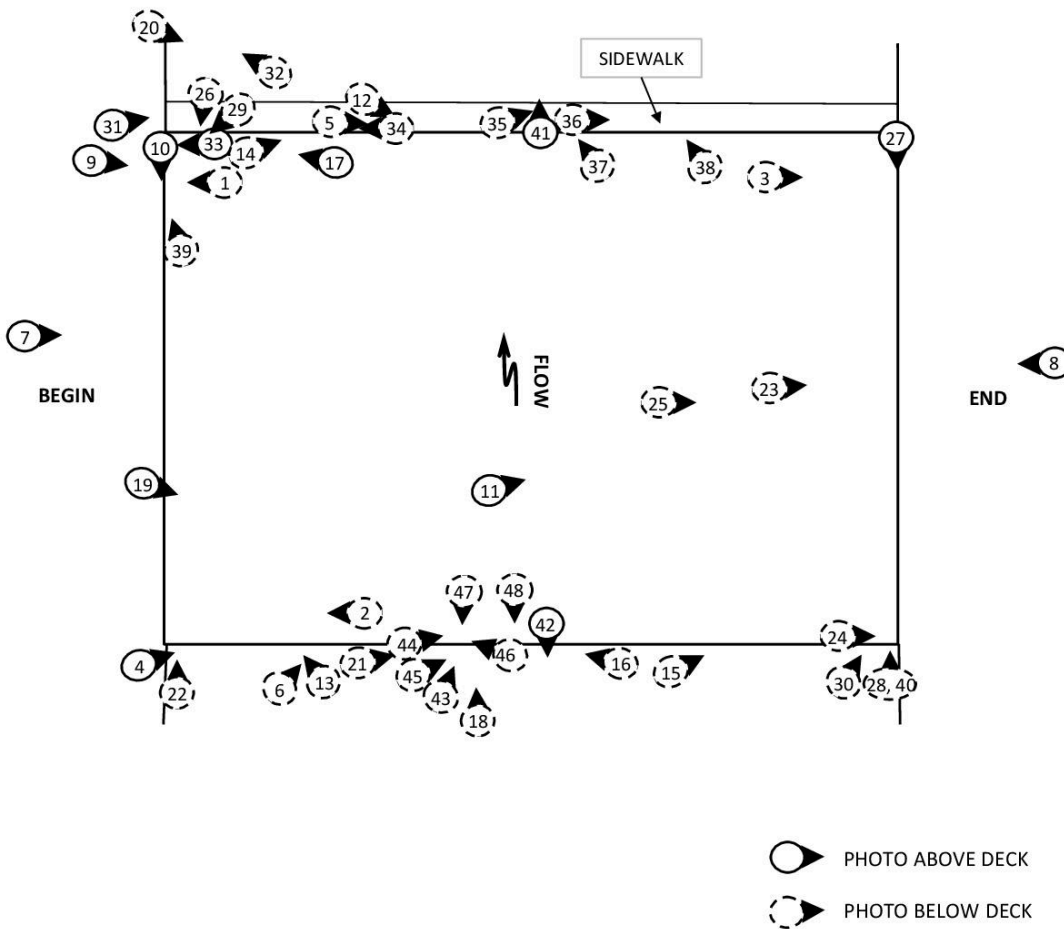
Sketch Number: 1

Sketch Description: Photo Location Plan
